## **Fire Risk Appraisal of External Walls**

**Harold Court, Holdbrook South,  
Waltham Cross  
Hertfordshire EN8 7SR.  
B3Living Ltd.**

**Report Issued: February 2026**

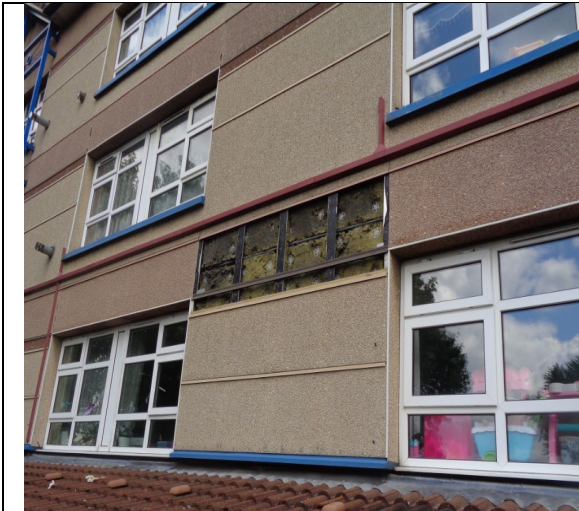
The presence of the combustible Steni GRP rainscreen cladding panels results in this wall type having an indicative fire load value of  $210 \text{ MJ/m}^2$  and together with the construction defects found indicate that a complete 'Basic' PAS 9980 assessment (Steps 3 to 5) is necessary for this wall type.

Figure 15: General view of External Wall Type #1.

| | Recommendations | Priority | Time frame |
|---|---|---|---|
| 2. | Remove the combustible Steni GRP rainscreen cladding panels and replace them with a cladding system using materials which are non-combustible or of limited combustibility (Euroclass A2-s1, d0 or better).<br><br>The applicable areas for removal are all elevations. | High | Aim to commence the works within 9 - 12 months. |

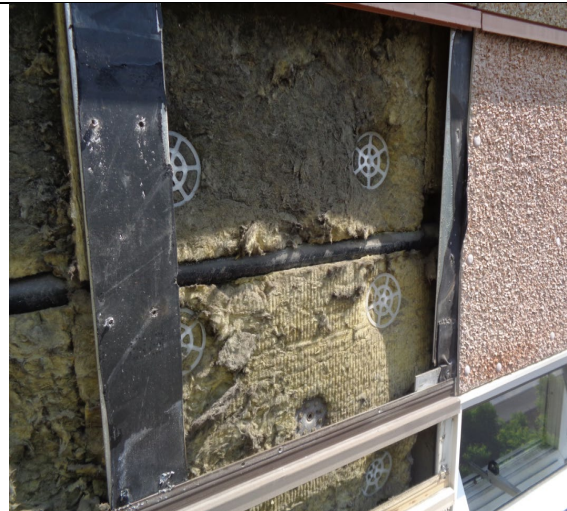
Figure 16: Close up view to show mineral wool insulation.

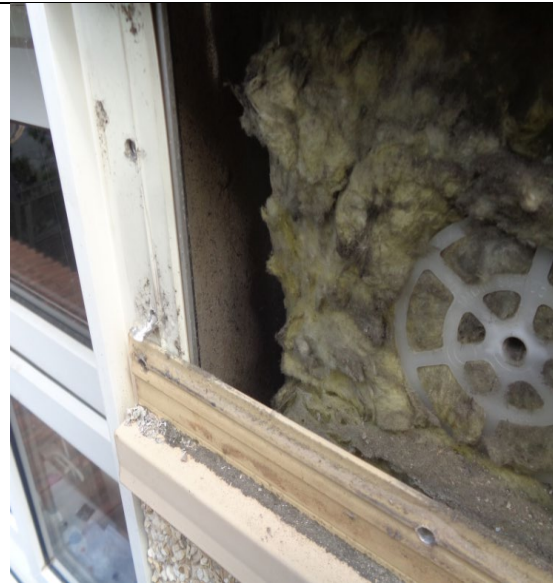
Figure 22: General view to missing insulation to window jamb.

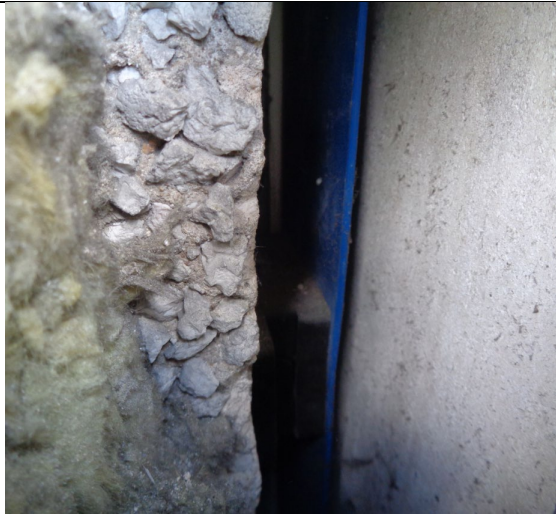
*Figure 23: Alternative view to show no insulation installed to window jamb.*

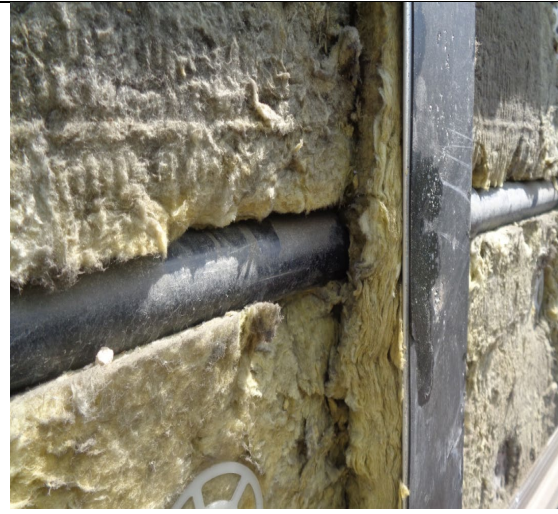
*Figure 24: General view to show service pipes / cables located with mineral wool insulation.*

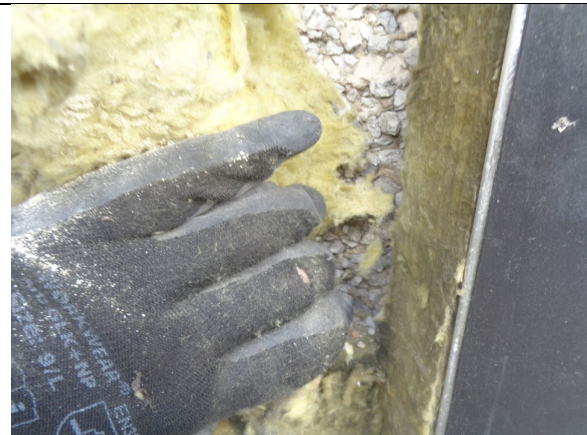
The cavity to the Steni GRP rainscreen cladding panels is continuous vertically with no cavity barriers installed at compartment floor locations observed during our inspections. Vertical cavity barriers, in the form of a solid mineral wool batt, had been installed in some compartment wall locations but these are unsuitable as they are not fully in compression to the pebble dash render and the rear of the Steni GRP rainscreen cladding. In the event of a fire, fire and smoke would be able to pass along the cavity to the rainscreen cladding. Voids were noted to be present behind the insulation installed around the window reveal cladding panels.

*Figure 26: General view of unsuitable vertical cavity barrier installed at compartment wall location – cavity barrier is not in compression against the rear of the Steni GRP panel.*

| | Recommendations | Priority | Time frame |
|---|---|---|---|
| 4. | Where cavities are present in any replacement cladding system, ensure suitable cavity barriers are installed at floor & wall compartment lines, wall edges, around vent penetrations and around window openings. | High | During remediation. |

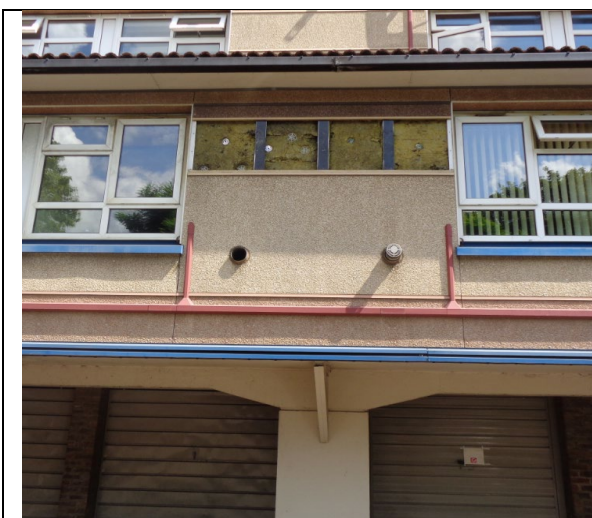
The presence of the combustible Steni GRP rainscreen cladding panels results in this wall type having an indicative fire load value of 210 MJ/m<sup>2</sup> and together with the construction defects found indicate that a complete 'Basic' PAS 9980 assessment (Steps 3 to 5) is necessary for this wall type.

Figure 27: General view of External Wall Type #2.

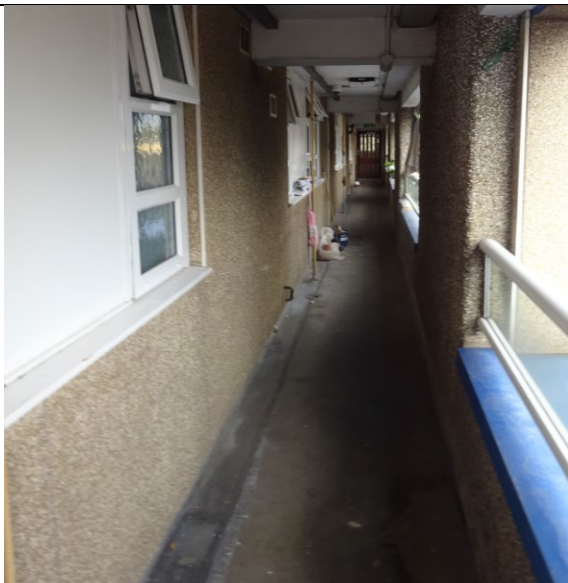
The presence of the combustible Steni GRP rainscreen cladding panels results in this wall type having an indicative fire load value of 210 MJ/m<sup>2</sup> indicates that a complete 'Basic' PAS 9980 assessment (Steps 3 to 5) is necessary for this wall type.

*Figure 53: General view of the Steni GRP panels installed along the open access balconies along the east elevation at first floor level.*

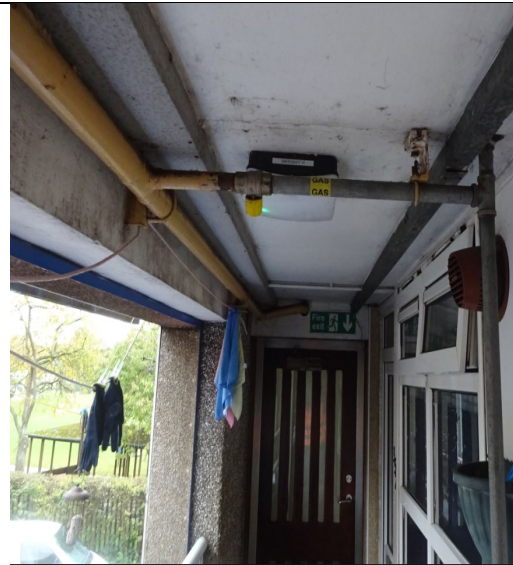
It should be noted that the mains gas supply pipework runs along the length of the open access balconies, see Figure 74. Any potential damage to the pipework could lead to an escalation of a fire affecting the open access balconies.

Figure 74: General view to show Fire Door installed at the opposite end of the open access balcony prior to entering the escape staircase and the concrete soffit to the open access balcony.

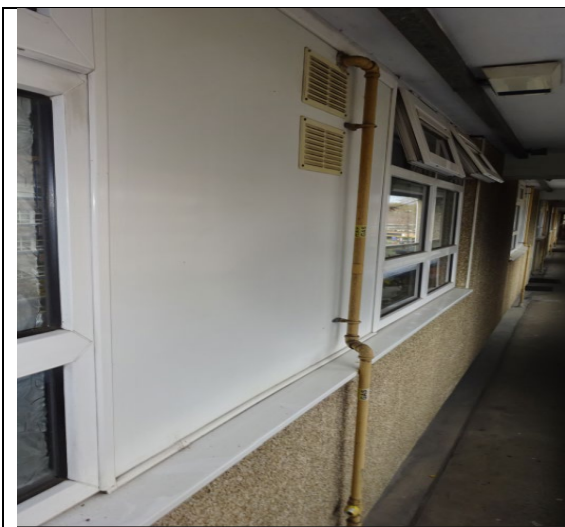
The presence of the combustible solid uPVC panels results in this wall type having an indicative fire load value of 574 MJ/m<sup>2</sup> indicates that a complete 'Basic' PAS 9980 assessment (Steps 3 to 5) is necessary for this wall type.

Figure 87: General view of the solid uPVC panels installed along the open access balconies located along the east elevation.

| | Recommendations | Priority | Time frame |
|---|---|---|---|
| 3. | Remove the combustible solid white uPVC cladding panels and replace them with a cladding system using materials which are non-combustible or of limited combustibility (Euroclass A2-s1, d0 or better).<br><br>The applicable areas for removal are the first, second, third and fourth floor levels to the east elevation. | High | Aim to commence the works within 9 - 12 months. |

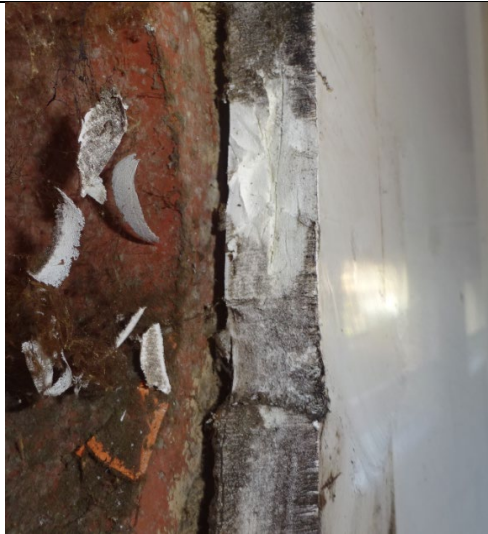
*Figure 91: Close up view to show 20mm solid uPVC panel.*

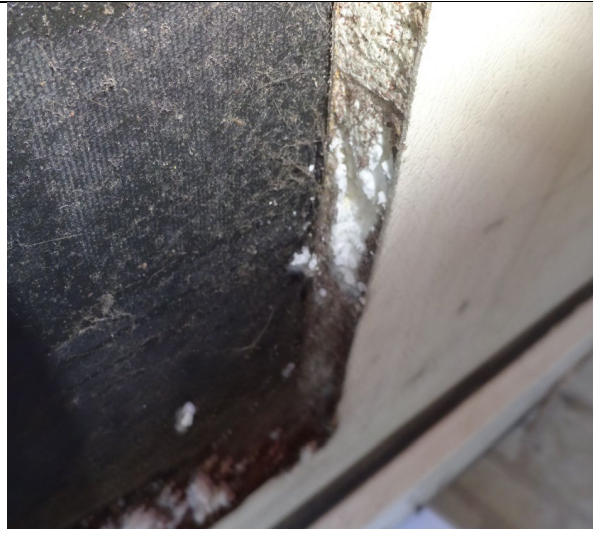
*Figure 92: General view to show EPS insulated panel installed at low level to flat entrance door to Flat No. 354.*

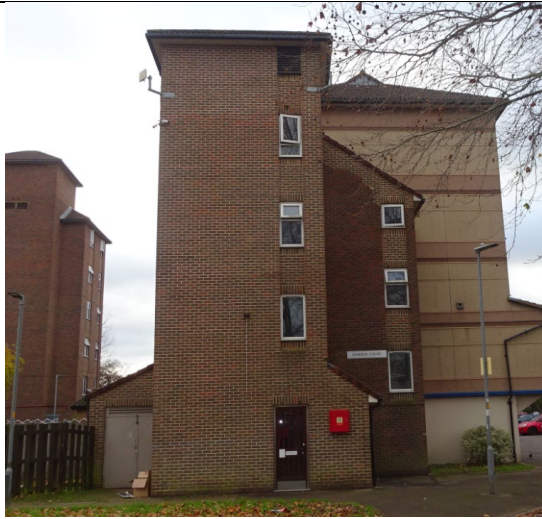
As this wall type contains two leaves of masonry at least 100mm thick, with no combustible insulation, the resulting risk of fire spread is very low and therefore PAS 9980 Steps 3 to 5 are not applicable, and no further assessment of this wall type is required.

Therefore, the risk rating for external wall type #6 is Low.

*Figure 95: General view of the traditional masonry cavity wall construction to the escape staircase located on the north elevation.*

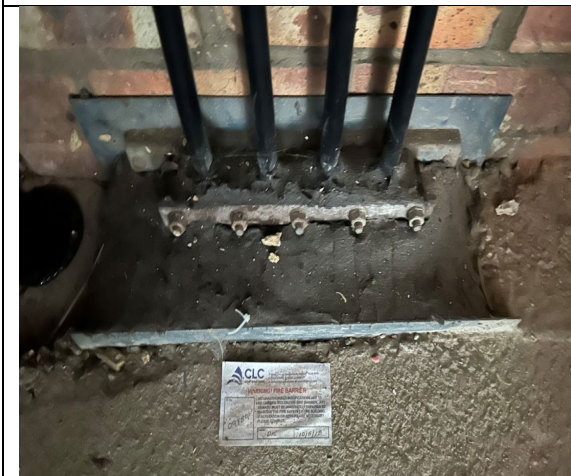
Figure 101: General view to show fire stopping works including ID labels completed to riser cupboards located in escape staircases.

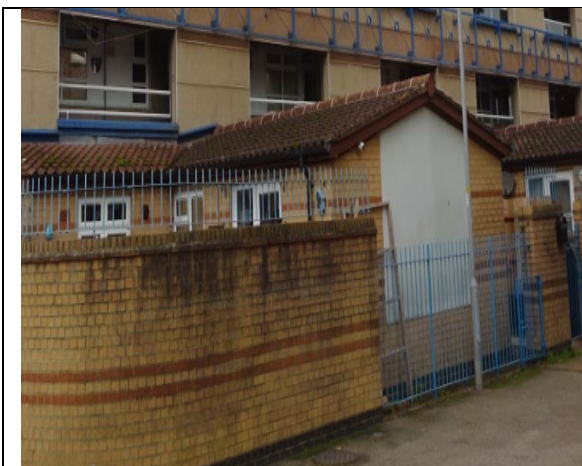
Therefore, the risk rating for external wall type #7 is **Low**.

Figure 111: General view of the traditional masonry cavity wall construction to the ground floor flats along the east elevation.

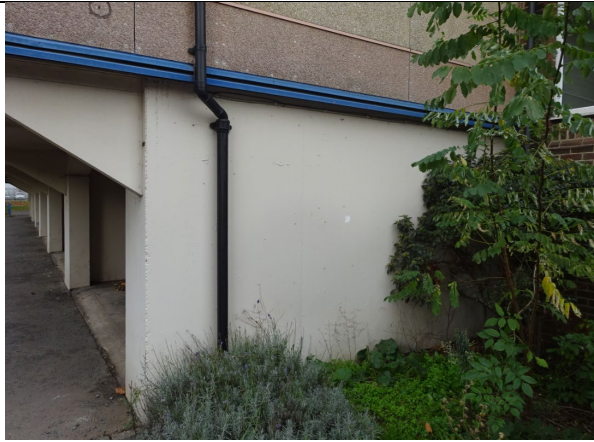
Therefore, the risk rating for external wall type #8 is **Low**.

Figure 115: General view of the reinforced concrete wall to the south elevation at ground floor level, showing sample location.

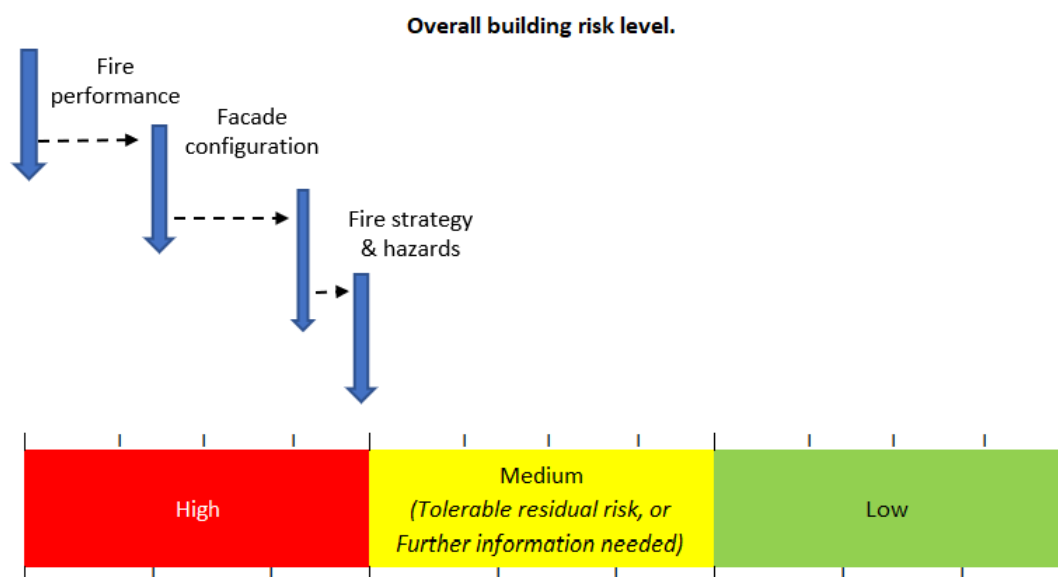
Figure 127: External wall overall fire risk level.

Due to the height of the building, the risk level is judged to be at the very lower end of the 'high' band, but within the 'high' band due to the extent of the combustible Steni GRP rainscreen cladding panels, the lack of suitable cavity barriers at compartment wall and floor locations and the combustible solid white uPVC panels located along the open access balconies, which could potentially compromise the escape routes.
