Fire Risk Appraisal of External Walls

**Alexandra Court, Holdbrook South,
Waltham Cross
Hertfordshire EN8 7SW.
B3Living Ltd.**

Report Issued: February 2026

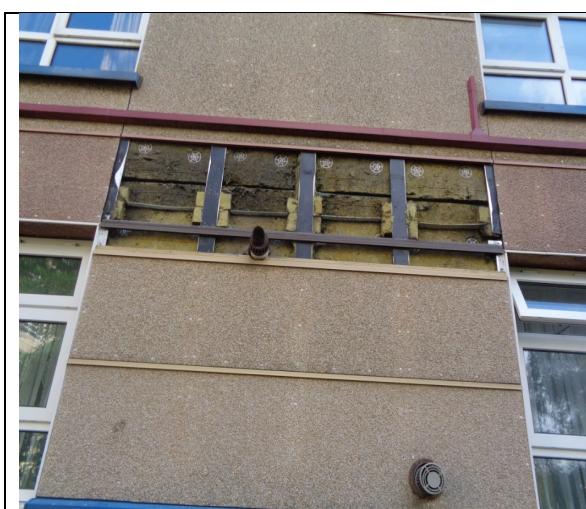
The cavity to the Steni GRP rainscreen cladding panels is continuous vertically with no cavity barriers installed at compartment floor locations observed during our inspections. Vertical cavity barriers, in the form of a solid mineral wool batt, had been installed in some compartment wall locations but these are unsuitable as they are not fully in compression to the pebble dash render and the rear of the Steni GRP rainscreen cladding. In the event of a fire, fire and smoke would be able to pass along the cavity to the rainscreen cladding. Voids were noted to be present behind the insulation installed around the window reveal cladding panels.

The presence of the combustible Steni GRP rainscreen cladding panels results in this wall type having an indicative fire load value of 210 MJ/m² and together with the construction defects found indicate that a complete 'Basic' PAS 9980 assessment (Steps 3 to 5) is necessary for this wall type.

Figure 15: General view of External Wall Type #1.

2.	Remove the combustible Steni GRP rainscreen cladding panels and replace them with a cladding system using materials which are non-combustible or of limited combustibility (Euroclass A2-s1, d0 or better). The applicable areas for removal are all elevations.	High	Aim to commence the works within 9 -12 months.

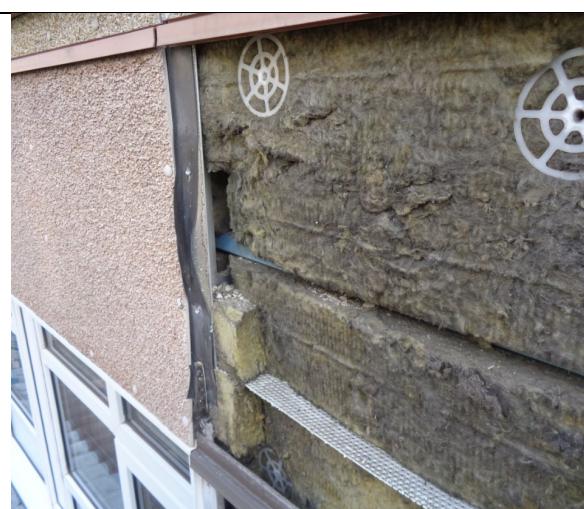
Figure 16: Close up view to show mineral wool insulation with limited mechanical fixings.

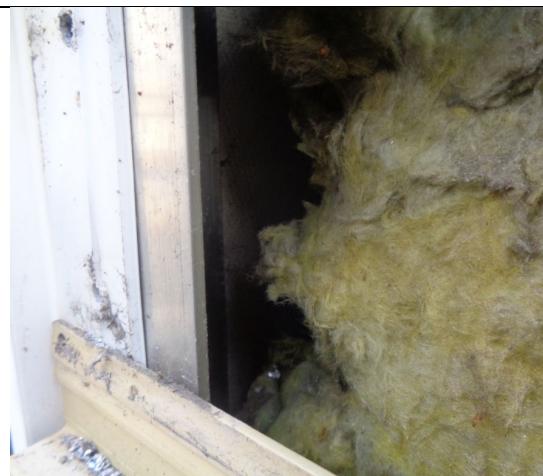
Figure 22: General view to missing insulation to window jamb.

4.	Where cavities are present in any replacement cladding system, ensure suitable cavity barriers are installed at floor & wall compartment lines, wall edges, around vent penetrations and around window openings.	High	During remediation.

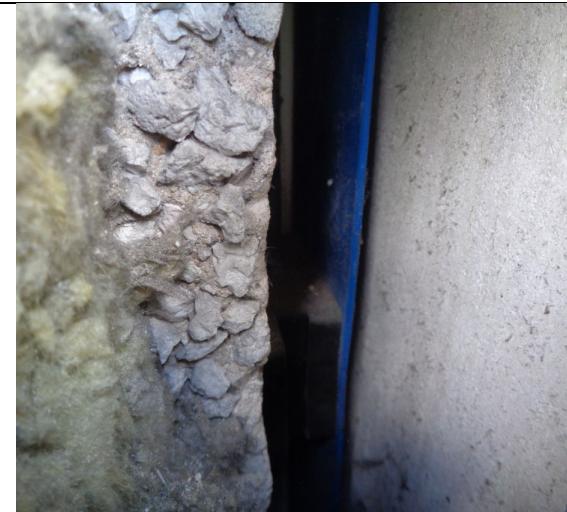
Figure 23: Alternative view to show no insulation installed to window jamb.

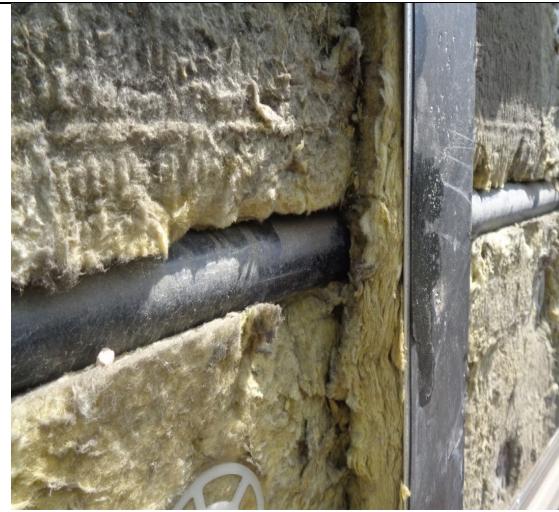
Figure 24: General view to show service pipes / cables located with mineral wool insulation.

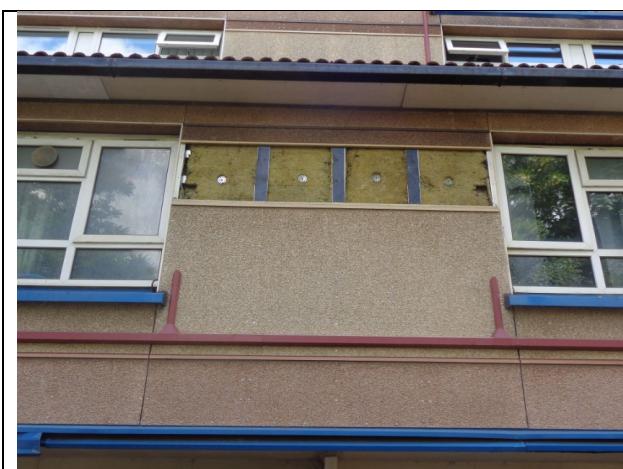
The cavity to the Steni GRP rainscreen cladding panels is continuous vertically with no cavity barriers installed at compartment floor locations observed during our inspections. Vertical cavity barriers, in the form of a solid mineral wool batt, had been installed in some locations at compartment wall locations but these are unsuitable as they are not fully in compression to the pebble dash render and the rear of the Steni GRP rainscreen cladding. In the event of a fire, fire and smoke would be able to pass along the cavity to the rainscreen cladding. Voids were noted to be present behind the insulation installed around the window reveal cladding panels.

The presence of the combustible Steni GRP rainscreen cladding panels results in this wall type having an indicative fire load value of 210 MJ/m² and together with the construction defects found indicate that a complete 'Basic' PAS 9980 assessment (Steps 3 to 5) is necessary for this wall type.

Figure 27: General view of External Wall Type #2.

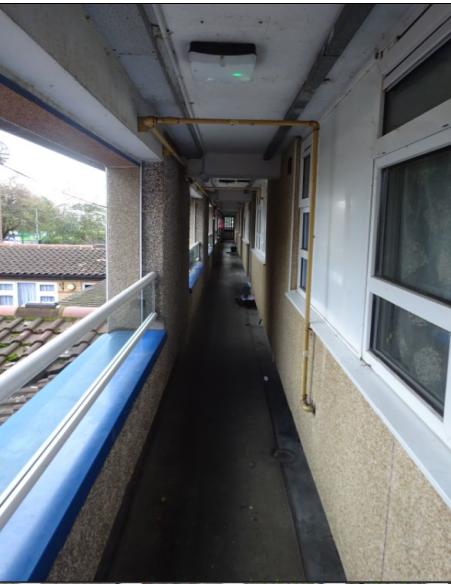
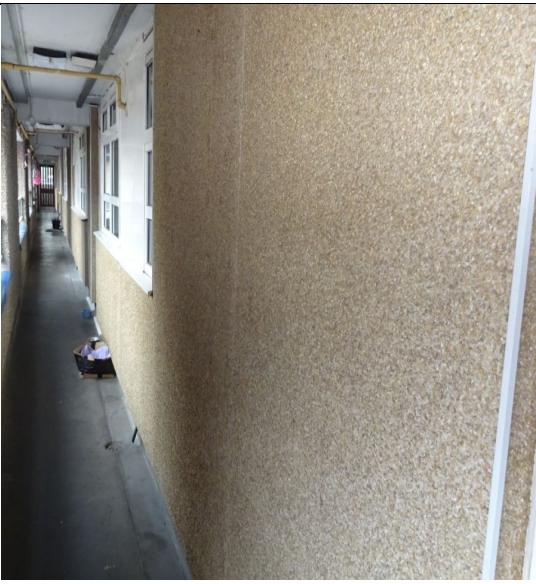
The presence of the combustible Steni GRP rainscreen cladding panels results in this wall type having an indicative fire load value of 210 MJ/m² indicates that a complete 'Basic' PAS 9980 assessment (Steps 3 to 5) is necessary for this wall type.

<p>Figure 53: General view of the Steni GRP panels installed along the open access balconies along the east elevation at first floor level.</p>	<p>Figure 54: Close up view of the Steni GRP panels installed along the open access balconies.</p>

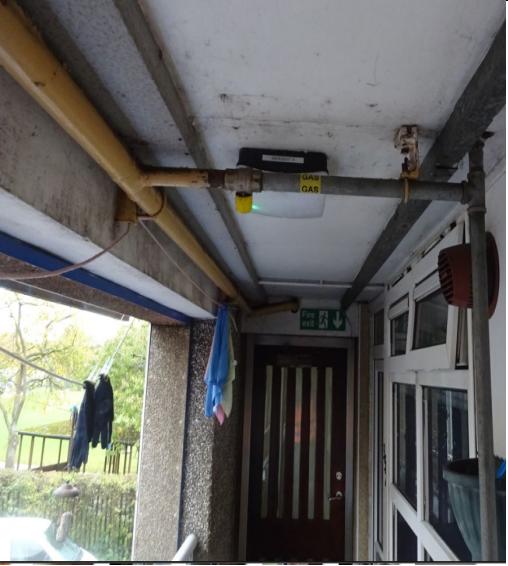
It should be noted that the mains gas supply pipework runs along the length of the open access balconies, see Figure 74. Any potential damage to the pipework could lead to an escalation of a fire affecting the open access balconies.

<p>Figure 73: General view of Fire Door installed at the end of the open access balcony prior to entering the escape staircase.</p>	<p>Figure 74: General view to show Fire Door installed at the opposite end of the open access balcony prior to entering the escape staircase and the concrete soffit to the open access balcony.</p>

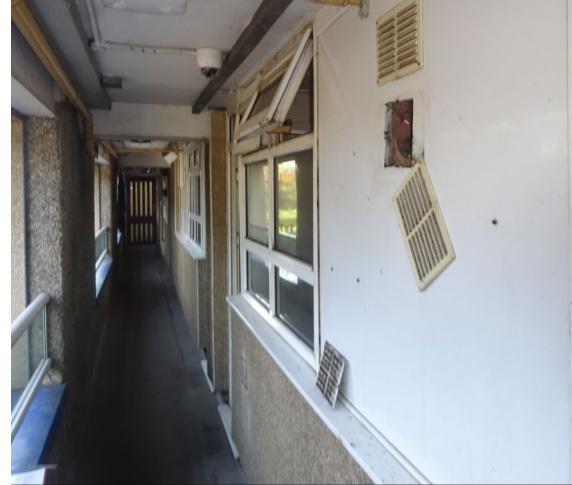
The presence of the combustible solid uPVC panels results in this wall type having an indicative fire load value of 574 MJ/m² indicates that a complete 'Basic' PAS 9980 assessment (Steps 3 to 5) is necessary for this wall type.

Figure 87: General view of the solid uPVC panels installed along the open access balconies located along the east elevation.	Figure 88: General view of the sample location at first floor level (Harrold Court).

3.	Remove the combustible solid white uPVC cladding panels and replace them with a cladding system using materials which are non-combustible or of limited combustibility (Euroclass A2-s1, d0 or better). The applicable areas for removal are the first, second, third and fourth floor levels to the east elevation.	High	Aim to commence the works within 9 -12 months.

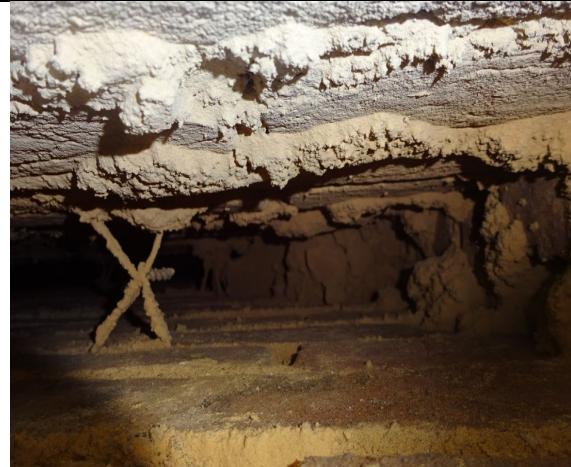
The intrusive survey identified that a clear cavity exists between the two leaves of masonry construction. The cavity is continuous vertically and horizontal with no cavity barriers observed during the inspection. However, the window openings are closed with the brickwork returning to close the cavity.

Figure 109: General view to show clear cavity to masonry wall.
