Fire Risk Appraisal of External Walls

**Queens Court, Holdbrook South,
Waltham Cross
Hertfordshire EN8 7SN.
B3Living Ltd.**

Report Issued: February 2026

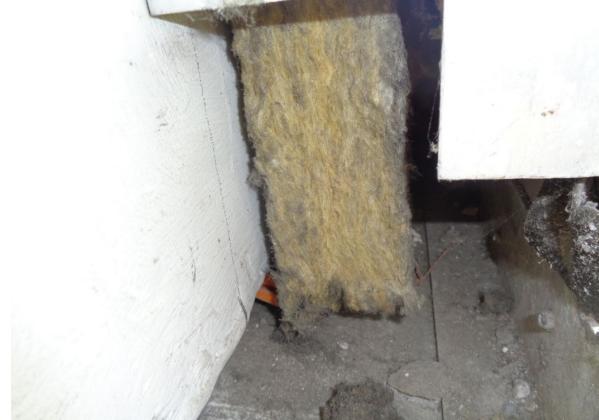
The cavity to the Steni GRP rainscreen cladding panels is continuous vertically with no cavity barriers installed at compartment floor locations observed during our inspections. Vertical cavity barriers, in the form of a solid mineral wool batt, had been installed in some compartment wall locations but these are unsuitable as they are not fully in compression to the pebble dash render and the rear of the Steni GRP rainscreen cladding. In the event of a fire, fire and smoke would be able to pass along the cavity to the rainscreen cladding. Voids were noted to be present behind the insulation installed around the window reveal cladding panels.

| <p><i>Figure 19: General view to show loose mineral wool insulation at compartment floor location to south elevation. NB. Unsuitable cavity barrier installed at compartment floor location.</i></p> | <p><i>Figure 20: General view to show the Steni GRP rainscreen cladding panel and mineral wool insulation. NB. Some insulation is loose fixed and not mechanically fixed to concrete wall.</i></p> |

| | Recommendations | Priority | Time frame |
|---|---|---|--|
| 4. | Where cavities are present in any replacement cladding system, ensure suitable cavity barriers are installed at floor & wall compartment lines, wall edges, around vent penetrations and around window openings. | High | During remediation. |

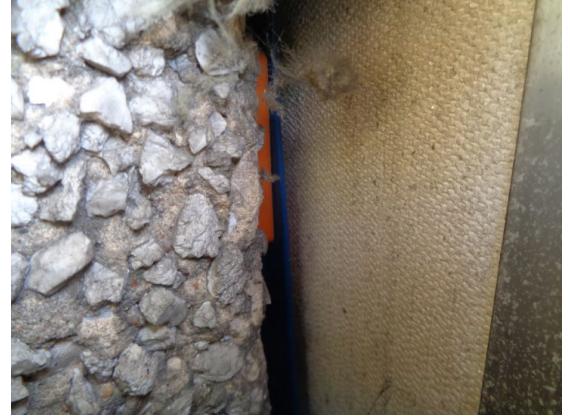
| <p><i>Figure 21: Close up view to show pebble dash render with Wimpey no fines concrete located behind render finish.</i></p> | <p><i>Figure 22: General view to missing insulation to window jamb.</i></p> |

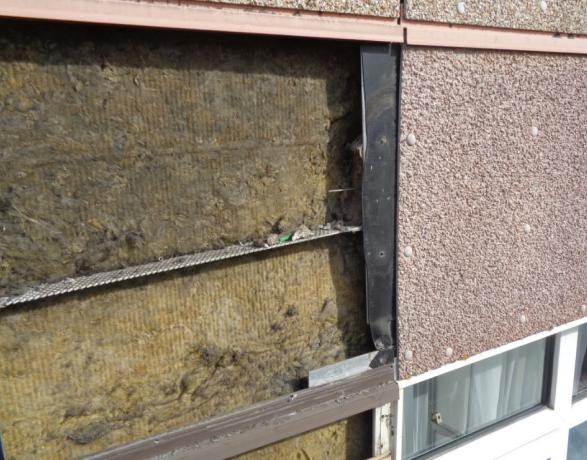
| <p>Figure 25: General view to show no horizontal cavity barrier installed at compartment floor location.</p> | <p>Figure 26: General view to show insulation mechanically fixed.</p> |

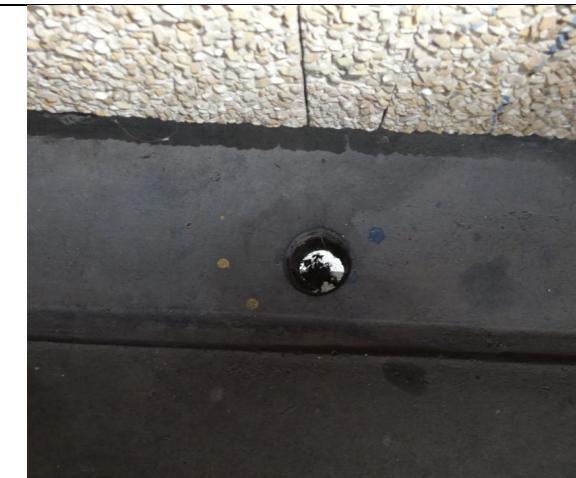
The FRA denotes that the compartmentation of the common areas and means of escape as being adequate. It was noted during our survey that redundant core holes, which pass through the concrete floor slab along the open access balconies, where the old gas pipe ran, have not been fire stopped when the pipe was removed, see Figures 57 & 58.

Figure 57: General view of redundant core holes through concrete floor slab to the open access balconies, which require fire stopping works to be completed.

It is recommended that the redundant core holes are fire stopped by a suitably Accredited FIRAS Contractor ASAP.

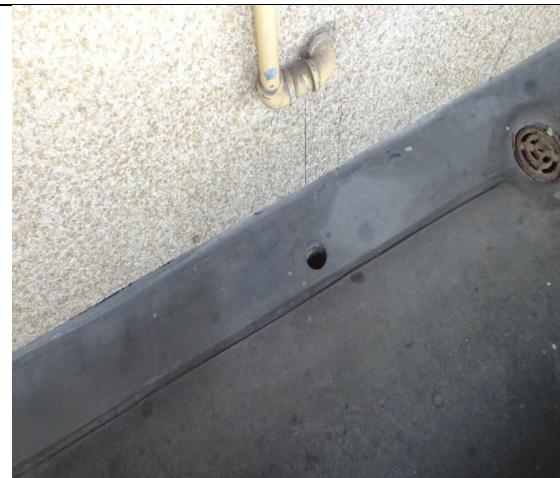
Figure 58: General view of redundant core holes through concrete floor slab to the open access balconies, which require fire stopping works to be completed.

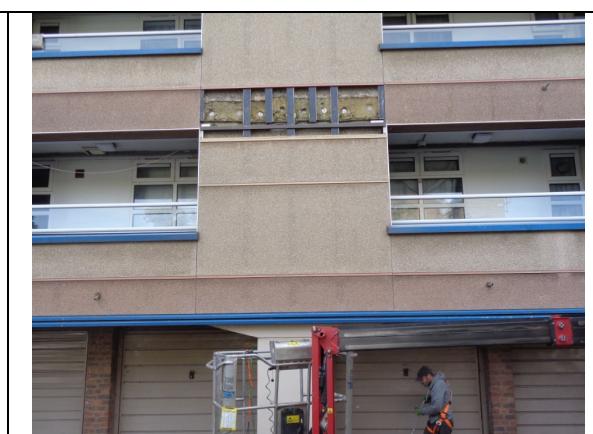
| <i>Figure 59: General view of External Wall Type #3</i> | <i>Figure 60: General view of compartment floor location to show no horizontal cavity barrier at compartment (Taken from Queens Court 2021).</i> |

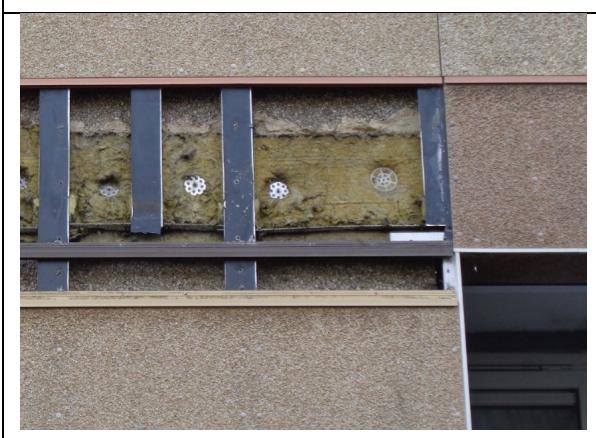
| <i>Figure 61: Close up view of compartment floor detail, which shows mineral wool insulation installed at compartment floor location, but this does not fully fill the void behind the Steni GRP rainscreen cladding panel (Taken from Queens Court 2021).</i> | <i>Figure 62: Alternative view of compartment floor detail, which shows mineral wool insulation installed at compartment floor location, but this does not fully fill the void behind the Steni GRP rainscreen cladding panel and the concrete floor slab (Taken from Queens Court 2021).</i> |

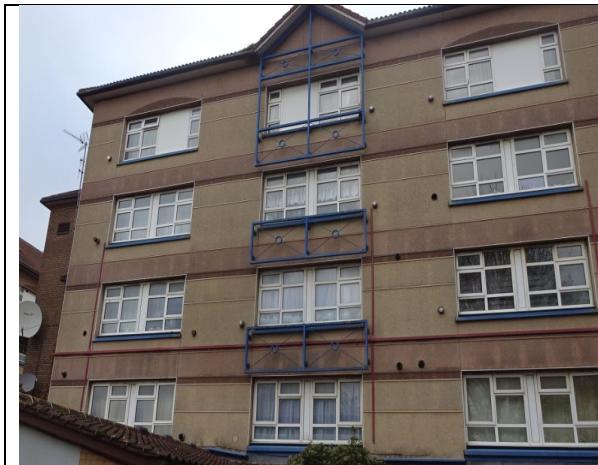
The presence of the combustible solid uPVC panels results in this wall type having an indicative fire load value of 574 MJ/m² indicates that a complete 'Basic' PAS 9980 assessment (Steps 3 to 5) is necessary for this wall type.

Figure 79: General view to show solid uPVC panels installed at fourth floor level along the south elevation.

| | Recommendations | Priority | Time frame |
|---|---|---|--|
| 3. | Remove the combustible solid white uPVC cladding panels and replace them with a cladding system using materials which are non-combustible or of limited combustibility (Euroclass A2-s1, d0 or better). The applicable areas for removal are the first, second, third and fourth floor levels to the north elevation and at fourth floor level to the south elevation. | High | Aim to commence the works within 9 -12 months. |

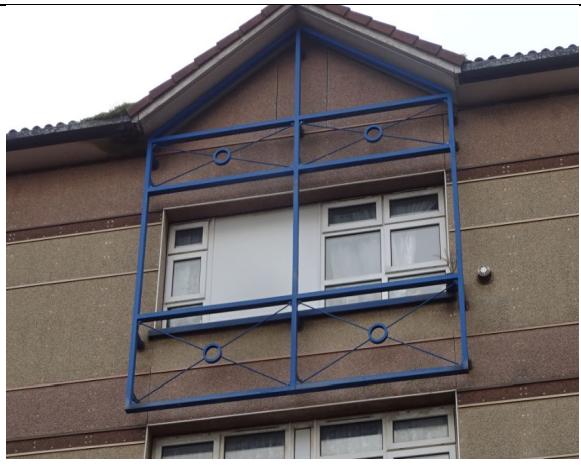
Figure 80: Close up view of the solid uPVC panels installed at fourth floor level along the south elevation.
