## **Fire Risk Appraisal of External Walls**

**Albert Court, Holdbrook South,  
Waltham Cross  
Hertfordshire EN8 7SS.  
B3Living Ltd.**

**Report Issued: February 2026**

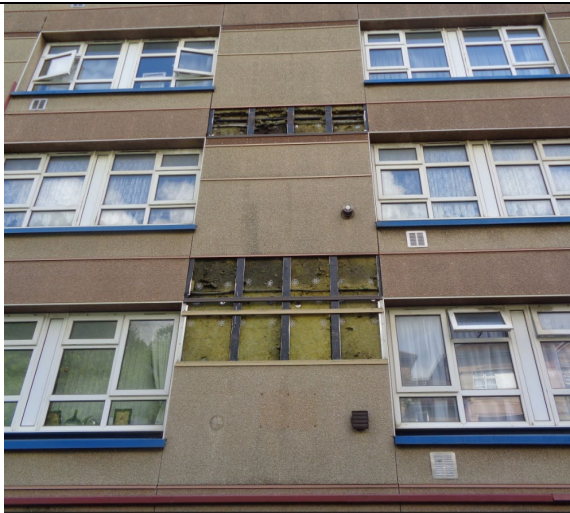
The intrusive survey identified that a cavity exists behind the Steni GRP rainscreen facade, this cavity was partially filled with mineral wool insulation batts mechanically fixed to the original pebble dash render. Stainless steel helping hand brackets support the Steni GRP rainscreen cladding panels. The substrate behind the pebble dash render comprises of a Wimpy no fines concrete wall.

The presence of the combustible Steni GRP rainscreen cladding panels results in this wall type having an indicative fire load value of 210 MJ/m<sup>2</sup> and together with the construction defects found indicate that a complete 'Basic' PAS 9980 assessment (Steps 3 to 5) is necessary for this wall type.

Figure 15: General view of External Wall Type #1.

| | Recommendations | Priority | Time frame |
|---|---|---|---|
| 2. | Remove the combustible Steni GRP rainscreen cladding panels and replace them with a cladding system using materials which are non-combustible or of limited combustibility (Euroclass A2-s1, d0 or better).<br><br>The applicable areas for removal are all elevations. | High | Aim to commence the works within 9 -12 months. |

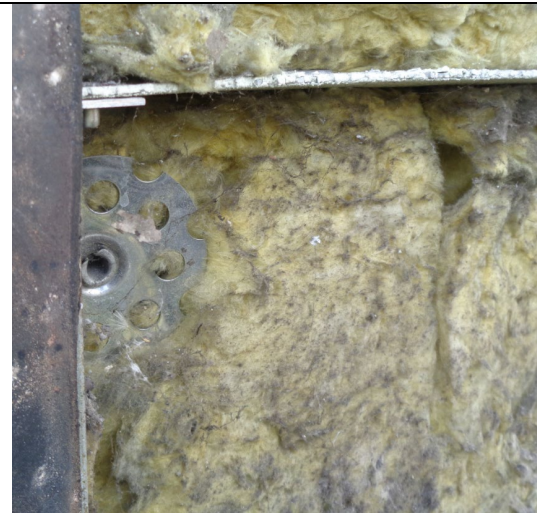
Figure 16: Close up view to show mineral wool insulation.

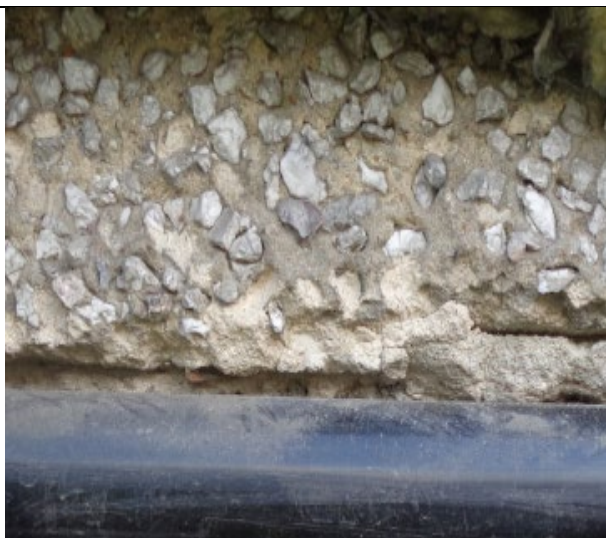
Figure 17: General view to show pebble dash render finish.

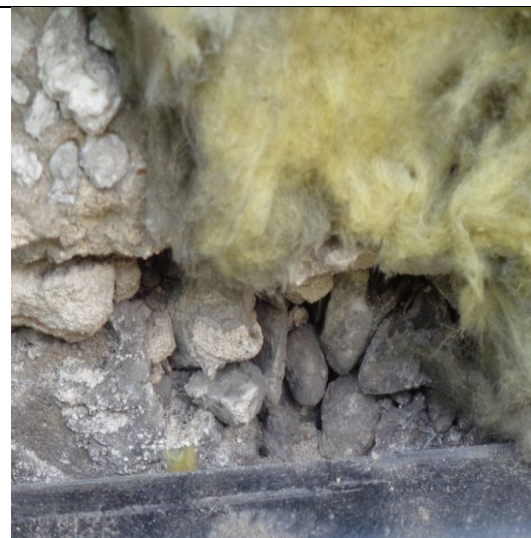
Figure 18: General view to show Wimpey no fines concrete.

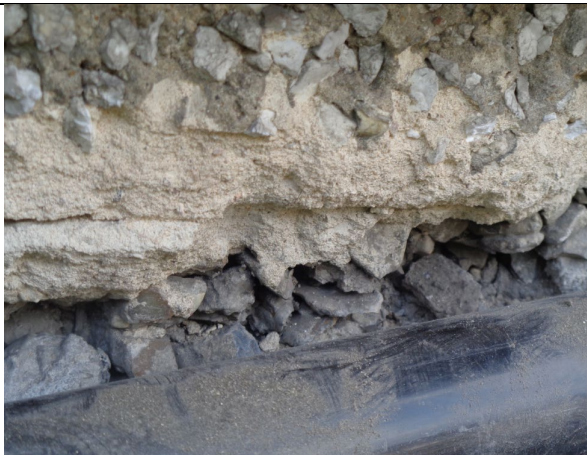
Figure 21: Close up view to show pebble dash render with Wimpey no fines concrete located behind render finish.

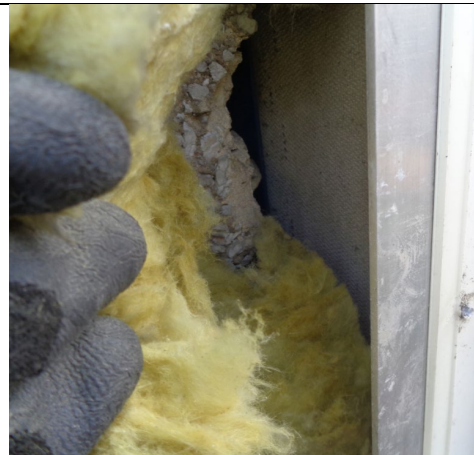
the rainscreen cladding. Voids were noted to be present behind the insulation installed around the window reveal cladding panels.

Figure 22: General view to missing insulation to window jamb.

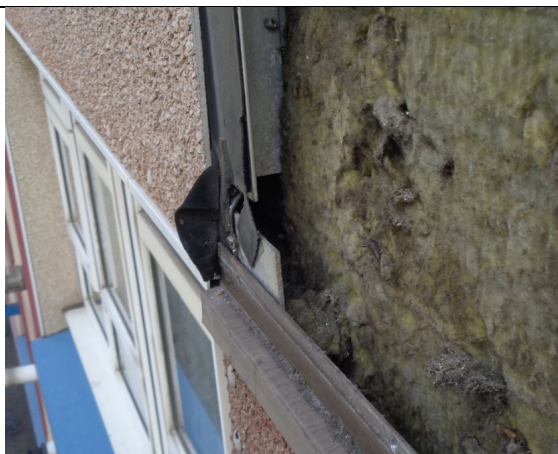
Figure 23: General view to show Steni GRP rainscreen cladding panel, stainless steel helping hand brackets and mineral wool insulation.

| Wall Type 1 - Steni GRP Rainscreen Cladding Panels on Wimpey No Fines Concrete. | | Rating | Comments / justification |
|---|---|---|---|
| | Fixings | Positive | The Steni GRP rainscreen cladding panels are mechanically fixed (riveted) to stainless steel helping hands which are bolted to the Wimpey no fines concrete walls. |

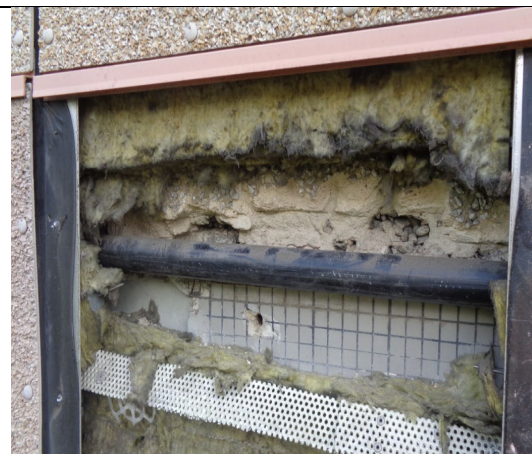
Figure 24: General view to show service pipes / cables located with mineral wool insulation.

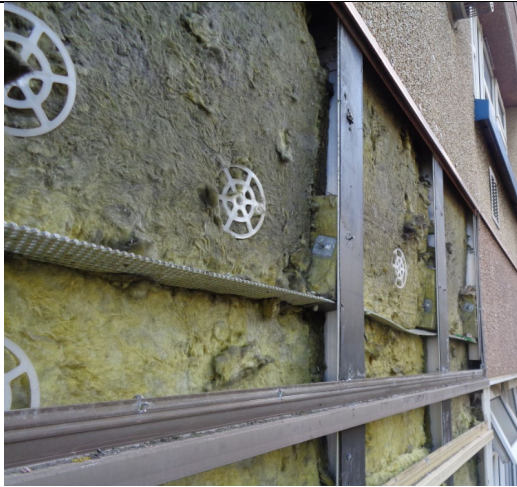
The cavity to the Steni GRP rainscreen cladding panels is continuous vertically with no cavity barriers installed at compartment floor locations observed during our inspections. Vertical cavity barriers, in the form of a solid mineral wool batt, had been installed in some compartment wall locations but these are unsuitable as they are not fully in compression to the pebble dash render and the rear of the Steni GRP rainscreen cladding. In the event of a fire, fire and smoke would be able to pass along the cavity to

Figure 25: General view to show no horizontal cavity barrier installed at compartment floor location.

| | | Negative | Cavities are vertically and horizontally open with no horizontal cavity barriers present and where vertical cavity barriers have been installed at compartment wall locations, these are unsuitable due to not being fully in compression or missing. |

| | Recommendations | Priority | Time frame |
|---|---|---|---|
| 4. | Where cavities are present in any replacement cladding system, ensure suitable cavity barriers are installed at floor & wall compartment lines, wall edges, around vent penetrations and around window openings. | High | During remediation. |

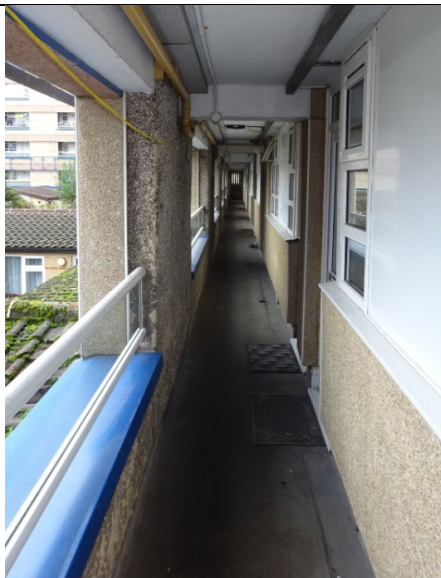
The presence of the combustible Steni GRP rainscreen cladding panels results in this wall type having an indicative fire load value of 210 MJ/m<sup>2</sup> indicates that a complete 'Basic' PAS 9980 assessment (Steps 3 to 5) is necessary for this wall type.

Figure 35: General view of the Steni GRP panels installed along the open access balconies along the east elevation at first floor level.

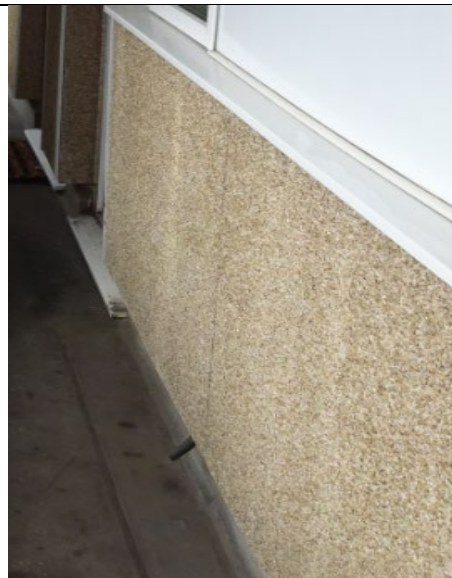
Figure 36: Close up view of the Steni GRP panels installed along the open access balconies.

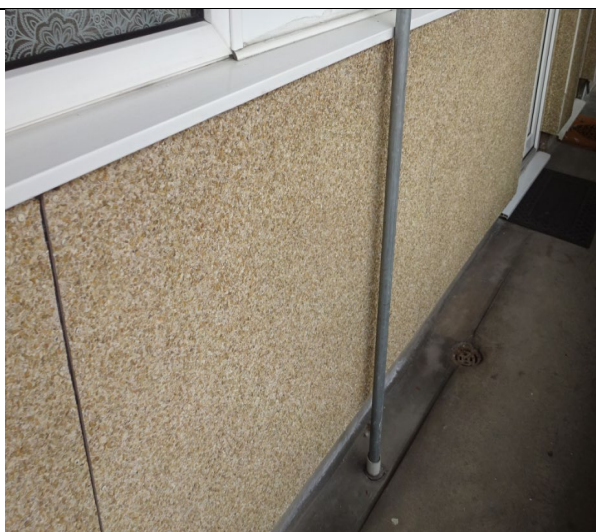
Figure 37: Close up view of the Steni GRP panels installed along the open access balconies.

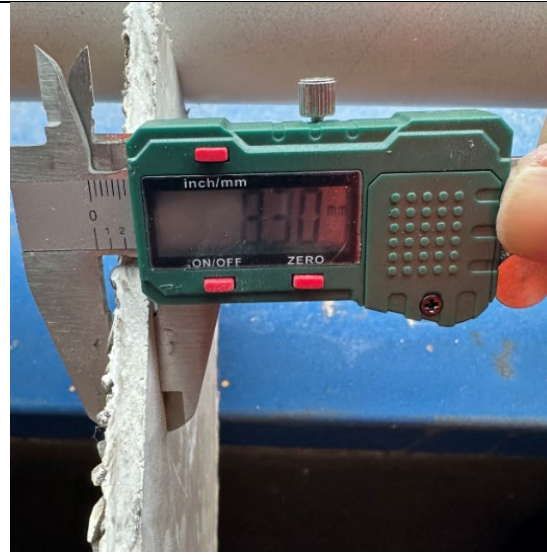
Figure 40: General view to confirm thickness of Steni GRP rainscreen cladding panel – 8mm.

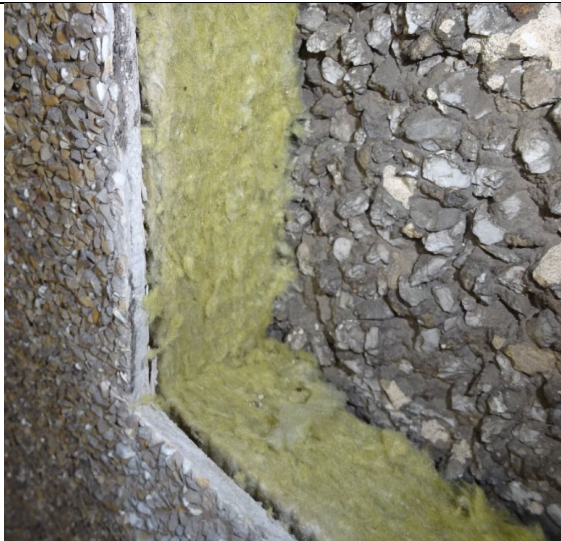
Figure 41: General view to show mineral wool insulation batt installed behind Steni GRP rainscreen cladding panel, with pebble dash render finish in the background.

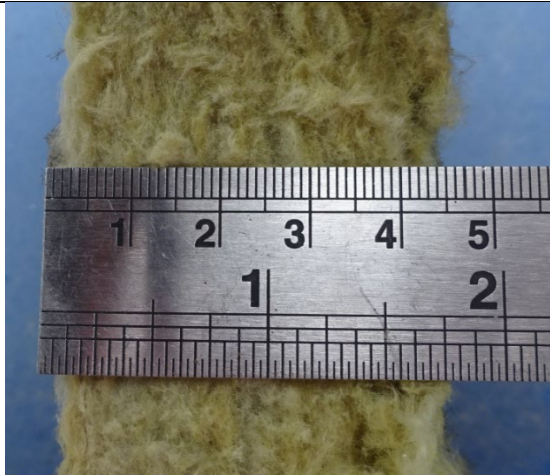
Figure 43: General view to confirm thickness of mineral wool insulation batt – 45mm.

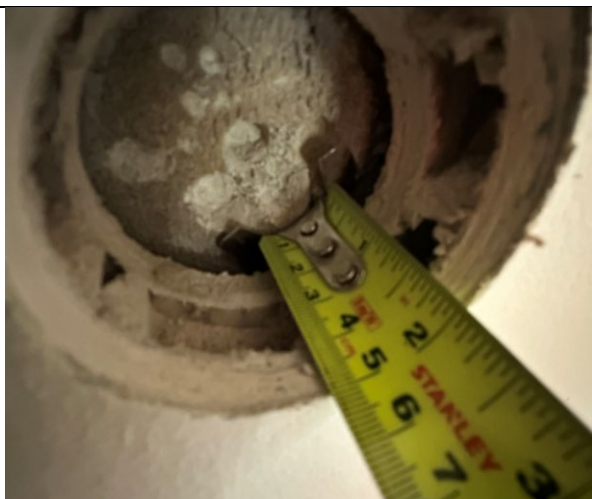
Figure 51: General view to show void between inner blockwork leaf and Paramount partition lining board – 10mm.

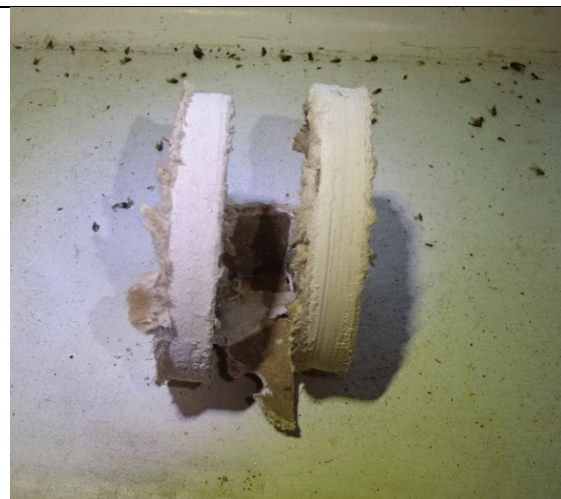
Figure 52: Close up view of Paramount partition lining board which comprises of two layers of 10mm plasterboard with an 18mm honeycomb cardboard core.

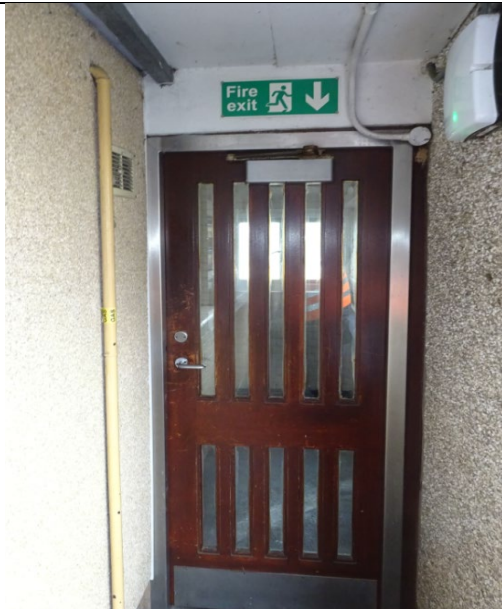
It should be noted that the mains gas supply pipework runs along the length of the open access balconies, see Figure 55. Any potential damage to the pipework could lead to an escalation of a fire affecting the open access balconies.

Figure 55: General view of Fire Door installed at the end of the open access balcony prior to entering the escape staircase.

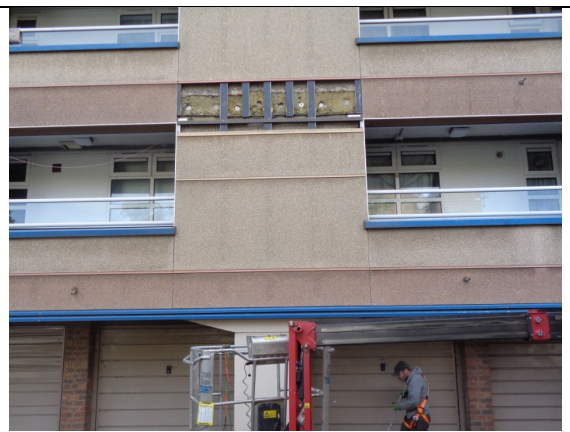
Figure 58: General view of compartment floor location to show no horizontal cavity barrier at compartment (Taken from Queens Court 2021).

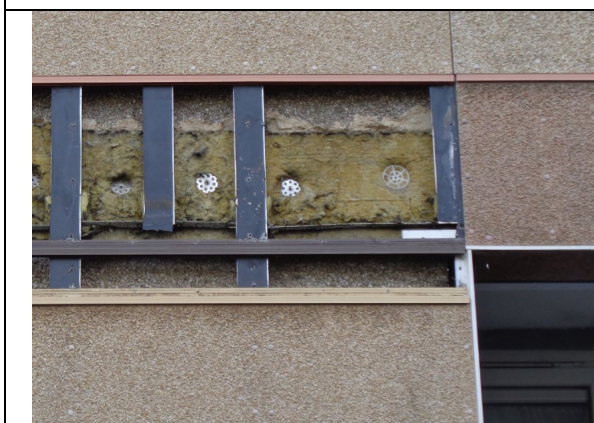
Figure 59: Close up view of compartment floor detail, which shows mineral wool insulation installed at compartment floor location, but this does not fully fill the void behind the Steni GRP rainscreen cladding panel (Taken from Queens Court 2021).

| | | Negative | Cavities are vertically and horizontally open with no vertical cavity barriers present and where horizontal cavity barriers have been installed at compartment floor locations, these are unsuitable due to not being fully in compression or missing. |

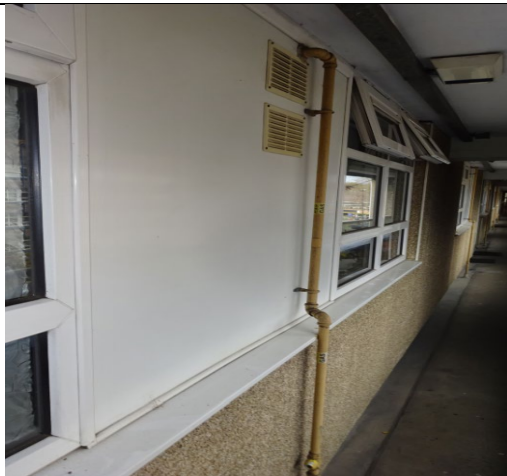
The presence of the combustible solid uPVC panels results in this wall type having an indicative fire load value of 574 MJ/m<sup>2</sup> indicates that a complete 'Basic' PAS 9980 assessment (Steps 3 to 5) is necessary for this wall type.

Figure 69: General view of the solid uPVC panels installed along the open access balconies located along the east elevation.

| | Recommendations | Priority | Time frame |
|---|---|---|---|
| 3. | Remove the combustible solid white uPVC cladding panels and replace them with a cladding system using materials which are non-combustible or of limited combustibility (Euroclass A2-s1, d0 or better).<br><br>The applicable areas for removal are the first, second, third and fourth floor levels to the east elevation and at fourth floor level to the west elevation. | High | Aim to commence the works within 9 -12 months. |

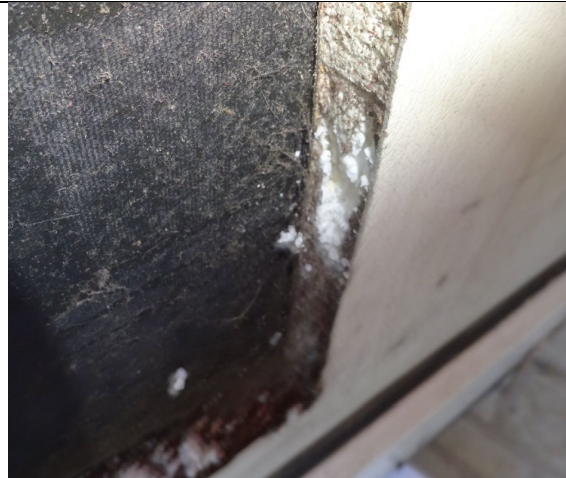
Figure 74: General view to show EPS insulated panel installed at low level to flat entrance door to Flat No. 354 (Harold Court).

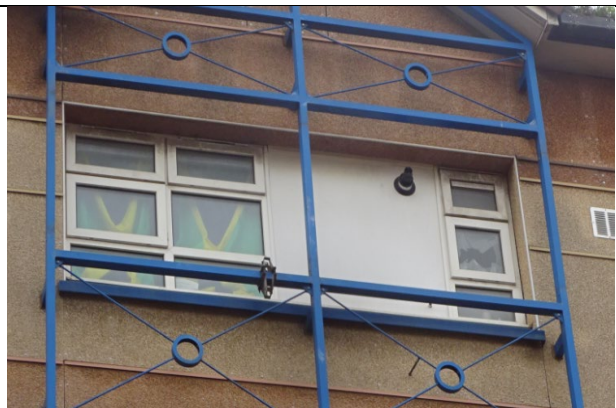
Figure 76: Close up view of the solid uPVC panels installed at fourth floor level along the east elevation.

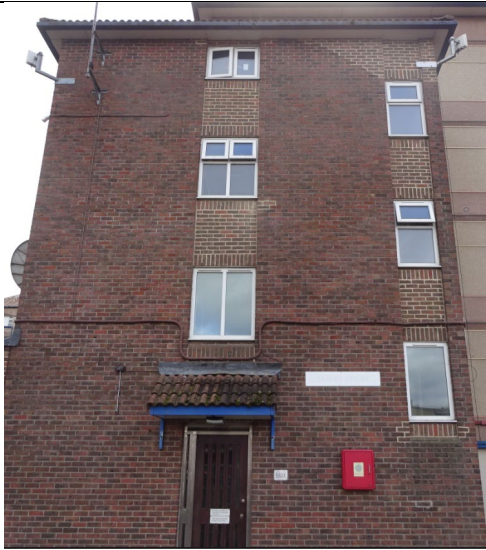
As this wall type contains two leaves of masonry at least 100mm thick, with no combustible insulation, the resulting risk of fire spread is very low and therefore PAS 9980 Steps 3 to 5 are not applicable, and no further assessment of this wall type is required.

Therefore, the risk rating for external wall type #5 is Low.

*Figure 79: General view of the traditional masonry cavity wall construction to the escape staircase located on the north elevation.*

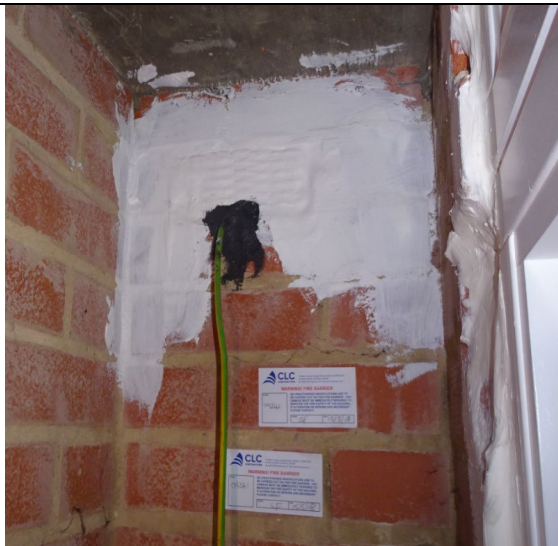
Figure 85: General view to show fire stopping works including ID labels completed to riser cupboards located in escape staircases.

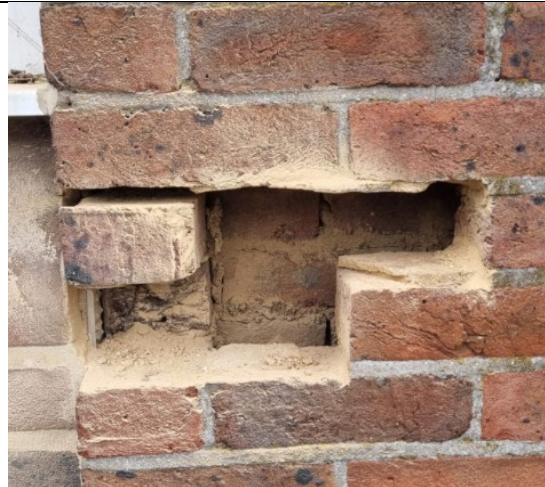
The intrusive survey identified that a clear cavity exists between the two leaves of masonry construction. The cavity is continuous vertically and horizontal with no cavity barriers observed during the inspection. However, the window openings are closed with the brickwork returning to close the cavity.

Figure 88: General view to show window cill cavity detail with masonry brickwork closing the cavity.

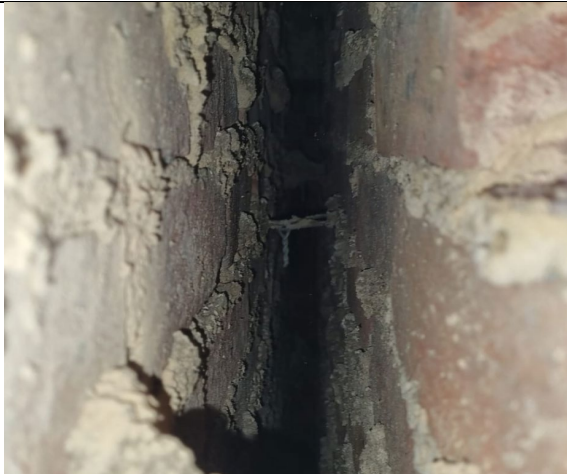
Figure 89: General view to show clear cavity.

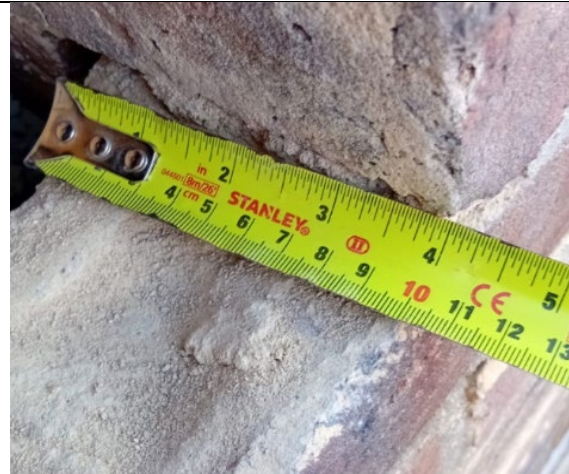
Figure 90: General view to confirm thickness of outer brickwork leaf – 100mm.

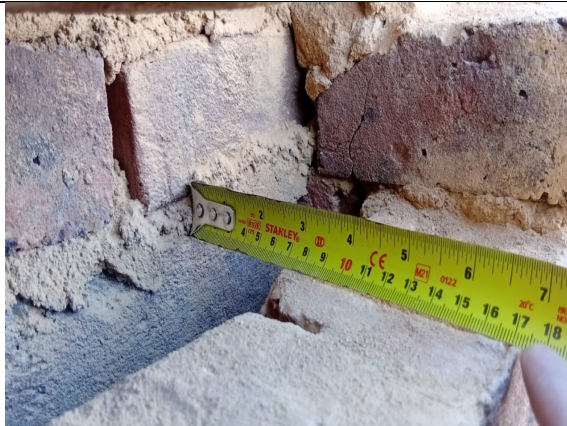
*Figure 93: General view to confirm thickness of cavity -70mm and outer brickwork leaf - 100mm at compartment floor location.*

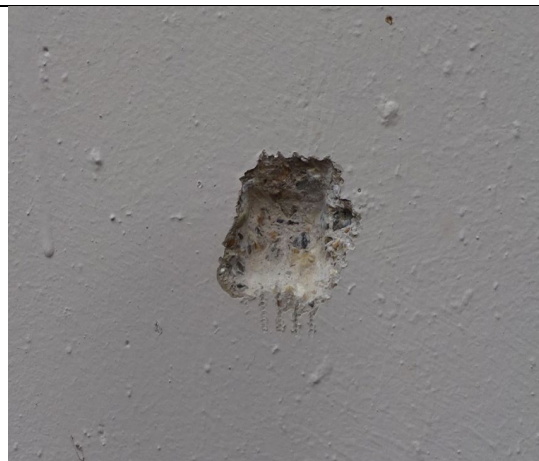
*Figure 100: Close up view of the sample location to confirm solid concrete shear wall (Harold Court).*

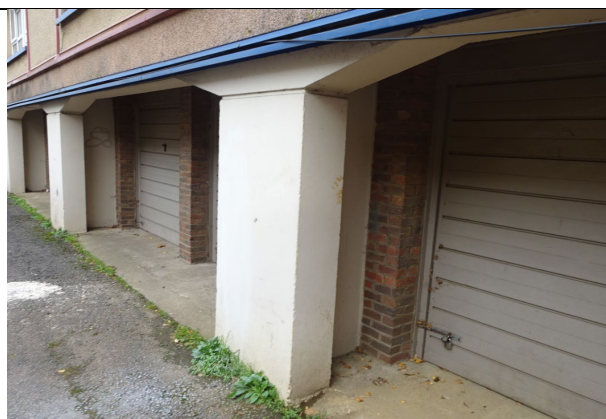
*Figure 101: General view of the reinforced concrete frame and concrete floor to the west elevation. NB. that the garages are recessed back from the main elevation.*

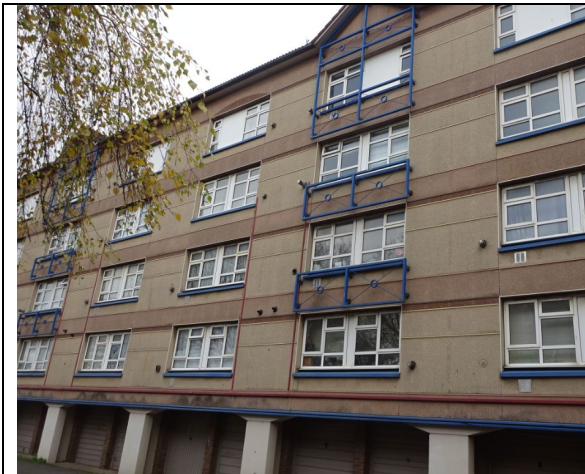
Therefore, the risk rating for the decorative steel attachments is **Low**.

Figure 105: General view of the decorative architectural steel attachments installed to the west elevation.
