## **Fire Risk Appraisal of External Walls**

**Harold Court, Holdbrook South,  
Waltham Cross  
Hertfordshire EN8 7SR.  
B3Living Ltd.**

**Report Issued: February 2026**

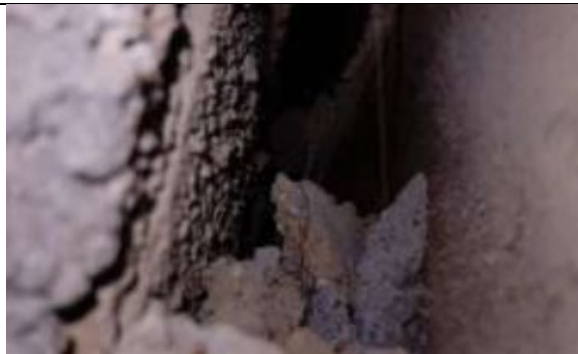
Figure 37: General view to show clear cavity located between inner blockwork lead and outer blockwork leaf.

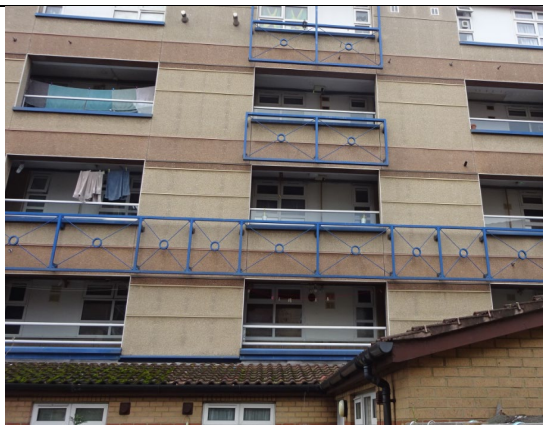
The presence of the combustible Steni GRP rainscreen cladding panels results in this wall type having an indicative fire load value of 185 MJ/m<sup>2</sup> indicates that a complete 'Basic' PAS 9980 assessment (Steps 3 to 5) is necessary for this wall type.

Figure 75: General view of External Wall Type #4

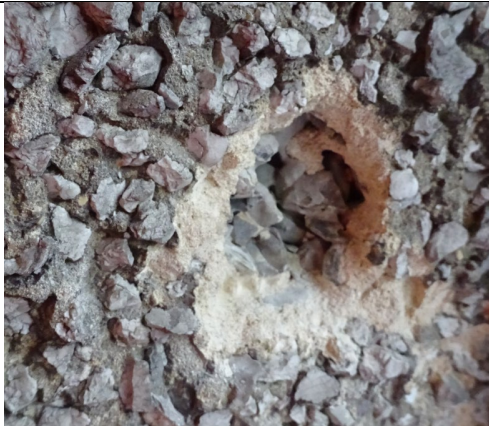
Figure 85: Close up view to show pebble dash render finish installed over Wimpey no fines concrete.

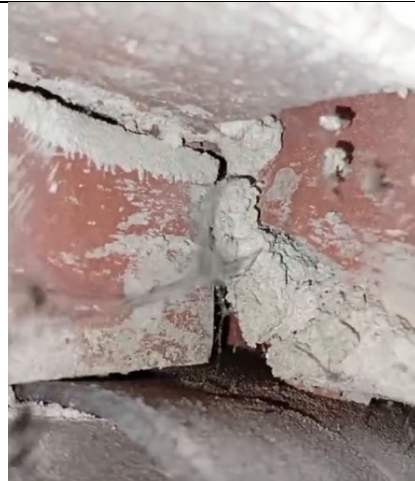
Figure 106: Alternative view to show masonry brickwork closing the cavity.

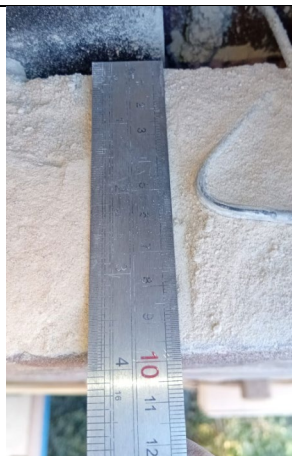
Figure 107: General view to confirm thickness of outer brickwork leaf – 100mm.

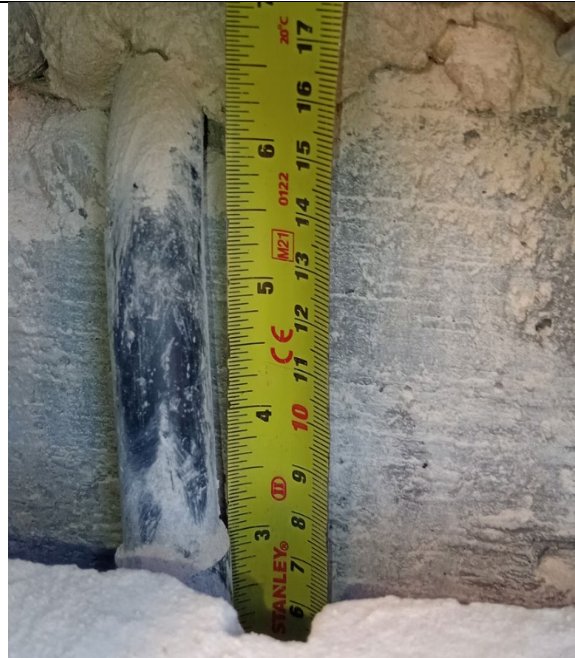
Figure 110: General view to confirm concrete slab thickness to escape staircases – 160mm.
