Fire Risk Appraisal of External Walls

**Alexandra Court, Holdbrook South,
Waltham Cross
Hertfordshire EN8 7SW.
B3Living Ltd.**

Report Issued: February 2026

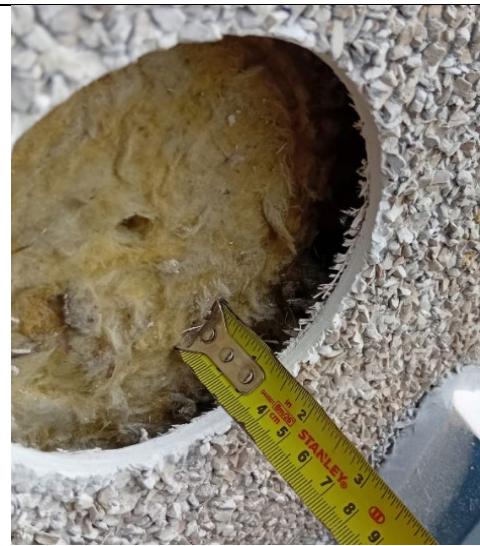
Figure 20: General view to show the Steni GRP rainscreen cladding panel, mineral wool insulation and Wimpey no fines concrete.

2.	Remove the combustible Steni GRP rainscreen cladding panels and replace them with a cladding system using materials which are non-combustible or of limited combustibility (Euroclass A2-s1, d0 or better). The applicable areas for removal are all elevations.	High	Aim to commence the works within 9 -12 months.

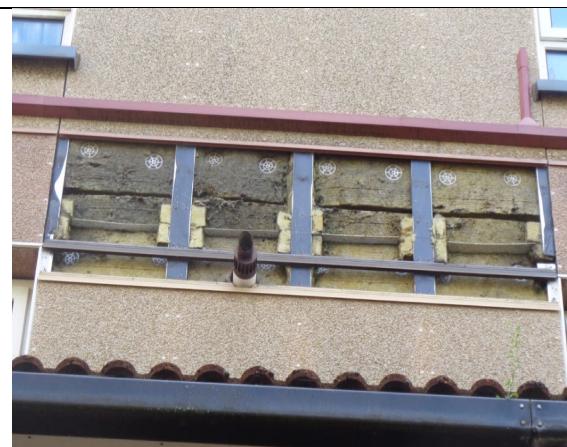
Figure 25: General view to show no horizontal cavity barrier installed at compartment floor location.

4.	Where cavities are present in any replacement cladding system, ensure suitable cavity barriers are installed at floor & wall compartment lines, wall edges, around vent penetrations and around window openings.	High	During remediation.

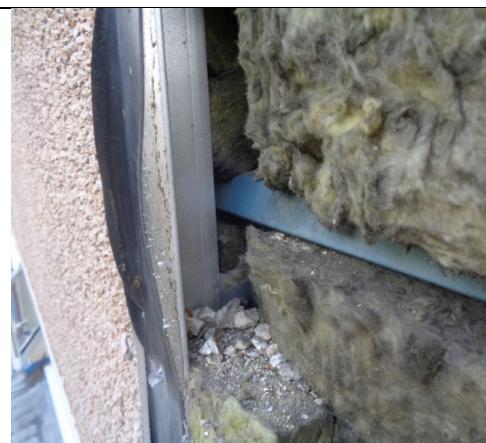
Figure 26: General view to show no vertical cavity barrier installed at compartment wall location.

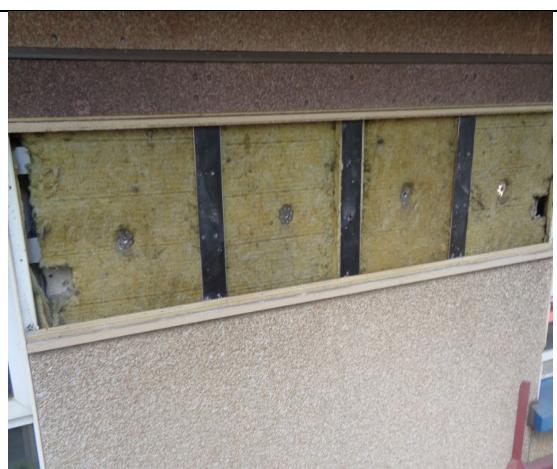
Figure 28: Alternative view of External Wall Type #2.

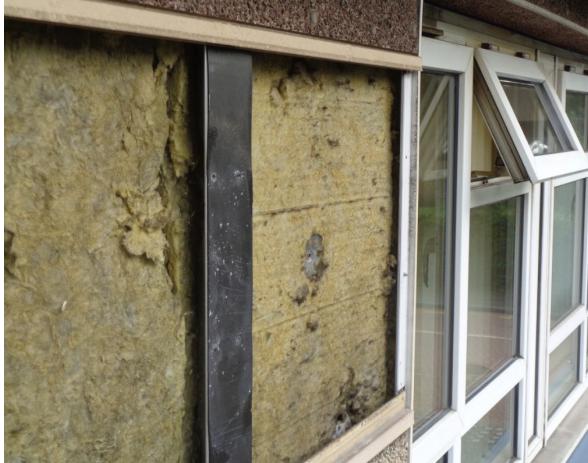
<p>Figure 29: Close up view to show Steni GRP panels and mineral wool insulation.</p>	<p>Figure 30: Close up view to show pebble dash render finish.</p>

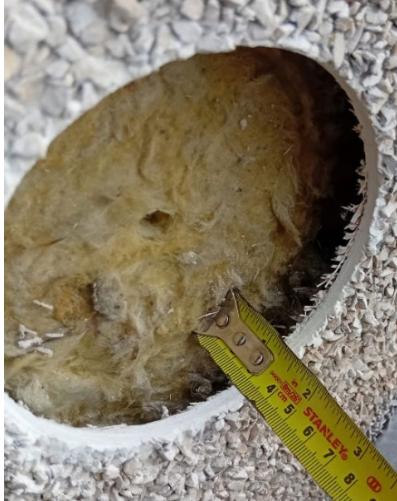
<p>Figure 31: General view of sample location to west elevation at first floor level.</p>	<p>Figure 32: General view to show Steni GRP rainscreen cladding panel, cavity void and mineral wool insulation.</p>

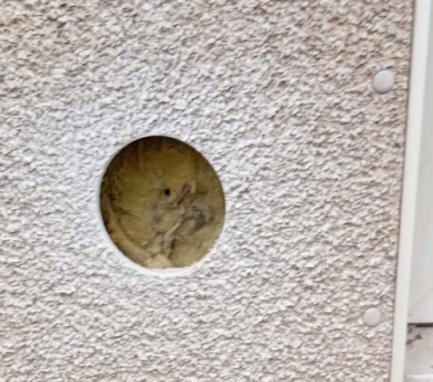
<p>Figure 39: General view of sample location to show Steni GRP rainscreen cladding panel, cavity void and mineral wool insulation.</p>	<p>Figure 40: Close up view to show Steni GRP rainscreen cladding panel, cavity void and mineral wool insulation.</p>

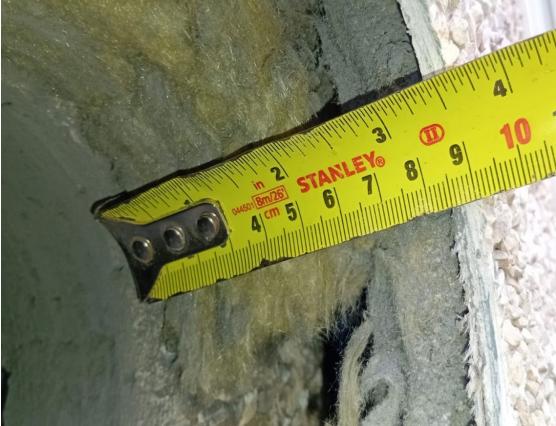
<p>Figure 41: General view to show Steni GRP rainscreen cladding panel, mineral wool insulation pebble dash render and blockwork outer leaf.</p>	<p>Figure 42: General view to show 60mm blockwork outer leaf, 50mm clear cavity and blockwork inner leaf.</p>

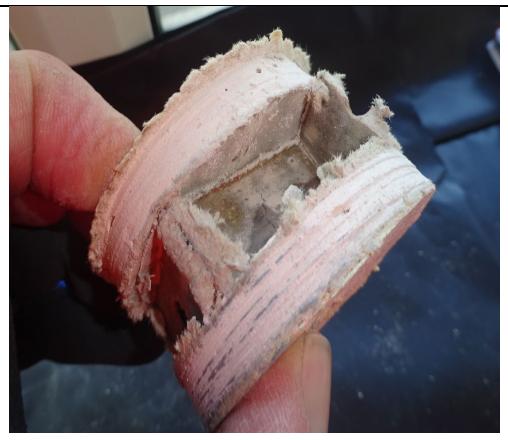
<p><i>Figure 47: General view to show void between inner blockwork leaf and Paramount partition lining board – 40mm.</i></p>	<p><i>Figure 48: Close up view of Paramount partition lining board which comprises of two layers of 10mm plasterboard with an 18mm honeycomb cardboard core.</i></p>

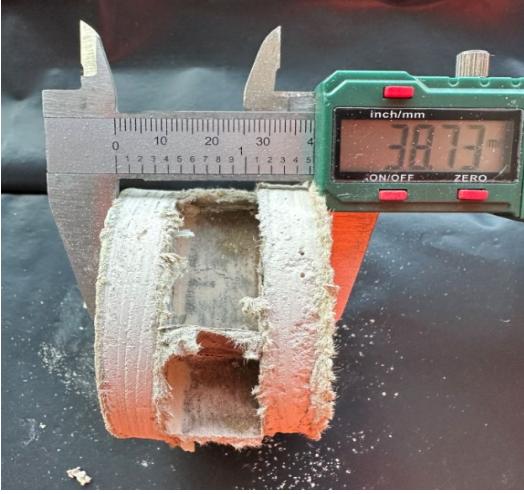
<p>Figure 69: General view to show void between inner blockwork leaf and Paramount partition lining board – 10mm.</p>	<p>Figure 70: Close up view of Paramount partition lining board which comprises of two layers of 10mm plasterboard with an 18mm honeycomb cardboard core.</p>

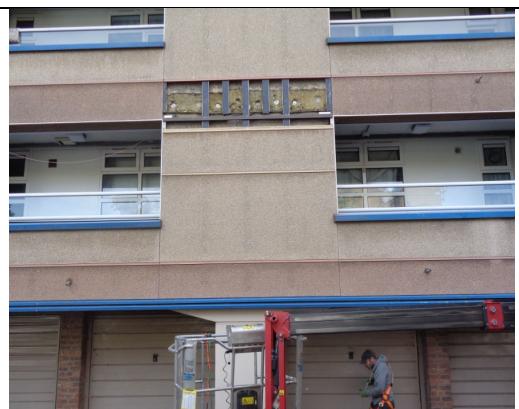
Figure 76: General view of compartment floor location to show no horizontal cavity barrier at compartment (Taken from Queens Court 2021).

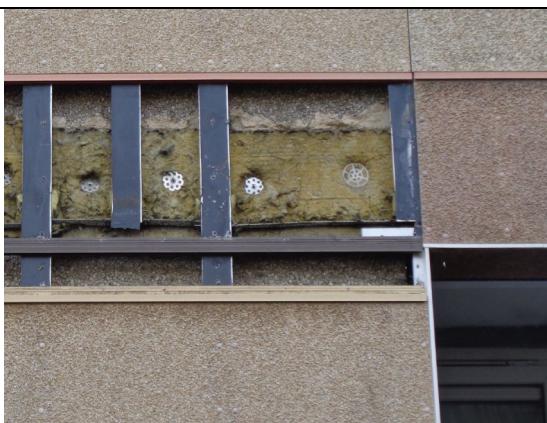
Figure 77: Close up view of compartment floor detail, which shows mineral wool insulation installed at compartment floor location, but this does not fully fill the void behind the Steni GRP rainscreen cladding panel (Taken from Queens Court 2021).

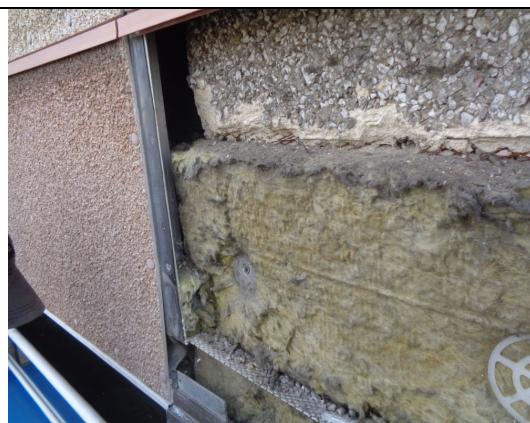
Figure 78: Alternative view of compartment floor detail, which shows mineral wool insulation installed at compartment floor location, but this does not fully fill the void behind the Steni GRP rainscreen cladding panel and the concrete floor slab (Taken from Queens Court 2021).

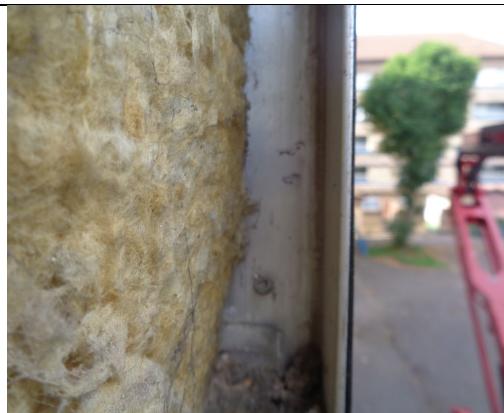
Figure 81: Close up view at compartment floor location to show that the mineral wool insulation does not fully fill the void and therefore does not form a suitable cavity barrier at compartment floor location (Taken from Queens Court 2021).

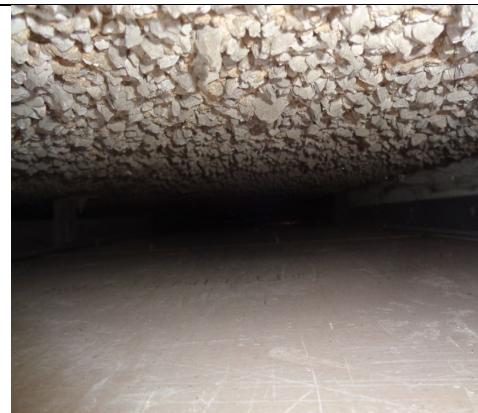
Figure 82: General view to show clear cavity between pebble dash render and the Steni GRP rainscreen cladding panel (Taken from Queens Court 2021).

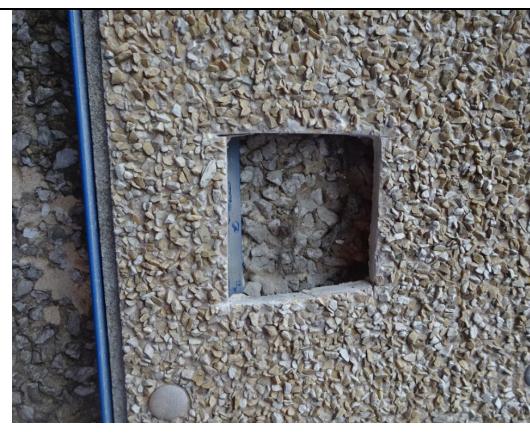
Figure 84: Close up view of Steni GRP rainscreen cladding panel installed over pebble dash render finish with 10mm void (Harold Court).

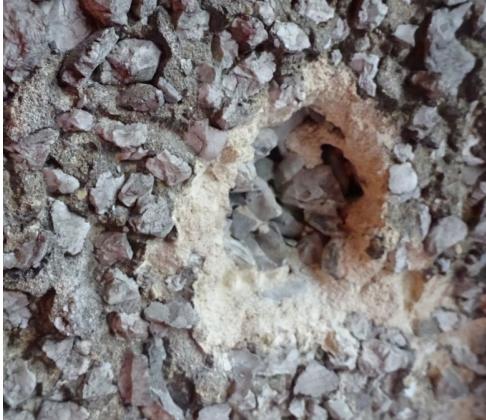
Figure 85 Close up view to show pebble dash render finish installed over Wimpey no fines concrete (Harold Court).	Figure 86 General view of pebble dash render finish to external wall of first floor open access balcony along the east elevation.

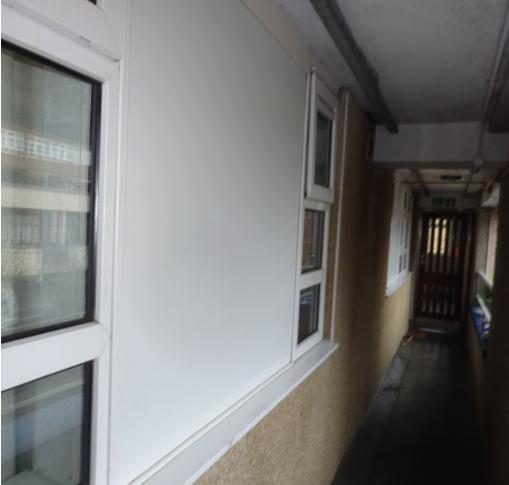
The presence of the combustible solid uPVC panels results in this wall type having an indicative fire load value of 574 MJ/m² indicates that a complete 'Basic' PAS 9980 assessment (Steps 3 to 5) is necessary for this wall type.

Figure 87: General view of the solid uPVC panels installed along the open access balconies located along the east elevation.	Figure 88: General view of the sample location at first floor level (Harrold Court).

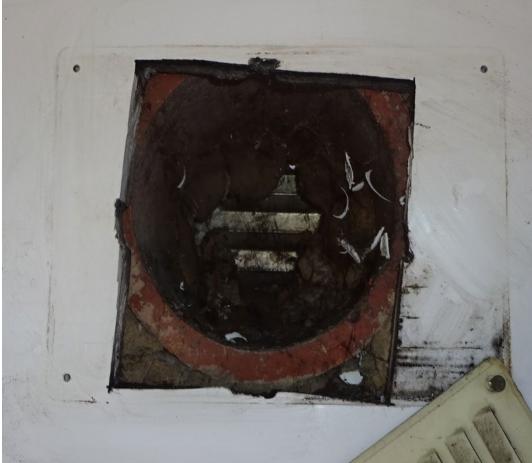
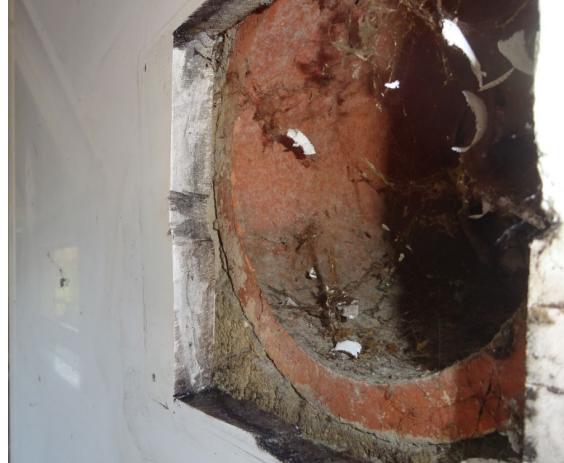
Figure 89: Close up view of the sample location (Harrold Court).	Figure 90: Close up view of the sample location (Harrold Court).

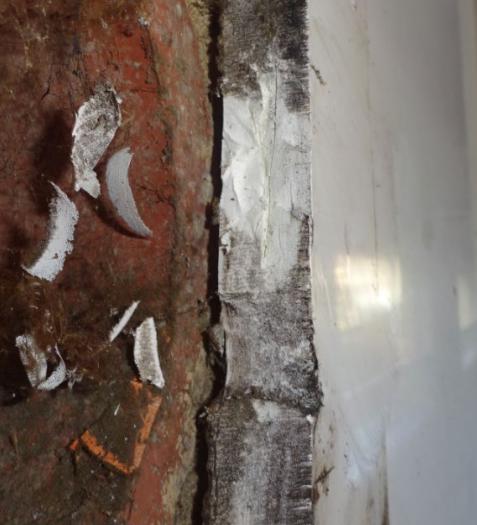
<p>Figure 91: Close up view to show 20mm solid uPVC panel (Harold Court).</p>	<p>Figure 92: General view to show EPS insulated panel installed at low level to flat entrance door to Flat No. 354 (Harold Court).</p>

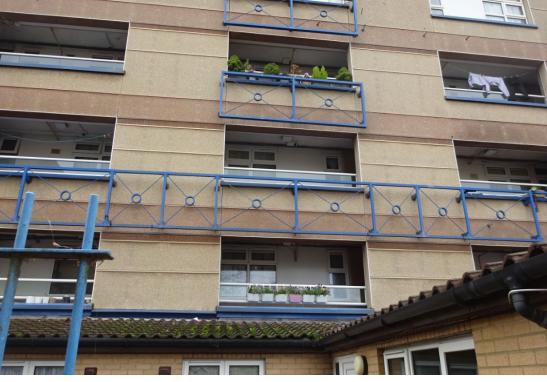
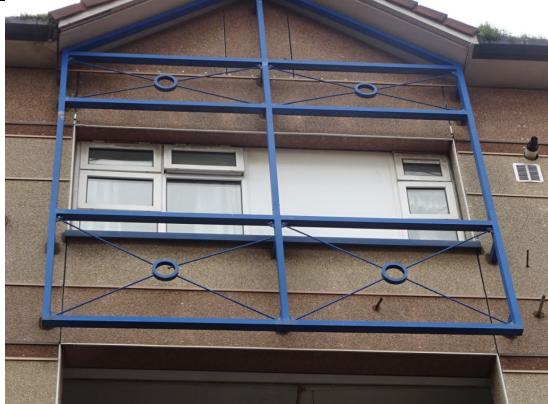
<p>Figure 93: General view to show solid uPVC panels installed at first, second, third and fourth floor levels along the east elevation.</p>	<p>Figure 94: Close up view of the solid uPVC panels installed at fourth floor level along the east elevation.</p>

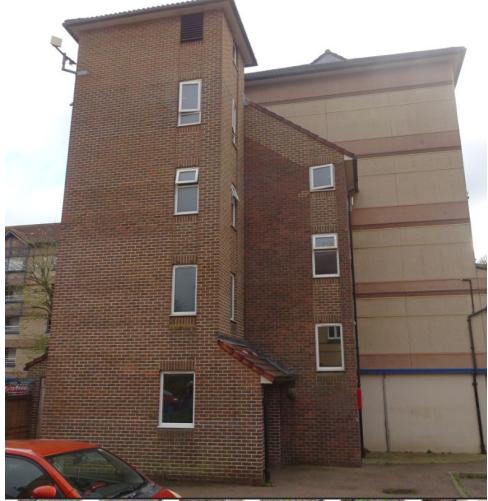
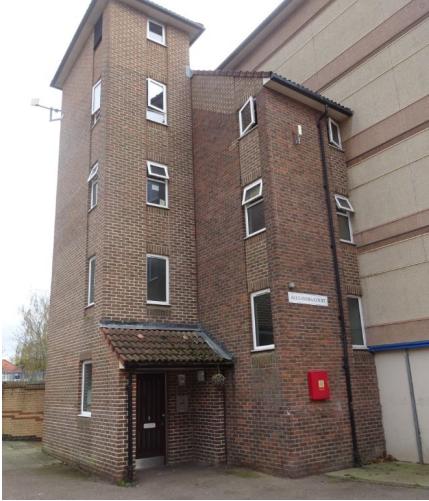
As this wall type contains two leaves of masonry at least 100mm thick, with no combustible insulation, the resulting risk of fire spread is very low and therefore PAS 9980 Steps 3 to 5 are not applicable, and no further assessment of this wall type is required.

Therefore, the risk rating for external wall type #6 is Low.

<p>Figure 95: General view of the traditional masonry cavity wall construction to the escape staircase located on the north elevation.</p>	<p>Figure 96: Alternative view of the traditional masonry cavity wall construction to the escape staircase located on the north elevation.</p>

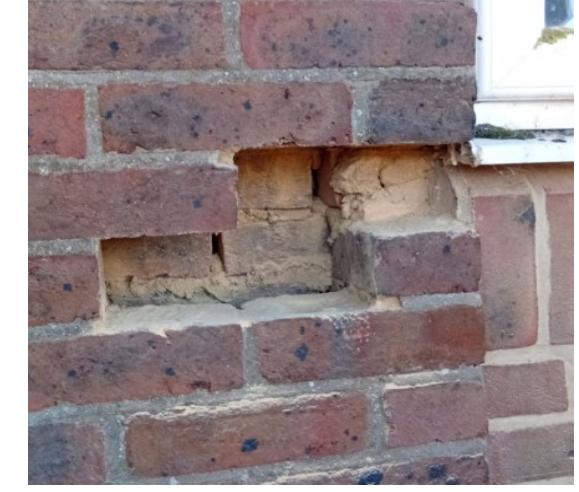
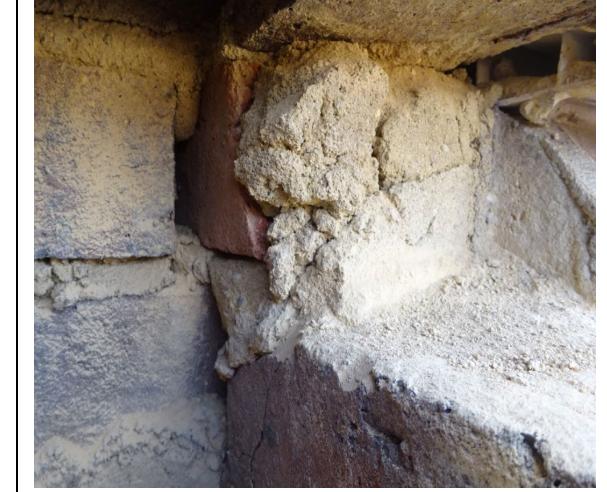
The intrusive survey identified that a clear cavity exists between the two leaves of masonry construction. The cavity is continuous vertically and horizontal with no cavity barriers observed during the inspection. However, the window openings are closed with the brickwork returning to close the cavity.

<p>Figure 103: General view of sample location to window cill located on north elevation.</p>	<p>Figure 104: General view to show window cill cavity detail with masonry brickwork closing the cavity.</p>

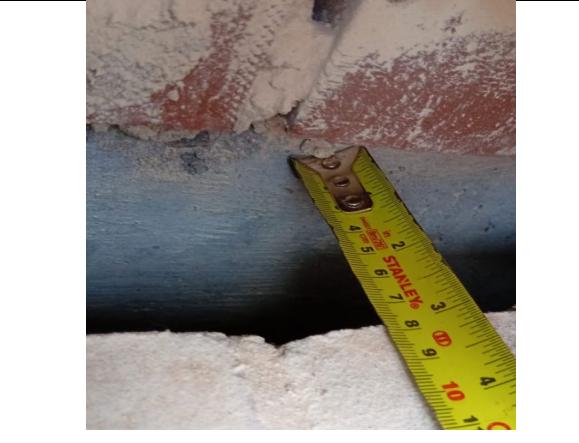
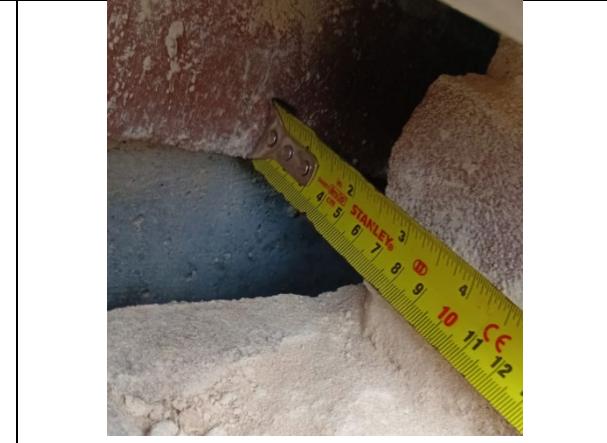
<p>Figure 107: General view to show concrete slab set back from inner leaf to give a clear cavity - 75mm.</p>	<p>Figure 108: General view to confirm thickness of clear cavity between inner brickwork leaf and outer brickwork leaf – 60mm.</p>

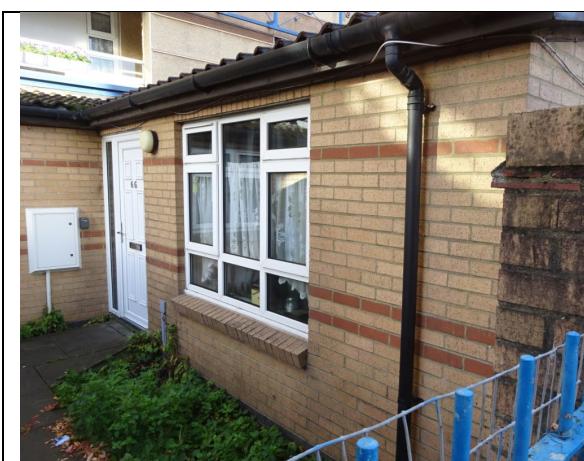
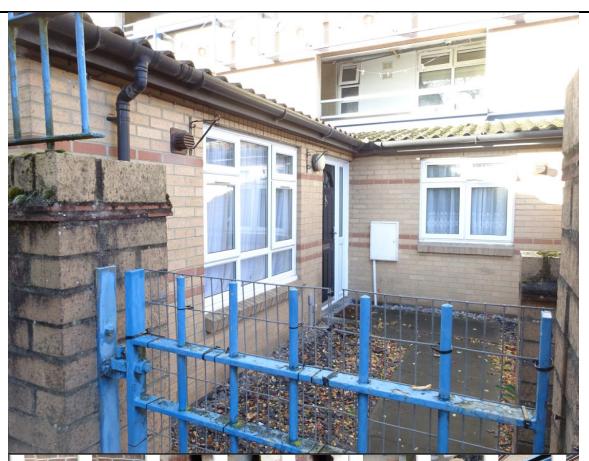
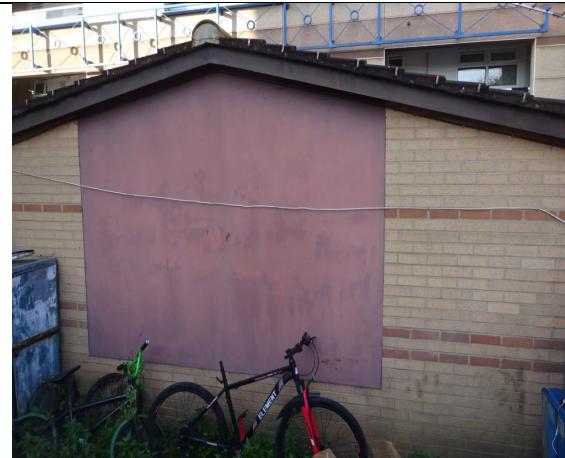
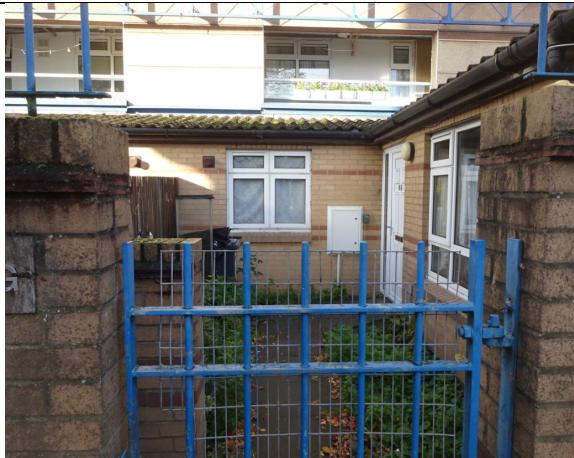
If this wall type did contain combustible insulation enclosed within two leaves of masonry at least 100mm thick, the resulting risk of fire spread is very low and therefore PAS 9980 Steps 3 to 5 are not applicable, and no further assessment of this wall type is required.

Therefore, the risk rating for external wall type #7 is **Low**.

Figure 111: General view of the traditional masonry cavity wall construction to the ground floor flats along the east elevation.

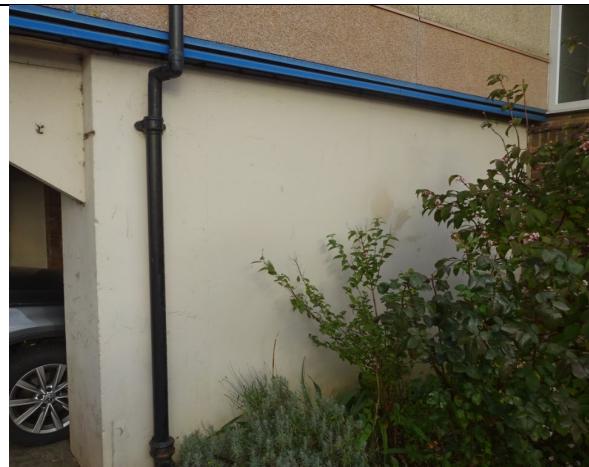
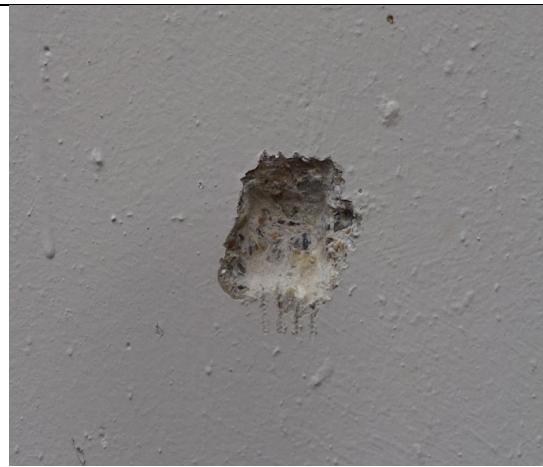
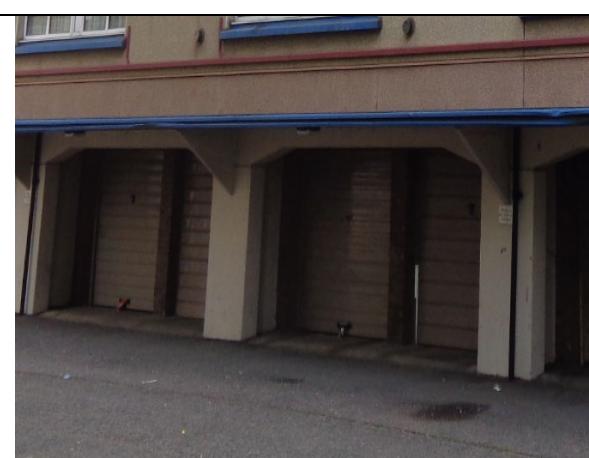
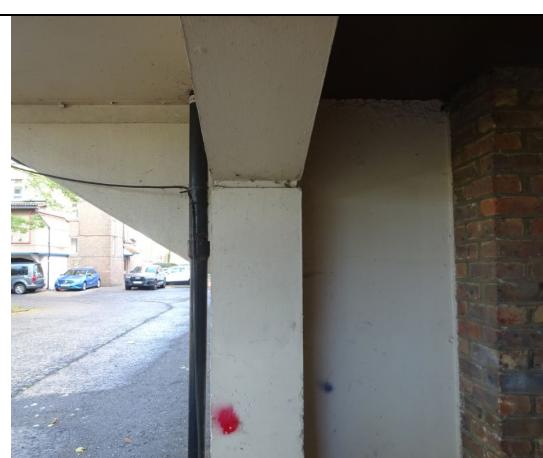
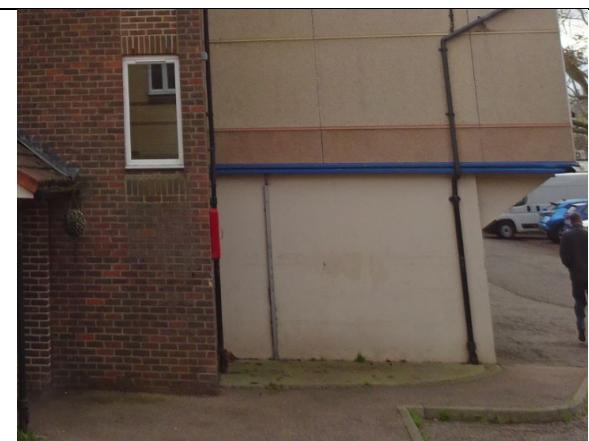
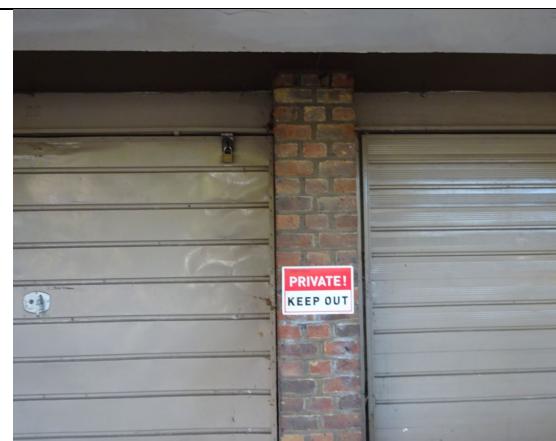
The presence of no combustible insulation and the fact the wall built-up is reinforced concrete. There is no risk of the system acting as a medium for fire. The configuration results in this wall type having an indicative fire load value of 0 MJ/m² and indicates that a complete ‘Basic’ PAS 9980 assessment (Steps 3 to 5) is not necessary for this wall type.

Therefore, the risk rating for external wall type #8 is **Low**.

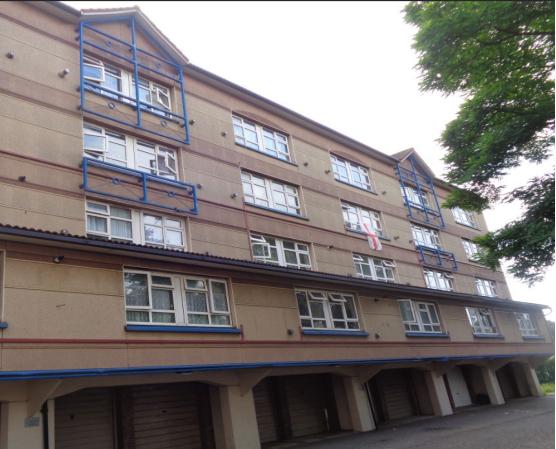
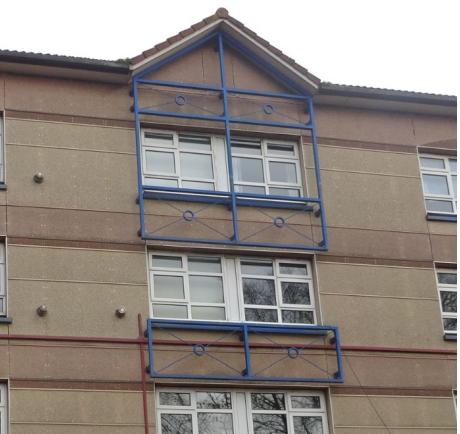
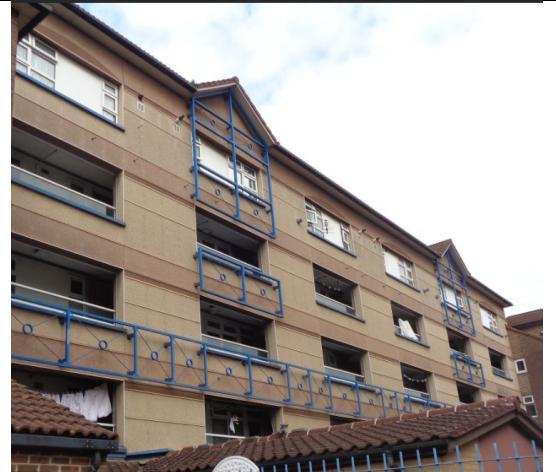
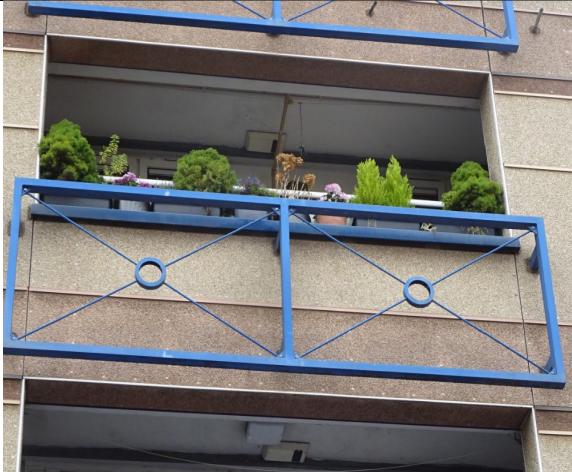
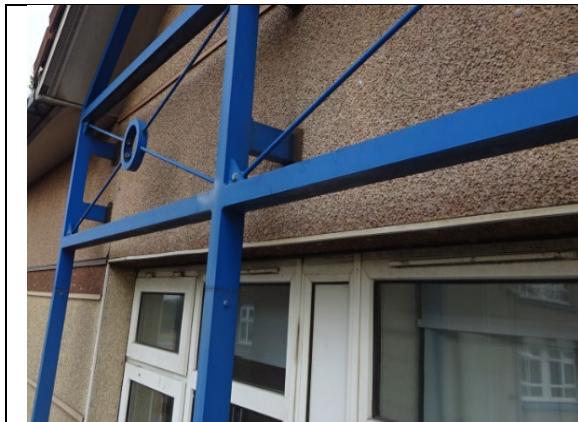
The decorative architectural steel attachments are of powder coated steel construction, measuring 50mm x 50mm.

Therefore, the risk rating for the decorative steel attachments is **Low**.

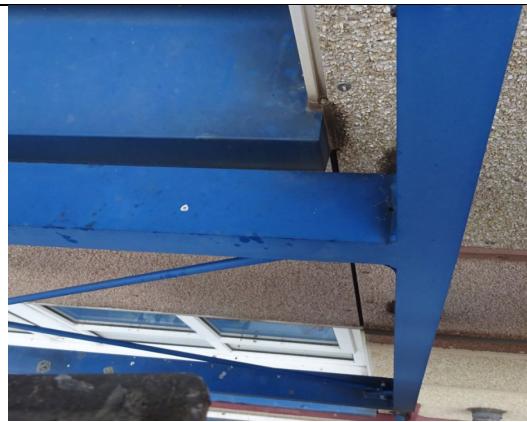
Figure 126: Close up view of the decorative architectural steel attachments installed to the west elevation.

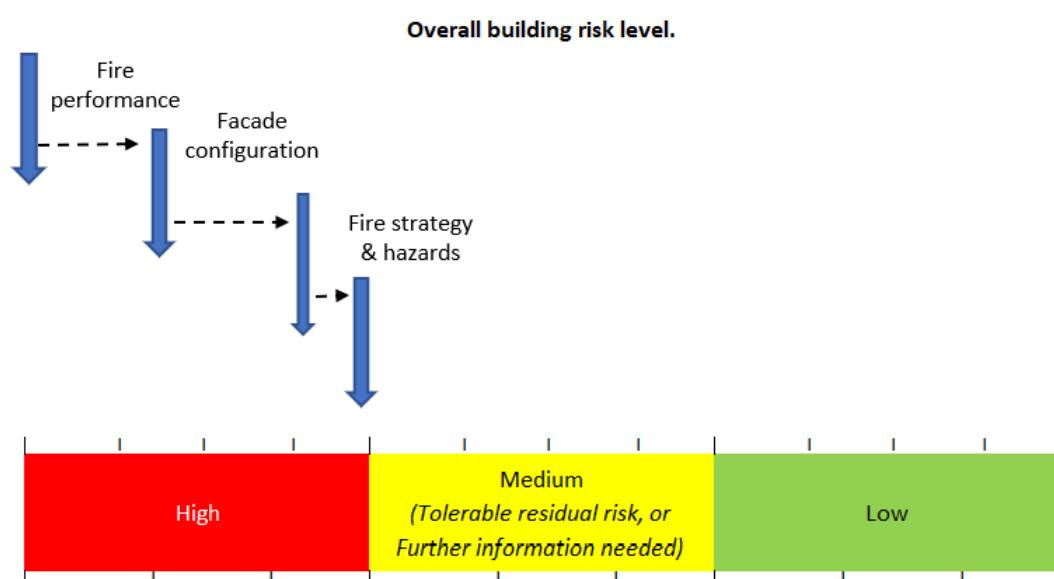
Due to the height of the building, the risk level is judged to be at the very lower end of the 'high' band, but within the 'high' band due to the extent of the combustible Steni GRP rainscreen cladding panels, the lack of suitable cavity barriers at compartment wall and floor locations and the combustible GRP and uPVC cladding panels located along the open access balconies, which could potentially compromise the escape routes.

Figure 127: External wall overall fire risk level.

This fire risk appraisal of the external wall construction has concluded that the level of fire risk relating to the likelihood of fire spread over, and or within, the external wall to be **High**, see figure 127 for overall risk rating.
