Fire Risk Appraisal of External Walls

**Queens Court, Holdbrook South,
Waltham Cross
Hertfordshire EN8 7SN.
B3Living Ltd.**

Report Issued: February 2026

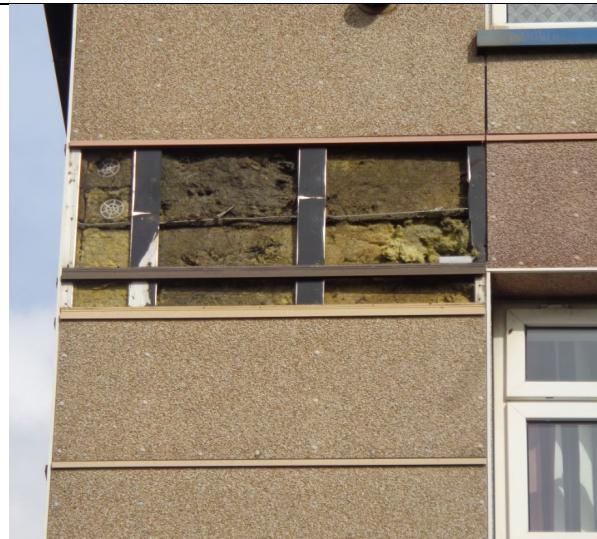
The presence of the combustible Steni GRP rainscreen cladding panels results in this wall type having an indicative fire load value of 210 MJ/m² and together with the construction defects found indicate that a complete 'Basic' PAS 9980 assessment (Steps 3 to 5) is necessary for this wall type.

| <p>Figure 15: General view of External Wall Type #1.</p> | <p>Figure 16: Close up view to show mineral wool insulation.</p> |

| | Recommendations | Priority | Time frame |
|---|---|---|--|
| 2. | Remove the combustible Steni GRP rainscreen cladding panels and replace them with a cladding system using materials which are non-combustible or of limited combustibility (Euroclass A2-s1, d0 or better). The applicable areas for removal are all elevations. | High | Aim to commence the works within 9 -12 months. |

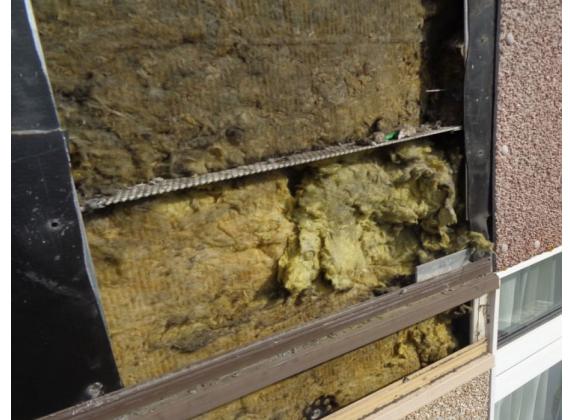
| <p><i>Figure 19: General view to show loose mineral wool insulation at compartment floor location to south elevation. NB. Unsuitable cavity barrier installed at compartment floor location.</i></p> | <p><i>Figure 20: General view to show the Steni GRP rainscreen cladding panel and mineral wool insulation. NB. Some insulation is loose fixed and not mechanically fixed to concrete wall.</i></p> |

| | Recommendations | Priority | Time frame |
|---|---|---|--|
| 4. | Where cavities are present in any replacement cladding system, ensure suitable cavity barriers are installed at floor & wall compartment lines, wall edges, around vent penetrations and around window openings. | High | During remediation. |

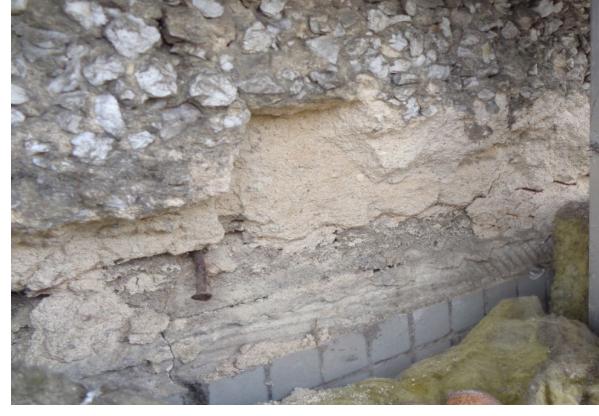
| <p><i>Figure 21: Close up view to show pebble dash render with Wimpey no fines concrete located behind render finish.</i></p> | <p><i>Figure 22: General view to missing insulation to window jamb.</i></p> |

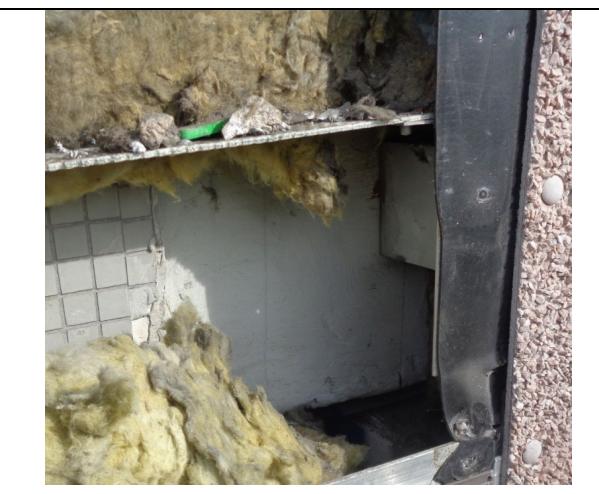
| <p><i>Figure 23: General view to show Steni GRP rainscreen cladding panel, stainless steel helping hand brackets and mineral wool insulation.</i></p> | <p><i>Figure 24: General view to show mineral wool insulation, pebble dash render with Wimpey no fines concrete.</i></p> |

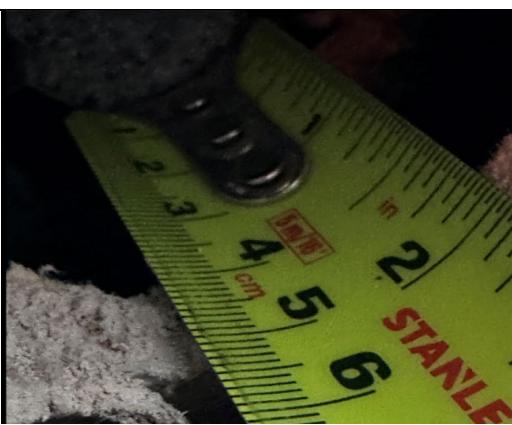
| <p>Figure 29: General view to show void between inner blockwork leaf and Paramount partition lining board – 40mm.</p> | <p>Figure 30: Close up view of Paramount partition lining board which comprises of two layers of 10mm plasterboard with an 18mm honeycomb cardboard core.</p> |

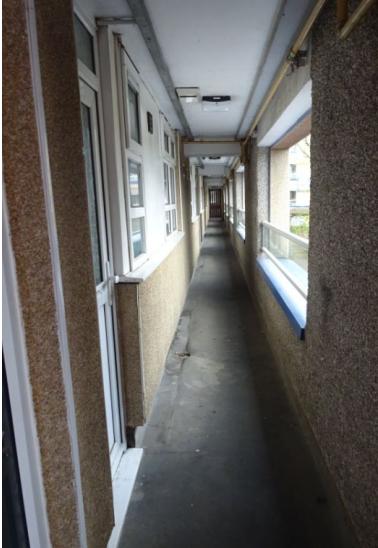
The presence of the combustible Steni GRP rainscreen cladding panels results in this wall type having an indicative fire load value of 210 MJ/m² indicates that a complete 'Basic' PAS 9980 assessment (Steps 3 to 5) is necessary for this wall type.

| <p><i>Figure 35: General view of the Steni GRP panels installed along the open access balconies along the north elevation at first floor level.</i></p> | <p><i>Figure 36: Close up view of the Steni GRP panels installed along the open access balconies.</i></p> |

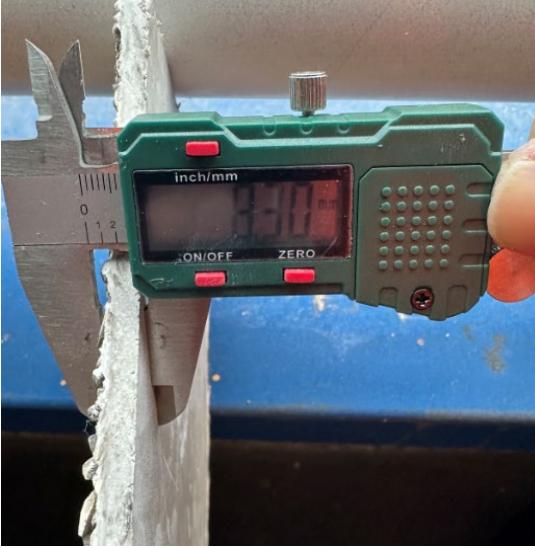
| <p>Figure 39: General view of Steni GRP rainscreen cladding panel.</p> | <p>Figure 40: General view to confirm thickness of Steni GRP rainscreen cladding panel – 8mm.</p> |

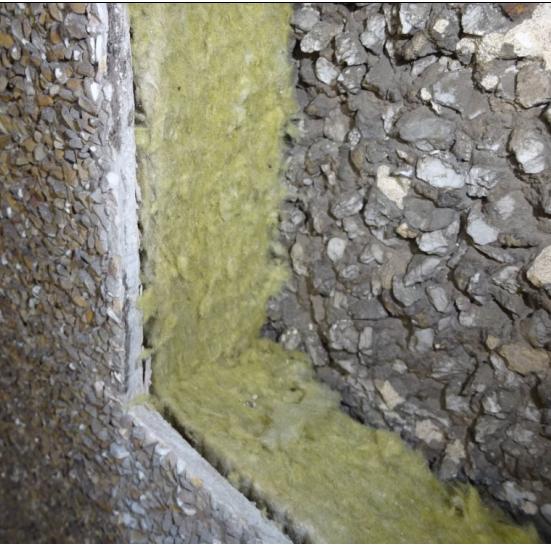
| <p>Figure 41: General view to show mineral wool insulation batt installed behind Steni GRP rainscreen cladding panel, with pebble dash render finish in the background.</p> | <p>Figure 42: General view to show mineral wool insulation batt.</p> |

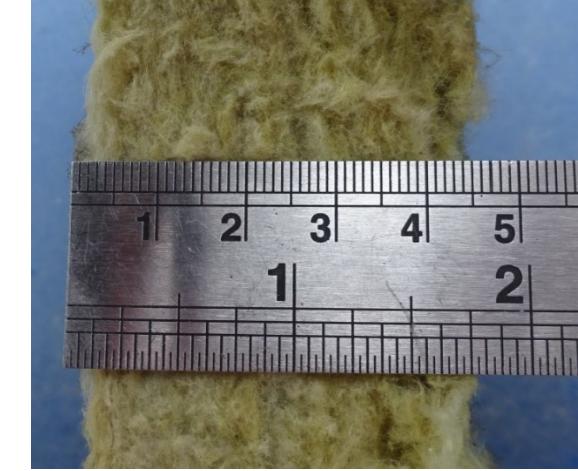
| <p><i>Figure 43: General view to confirm thickness of mineral wool insulation batt – 45mm.</i></p> | <p><i>Figure 44: General view to show pebble dash render finish with blockwork inner leaf.</i></p> |

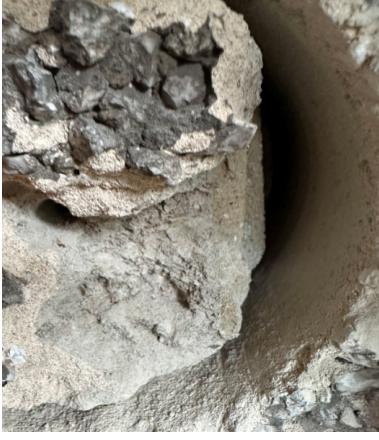
| <p><i>Figure 45: Alternative view to show pebble dash render finish with blockwork inner leaf.</i></p> | <p><i>Figure 46: General view of a section of the blockwork inner leaf.</i></p> |

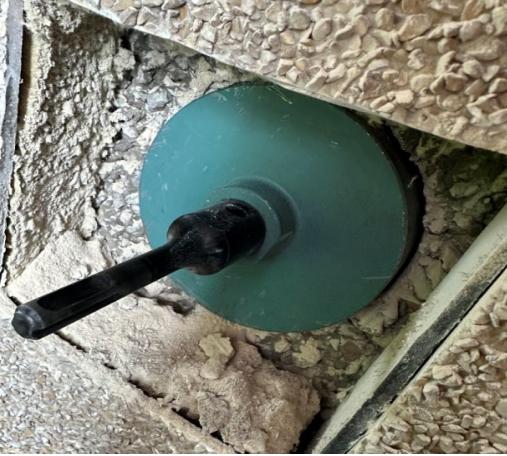
| <p><i>Figure 47: General view to show core hole drill bit at maximum depth drilling into blockwork inner leaf.</i></p> | <p><i>Figure 48: General view to show total depth of core hole drill bit – 150mm. Based upon the overall wall thickness and dimension of the other wall materials identified, the inner blockwork leaf is 200mm thick.</i></p> |

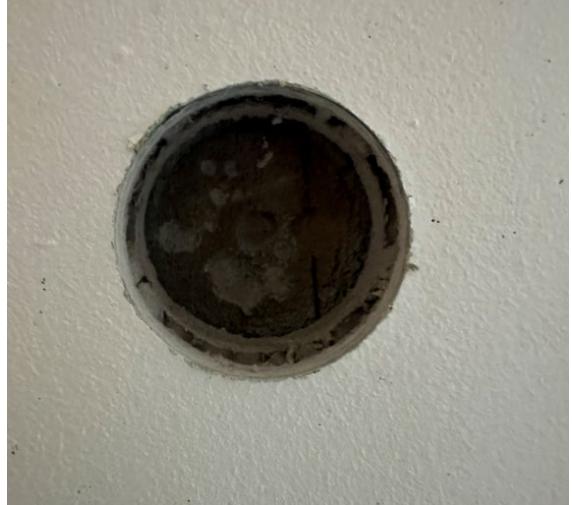
| <p>Figure 49: General view of internal sample location inside first floor Flat No. 354.</p> | <p>Figure 50: Close up view of the internal Paramount partition lining to the external wall.</p> |

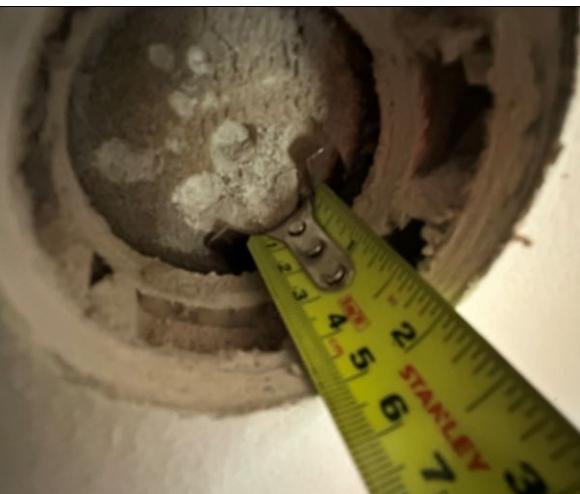
| <p>Figure 51: General view to show void between inner blockwork leaf and Paramount partition lining board – 10mm.</p> | <p>Figure 52: Close up view of Paramount partition lining board which comprises of two layers of 10mm plasterboard with an 18mm honeycomb cardboard core.</p> |

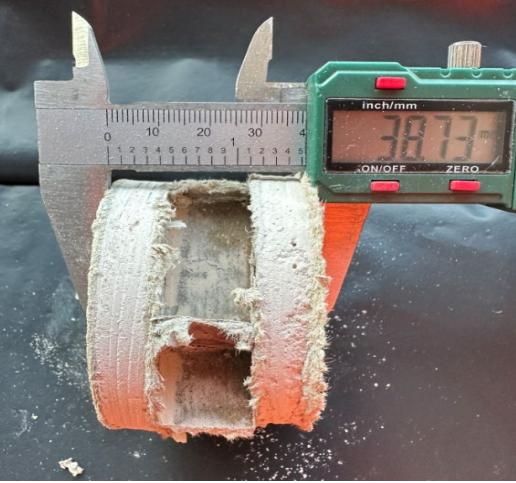
| <p>Figure 53: General view to confirm thickness of the Paramount partition lining board – 38mm.</p> | <p>Figure 54: General view to confirm thickness of internal window reveal – 155mm.</p> |

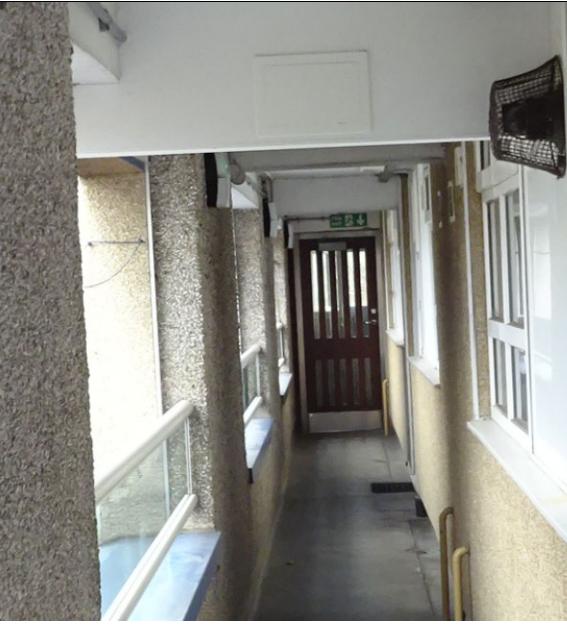
| <p>Figure 55: General view of Fire Door installed at the end of the open access balcony prior to entering the escape staircase.</p> | <p>Figure 56: General view to show Fire Door installed at the opposite end of the open access balcony prior to entering the escape staircase and the concrete soffit to the open access balcony.</p> |

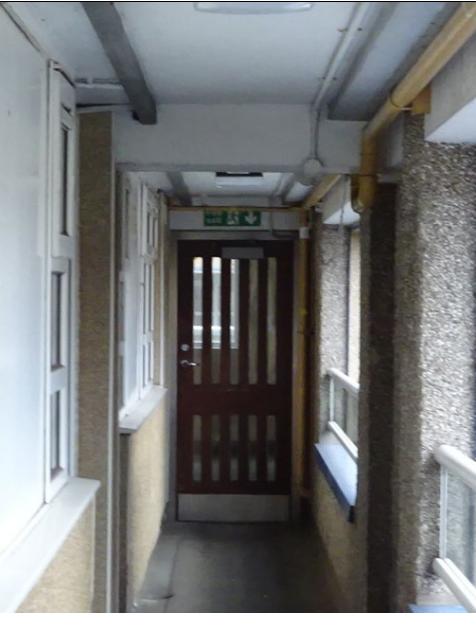
It should be noted that the mains gas supply pipework runs along the length of the open access balconies, see Figure 56. Any potential damage to the pipework could lead to an escalation of a fire affecting the open access balconies.

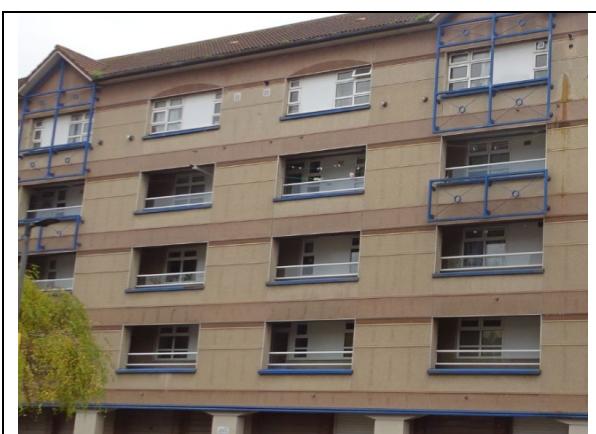
The presence of the combustible Steni GRP rainscreen cladding panels results in this wall type having an indicative fire load value of 185 MJ/m² indicates that a complete 'Basic' PAS 9980 assessment (Steps 3 to 5) is necessary for this wall type.

| <i>Figure 59: General view of External Wall Type #3</i> | <i>Figure 60: General view of compartment floor location to show no horizontal cavity barrier at compartment (Taken from Queens Court 2021).</i> |

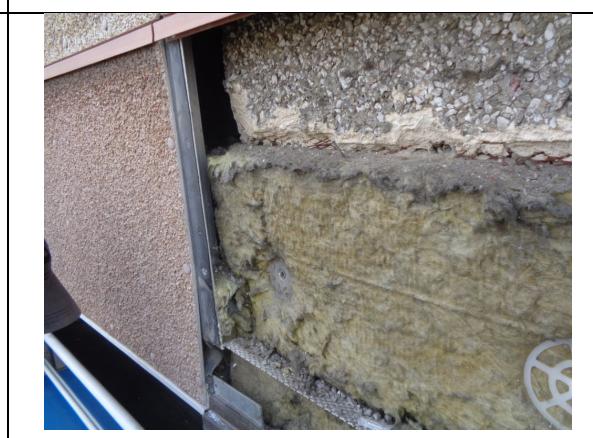
| <i>Figure 61: Close up view of compartment floor detail, which shows mineral wool insulation installed at compartment floor location, but this does not fully fill the void behind the Steni GRP rainscreen cladding panel (Taken from Queens Court 2021).</i> | <i>Figure 62: Alternative view of compartment floor detail, which shows mineral wool insulation installed at compartment floor location, but this does not fully fill the void behind the Steni GRP rainscreen cladding panel and the concrete floor slab (Taken from Queens Court 2021).</i> |

| | | Negative | Cavities are vertically and horizontally open with no vertical cavity barriers present and where horizontal cavity barriers have been installed at compartment floor locations, these are unsuitable due to not being fully in compression or missing. |

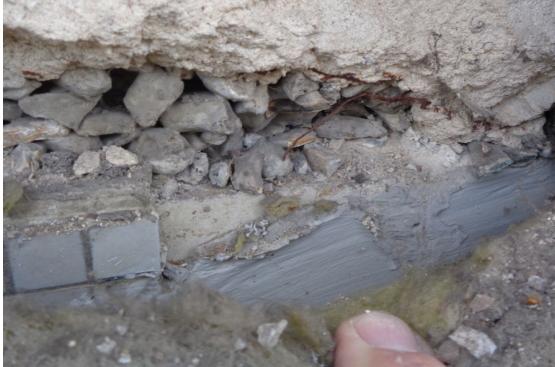
| <p><i>Figure 63: Close up view to show pebble dash render, Wimpey no fine concrete, concrete floor slab and mineral wool insulation installed at compartment floor location (Taken from Queens Court 2021).</i></p> | <p><i>Figure 64: Alternative view to show pebble dash render, Wimpey no fine concrete, concrete floor slab and mineral wool insulation installed at compartment floor location (Taken from Queens Court 2021).</i></p> |

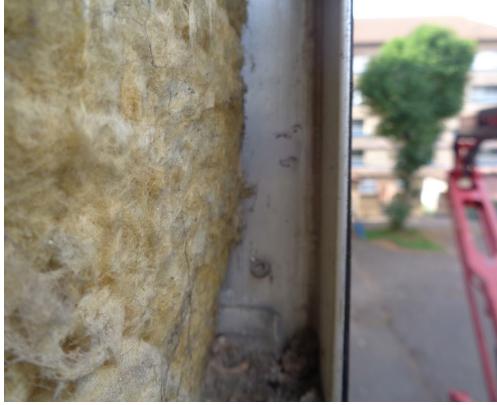
| <p><i>Figure 65: Close up view at compartment floor location to show that the mineral wool insulation does not fully fill the void and therefore does not form a suitable cavity barrier at compartment floor location (Taken from Queens Court 2021)</i></p> | <p><i>Figure 66: General view to show clear cavity between pebble dash render and the Steni GRP rainscreen cladding panel (Taken from Queens Court 2021).</i></p> |

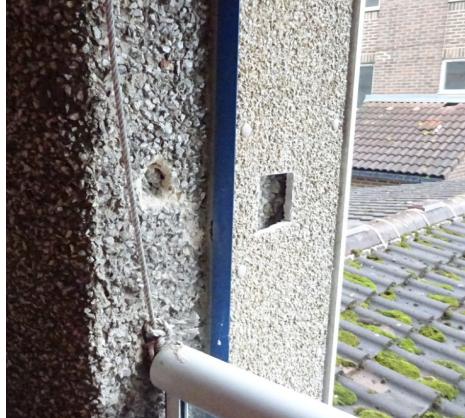
| <p><i>Figure 67: General view of sample locations to open access balcony wall reveals at first floor level (Harold Court).</i></p> | <p><i>Figure 68: Close up view of Steni GRP rainscreen cladding panel installed over pebble dash render finish.</i></p> |

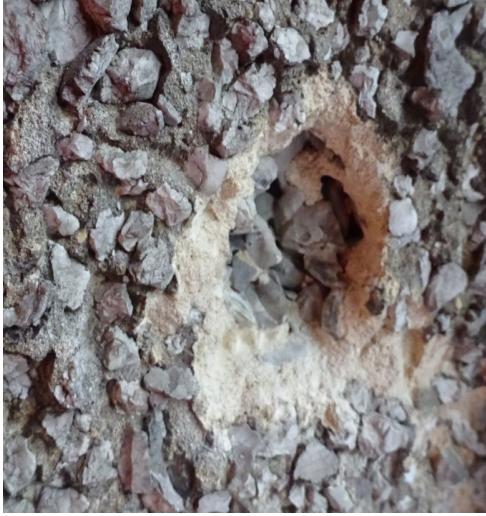
| <i>Figure 69: Close up view to show pebble dash render finish installed over Wimpey no fines concrete (Harold Court).</i> | <i>Figure 70: General view of pebble dash render finish to external wall of second floor open access balcony along the north elevation.</i> |

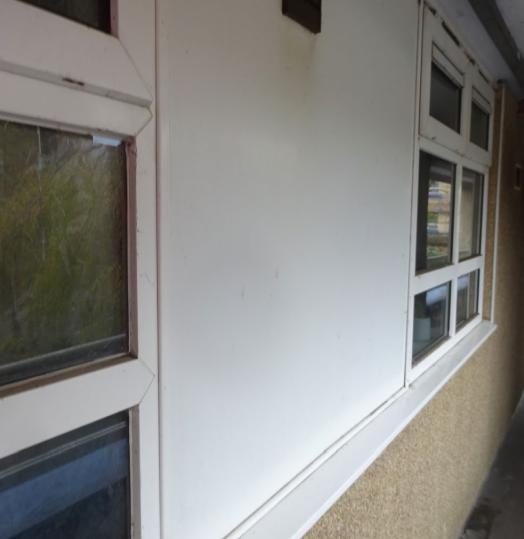
The presence of the combustible solid uPVC panels results in this wall type having an indicative fire load value of 574 MJ/m² indicates that a complete 'Basic' PAS 9980 assessment (Steps 3 to 5) is necessary for this wall type.

| <p>Figure 71: General view of the solid uPVC panels installed along the open access balconies located along the north elevation.</p> | <p>Figure 72: General view of the sample location at first floor level (Harold Court).</p> |

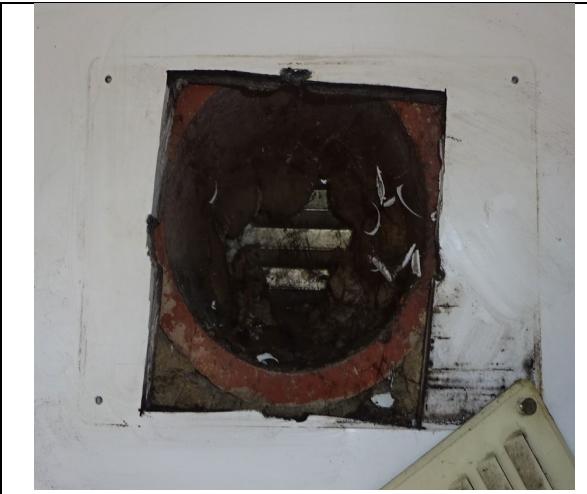
| <p>Figure 73: Close up view of the sample location (Harold Court).</p> | <p>Figure 74: Close up view of the sample location (Harold Court).</p> |

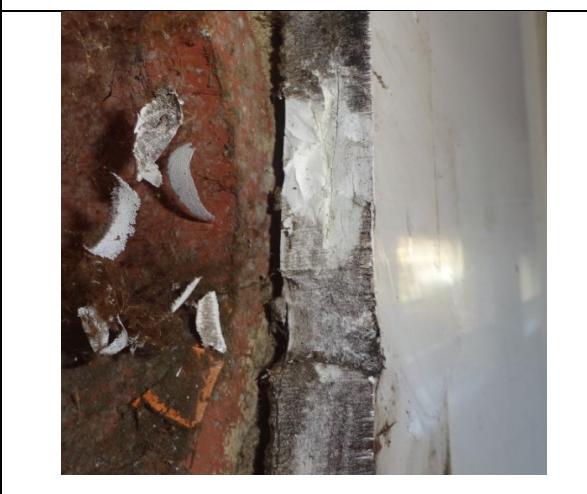
| <p>Figure 75: Close up view to show 20mm solid uPVC panel (Harold Court).</p> | <p>Figure 76: General view to show EPS insulated panel installed at low level to flat entrance door to Flat No. 354 (Harold Court).</p> |

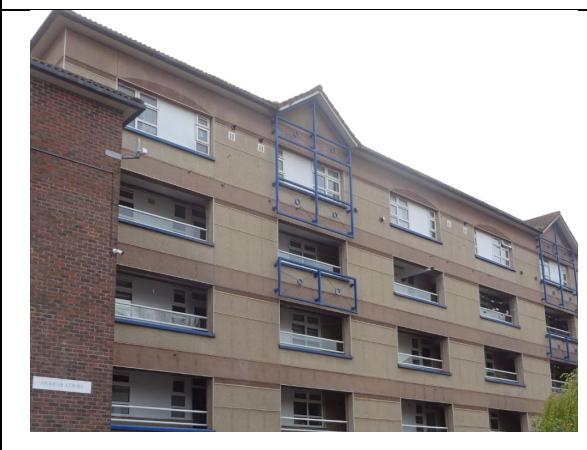
| <p>Figure 77: General view to show solid uPVC panels installed at fourth floor level along the north elevation.</p> | <p>Figure 78: Close up view of the solid uPVC panels installed at fourth floor level along the north elevation.</p> |

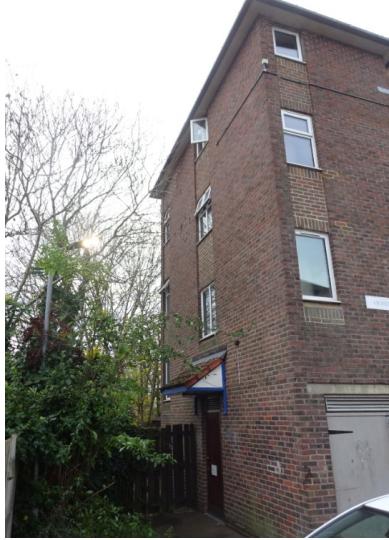
Therefore, the risk rating for external wall type #5 is Low.

| <p>Figure 81: General view of the traditional masonry cavity wall construction to the escape staircase located on the east elevation.</p> | <p>Figure 82: Alternative view of the traditional masonry cavity wall construction to the escape staircase located on the east elevation.</p> |

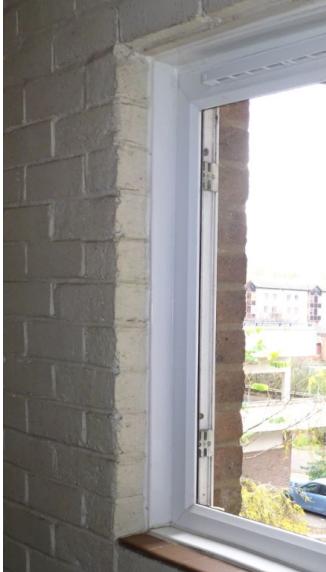
| <p>Figure 83: General view of the wall construction to show brick inner leaf and brick outer leaf.</p> | <p>Figure 84: General view of the traditional masonry cavity wall construction to the escape staircase located on the west elevation.</p> |

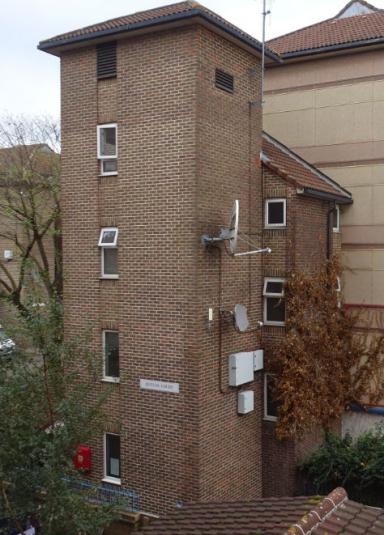
| <p><i>Figure 85: Alternative view of the traditional masonry cavity wall construction to the escape staircase located on the west elevation.</i></p> | <p><i>Figure 86: General view to show inner brick leaf and concrete escape staircase.</i></p> |

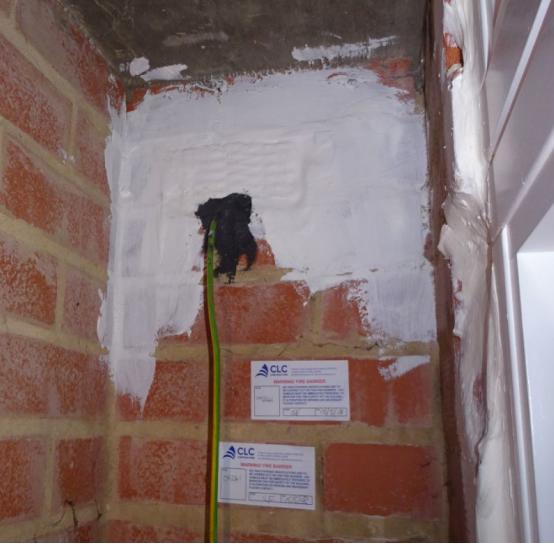
| <p><i>Figure 87: General view to show fire stopping works including ID labels completed to riser cupboards located in escape staircases (Albert Court).</i></p> | <p><i>Figure 88: Close up view to show fire stopping works including ID labels completed to riser cupboards located in escape staircases (Albert Court).</i></p> |

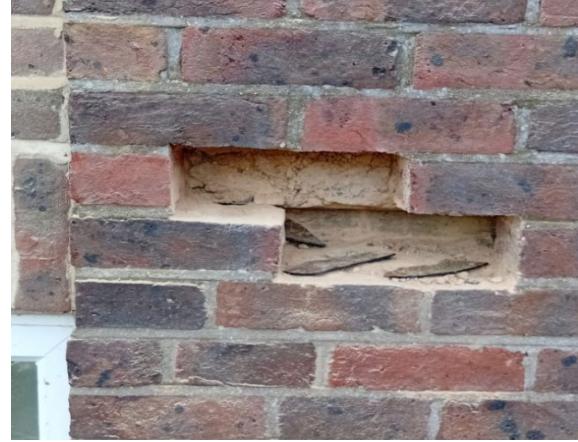
| <i>Figure 89: General view of sample location at compartment floor location located on north elevation.</i> | <i>Figure 90: Close up view to show concrete floor slab.</i> |

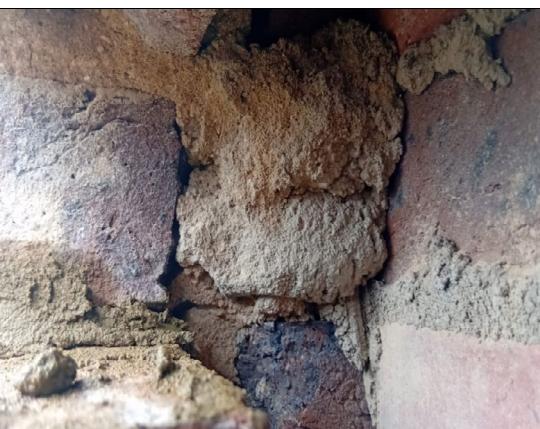
| <i>Figure 93: General view of window cill sample location to confirm that masonry wall closes the cavity.</i> | <i>Figure 94: General view to confirm thickness of clear cavity – 80mm.</i> |

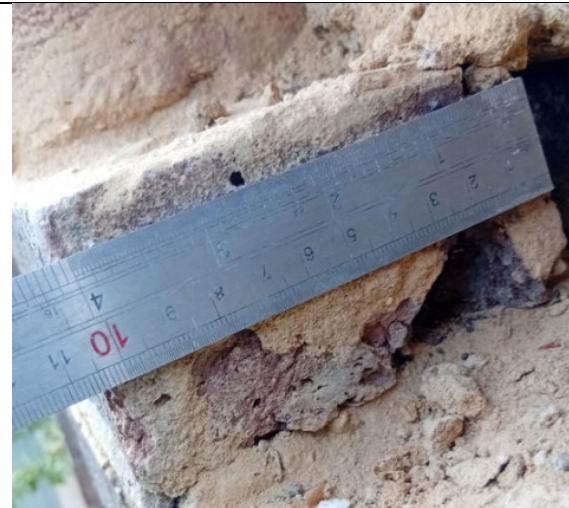
Figure 95: General view to confirm thickness outer brickwork leaf to window cill – 100mm.

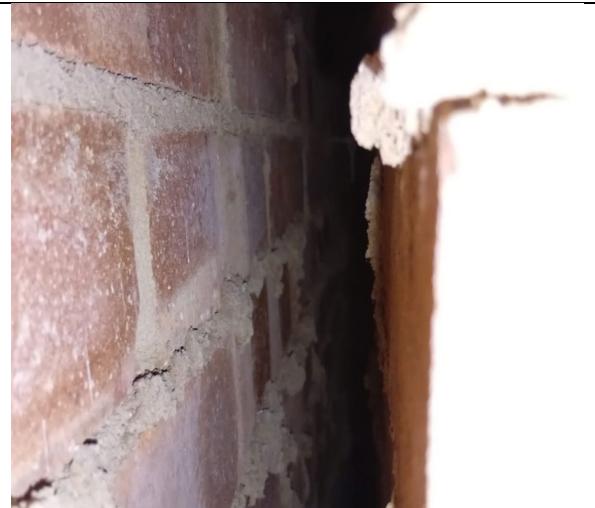
The intrusive survey identified that a clear cavity exists between the two leaves of masonry construction. The cavity is continuous vertically and horizontal with no cavity barriers observed during the inspection. However, the window openings are closed with the brickwork returning to close the cavity.

Figure 96: General view to show clear cavity.

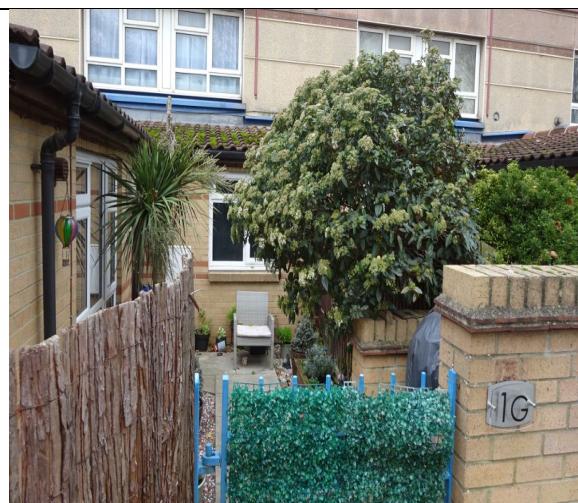
Therefore, the risk rating for external wall type #6 is **Low**.

Figure 97: General view of the traditional masonry cavity wall construction to the ground floor flats along the south elevation.

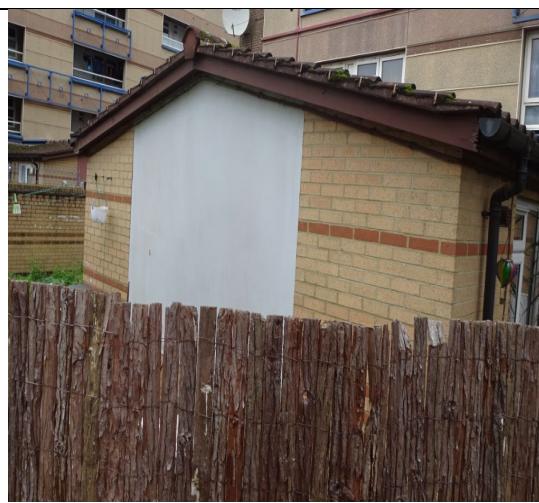
Figure 98: Alternative view of the traditional masonry cavity wall construction to the ground floor flats along the south elevation.

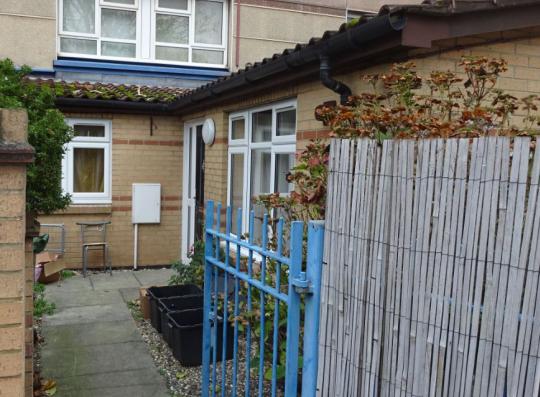
| Figure 99: Alternative view of the traditional masonry cavity wall construction to the ground floor flats along the south elevation. | Figure 100: Alternative view of the traditional masonry cavity wall construction to the ground floor flats along the south elevation. |

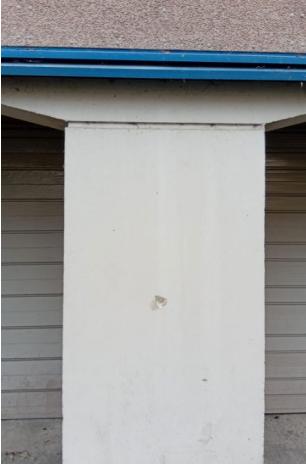
Therefore, the risk rating for external wall type #7 is **Low**.

| <p><i>Figure 101: General view of the reinforced concrete wall to the north elevation at ground floor level, showing sample location.</i></p> | <p><i>Figure 102: Close up view of the sample location to confirm solid concrete shear wall (Harold Court).</i></p> |

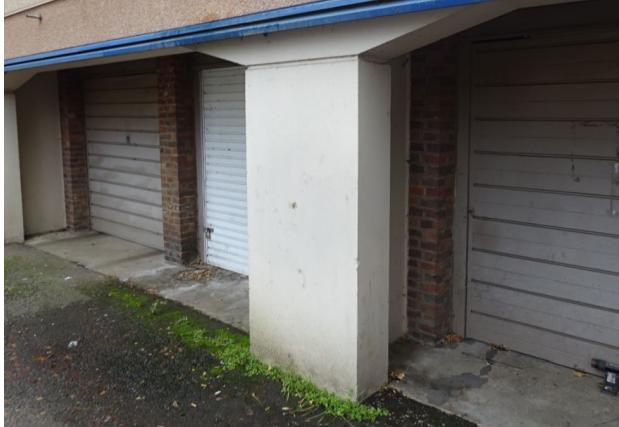
| <p><i>Figure 103: General view of the reinforced concrete frame and concrete floor to the north elevation. NB. that the garages are recessed back from the main elevation.</i></p> | <p><i>Figure 104: Alternative view of the reinforced concrete frame and concrete floor to the north elevation. NB. that the garages are recessed back from the main elevation.</i></p> |

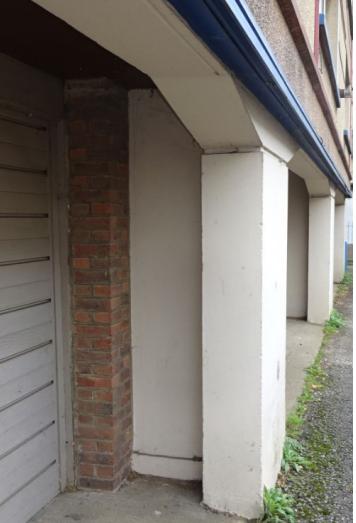
| <i>Figure 105: General view of the reinforced concrete wall to the north elevation at ground floor level.</i> | <i>Figure 106: General view to show solid masonry wall located between garages.</i> |

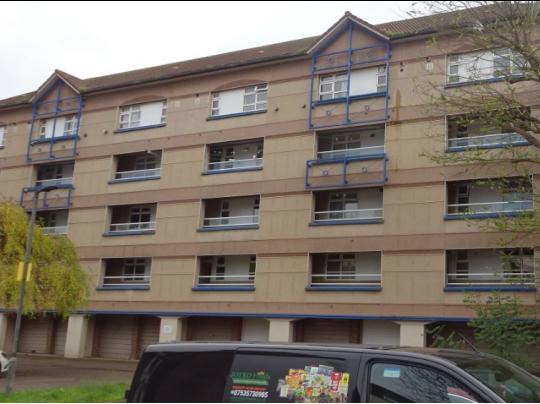
Therefore, the risk rating for the decorative steel attachments is **Low**.

| <i>Figure 107: General view of the decorative architectural steel attachments installed to the north elevation.</i> | <i>Figure 108: Alternative view of the architectural decorative steel attachments installed to the north elevation.</i> |

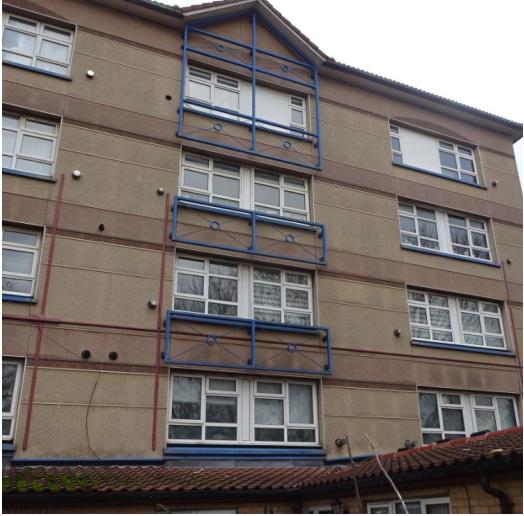
| <p>Figure 109: General view of the decorative architectural steel attachments installed to the south elevation.</p> | <p>Figure 110: Alternative view of the decorative architectural steel attachments installed to the south elevation.</p> |

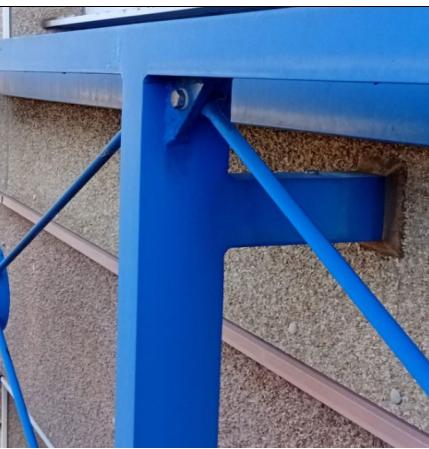
| <p>Figure 111: Close up view of the decorative architectural steel attachments installed (Albert Court).</p> | <p>Figure 112: Close up view of the decorative architectural steel attachments installed (Albert Court).</p> |

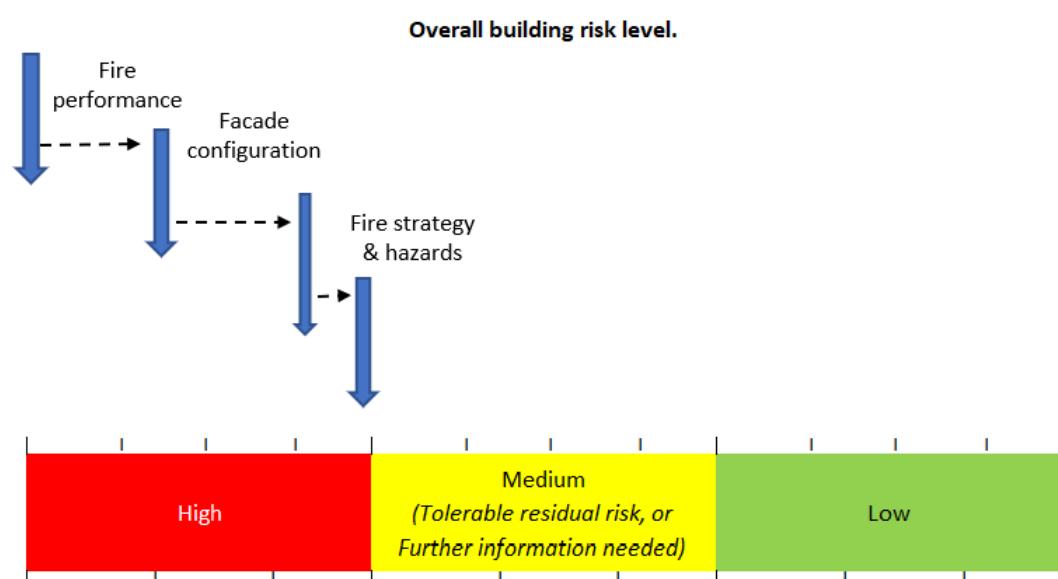
Figure 113: External wall overall fire risk level.

Due to the height of the building, the risk level is judged to be at the very lower end of the 'high' band, but within the 'high' band due to the extent of the combustible Steni GRP rainscreen cladding panels, the lack of suitable cavity barriers at compartment wall and floor locations and the combustible GRP and uPVC cladding panels located along the open access balconies, which could potentially compromise the escape routes.

This fire risk appraisal of the external wall construction has concluded that the level of fire risk relating to the likelihood of fire spread over, and or within, the external wall to be **High**, see figure 111 for overall risk rating.

Taking account of the factors above, it is concluded that the proportionate risk reduction approach is to remove all the combustible Steni GRP rainscreen cladding panels and solid white uPVC panels installed to the building. The specific recommendations are as follows:

1. It is recommended that this appraisal report is provided to the building's fire risk assessor, to assist those persons in concluding the overall fire risk level within the building.
2. Remove the combustible Steni GRP rainscreen cladding panels from all elevations and replace with a cladding system using materials which are non-combustible or of limited combustibility (Euroclass A2-s1, d0 or better).
3. Remove the combustible solid white uPVC panels and replace with a cladding system using materials which are non-combustible or of limited combustibility (Euroclass A2-s1, d0 or better).
4. Where cavities are present in any replacement cladding system, ensure suitable cavity barriers are installed at compartment floor and compartment wall lines, wall edges, around vent penetrations and around window openings.

Should the above remedial works be undertaken, specifically those set out in Recommendation 2, 3 and 4 above, subject to the works being completed to a satisfactory standard, we would expect the overall risk rating to be reduced to: **Low**
