## **Fire Risk Appraisal of External Walls**

**Harold Court, Holdbrook South,  
Waltham Cross  
Hertfordshire EN8 7SR.  
B3Living Ltd.**

**Report Issued: February 2026**

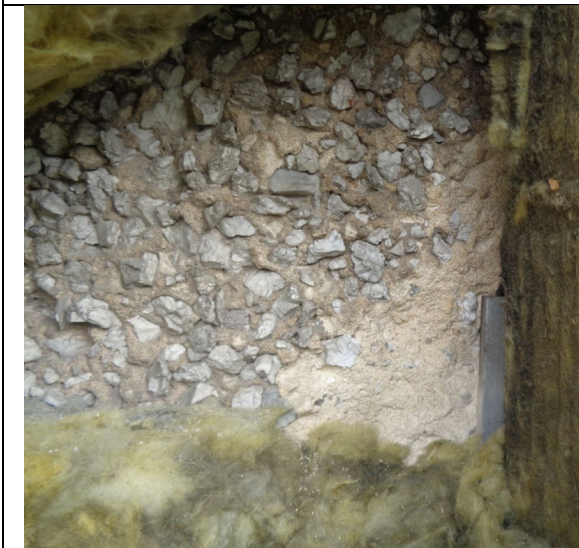
Figure 17: General view to show pebble dash render finish.

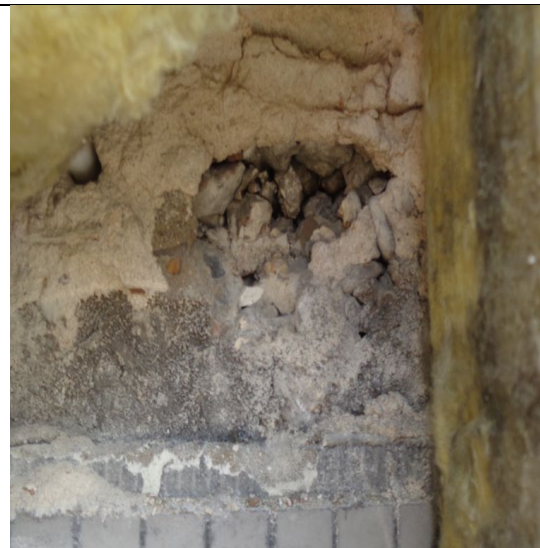
Figure 18: General view to show Wimpey no fines concrete.

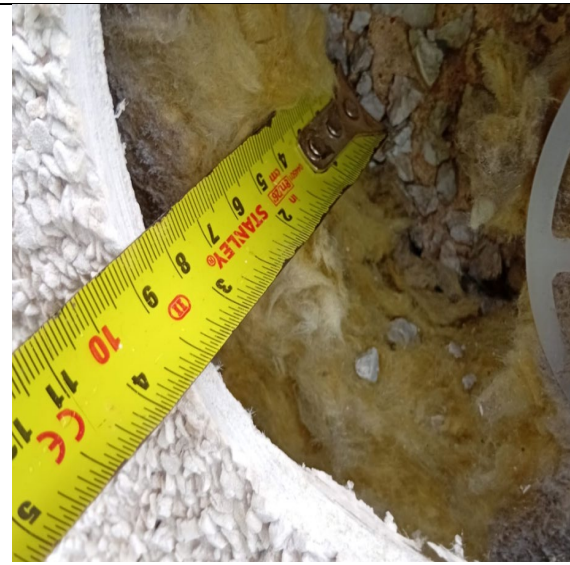
Figure 20: General view to show the Steni GRP rainscreen cladding panel

| | Recommendations | Priority | Time frame |
|---|---|---|---|
| 2. | Remove the combustible Steni GRP rainscreen cladding panels and replace them with a cladding system using materials which are non-combustible or of limited combustibility (Euroclass A2-s1, d0 or better).<br><br>The applicable areas for removal are all elevations. | High | Aim to commence the works within 9 - 12 months. |

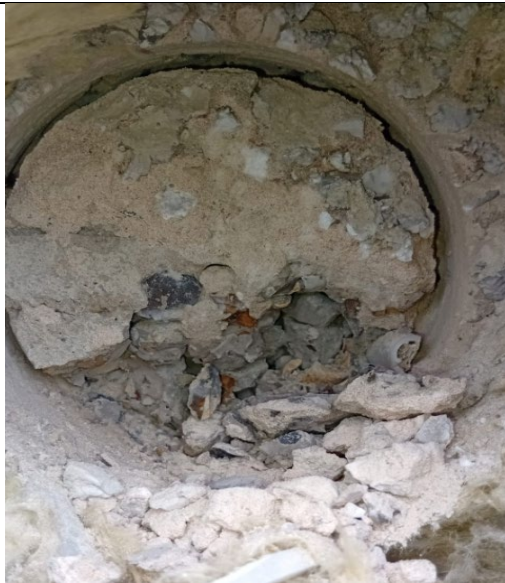
Figure 21: Close up view to show pebble dash render with Wimpey no fines concrete located behind render finish.

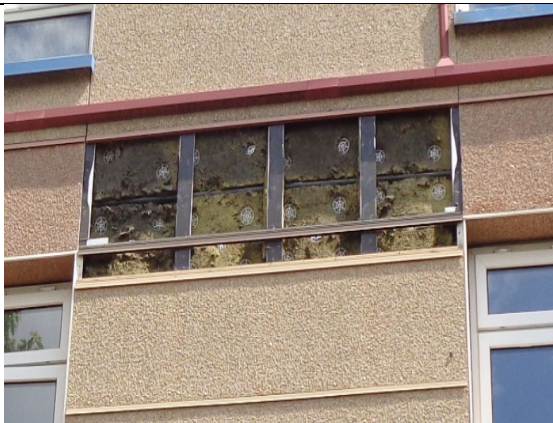
*Figure 25: General view to show no horizontal cavity barrier installed at compartment floor location.*

| | Recommendations | Priority | Time frame |
|---|---|---|---|
| 4. | Where cavities are present in any replacement cladding system, ensure suitable cavity barriers are installed at floor & wall compartment lines, wall edges, around vent penetrations and around window openings. | High | During remediation. |

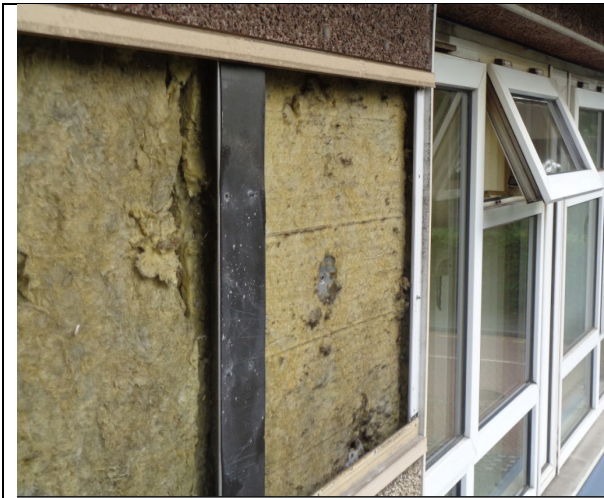
Figure 29: Close up view to show Steni GRP panels and mineral wool insulation.

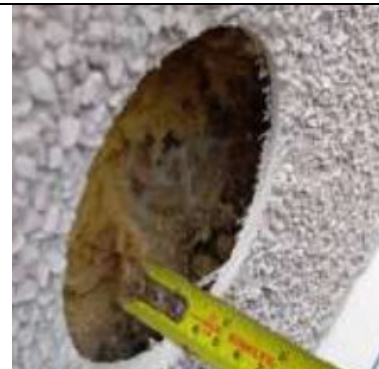
Figure 32: General view to show Steni GRP rainscreen cladding panel, cavity void and mineral wool insulation.

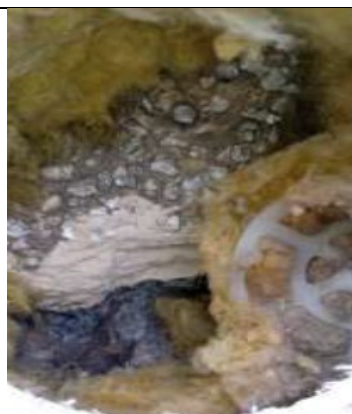
Figure 33: General view to show mineral wool insulation, pebble dash render with blockwork located behind.

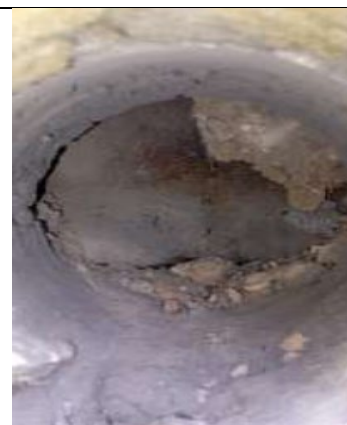
Figure 34: General view to show blockwork outer leaf and clear cavity.

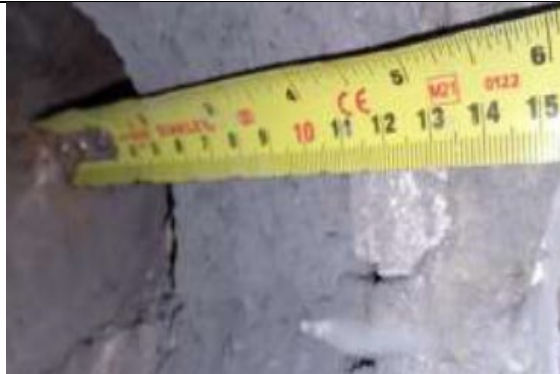
Figure 35: Alternative view to show 20mm pebble dash render, 60mm blockwork outer leaf and 50mm clear cavity.

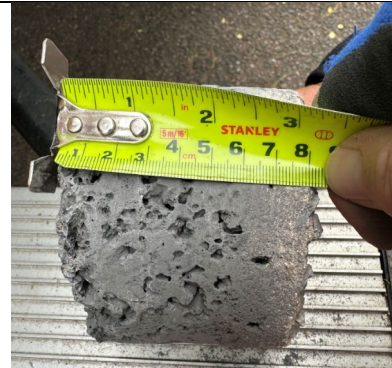
Figure 36: General view of core sample to show 60mm blockwork with 20mm pebble dash render finish.

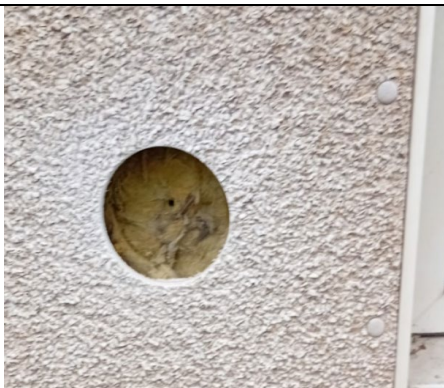
Figure 39: General view of sample location to show Steni GRP rainscreen cladding panel, cavity void and mineral wool insulation.

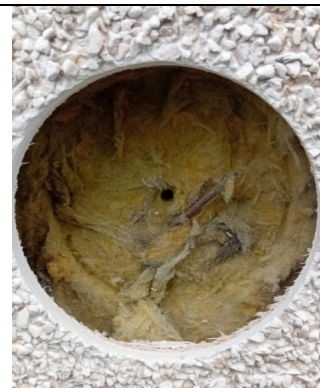
Figure 40: Close up view to show Steni GRP rainscreen cladding panel, cavity void and mineral wool insulation.

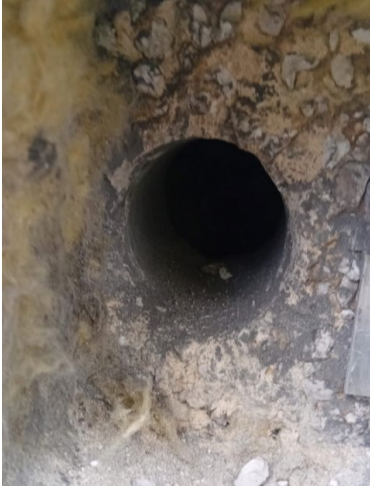
| <p><i>Figure 41: General view to show mineral wool insulation (removed), pebble dash render and blockwork outer leaf.</i></p> | <p><i>Figure 42: General view to show 20mm pebble dash render, 60mm blockwork outer leaf, 50mm clear cavity and blockwork inner leaf.</i></p> |

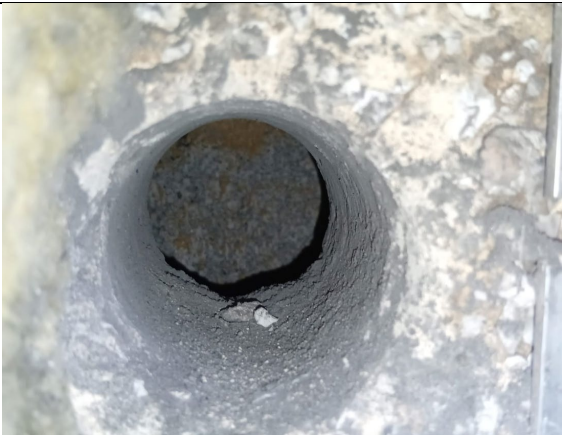
| <p><i>Figure 43: Alternative view to show 20mm pebble dash render, 60mm blockwork outer leaf, 50mm clear cavity and blockwork inner leaf.</i></p> | <p><i>Figure 44: General view of clear cavity to blockwork outer and inner leaves to show uPVC cavity closer to window jamb.</i></p> |

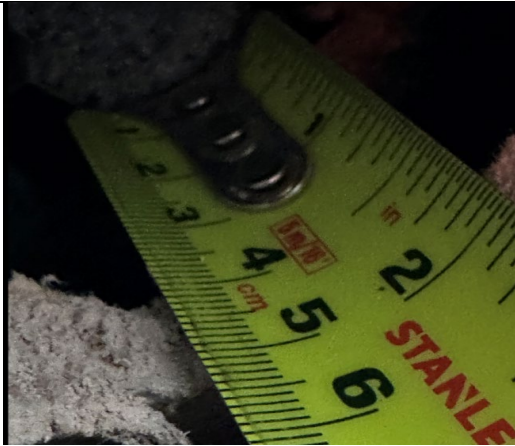
Figure 47: General view to show void between inner blockwork leaf and Paramount partition lining board – 40mm.

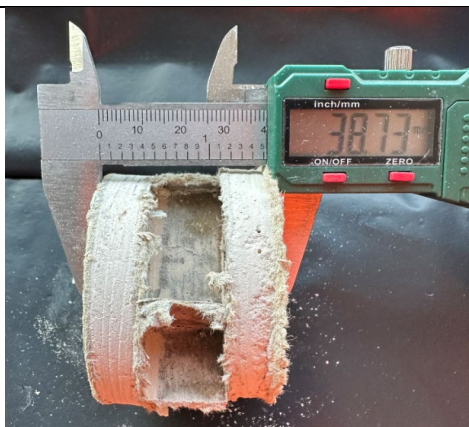
Figure 51: General view to confirm thickness of the Paramount partition lining board – 38mm.

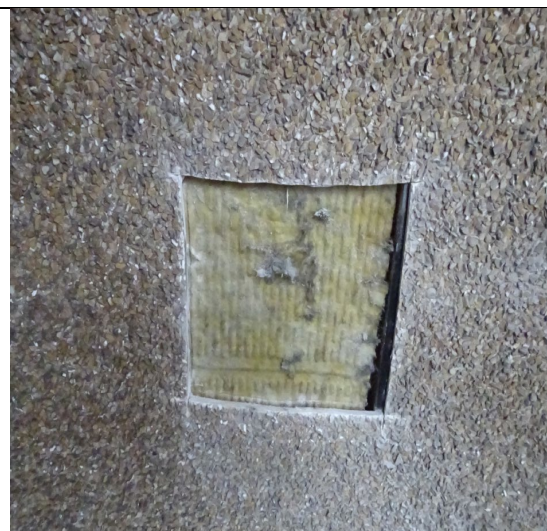
*Figure 56: General view of sample location located outside first floor Flat No. 354.*

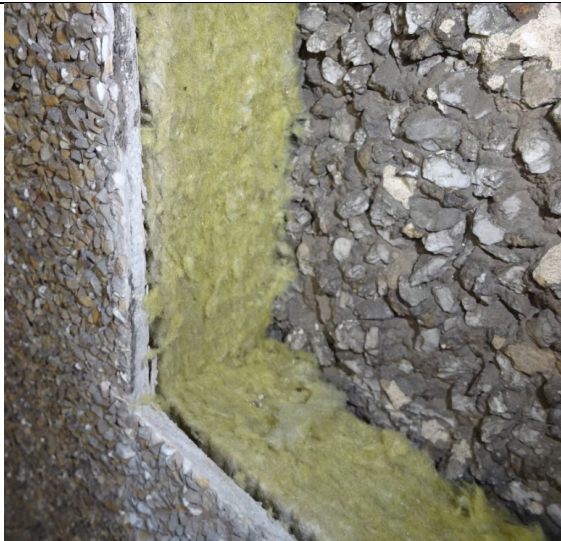
Figure 59: General view to show mineral wool insulation batt installed behind Steni GRP rainscreen cladding panel, with pebble dash render finish in the background.

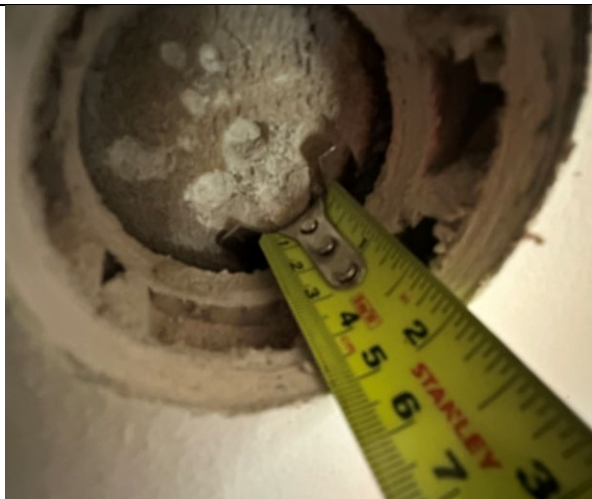
*Figure 69: General view to show void between inner blockwork leaf and Paramount partition lining board – 10mm.*

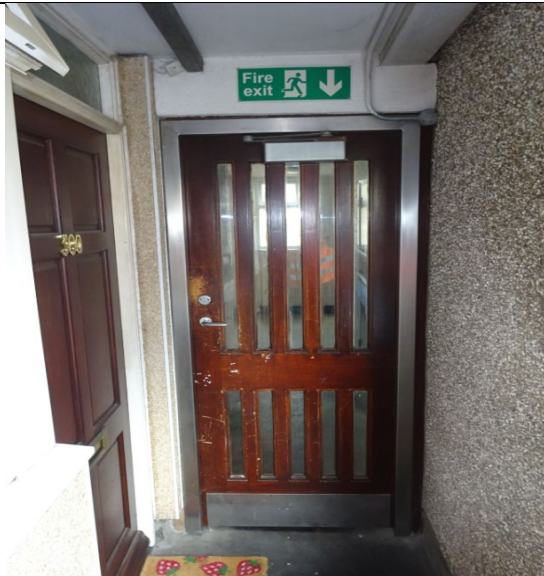
Figure 73: General view of Fire Door installed at the end of the open access balcony prior to entering the escape staircase.

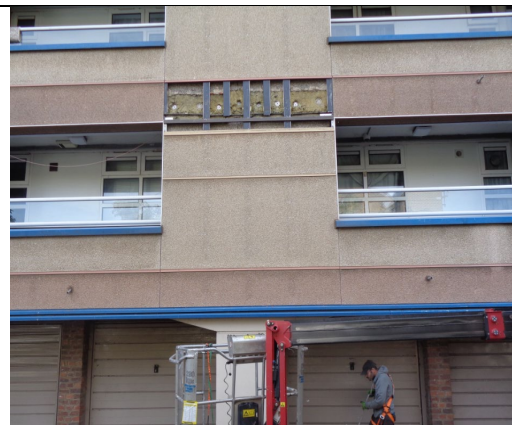
Figure 76: General view of compartment floor location to show no horizontal cavity barrier at compartment (Taken from Queens Court 2021).

| | | Negative | Cavities are vertically and horizontally open with no horizontal cavity barriers present and where vertical cavity barriers have been installed at compartment wall locations, these are unsuitable due to not being fully in compression or missing. |

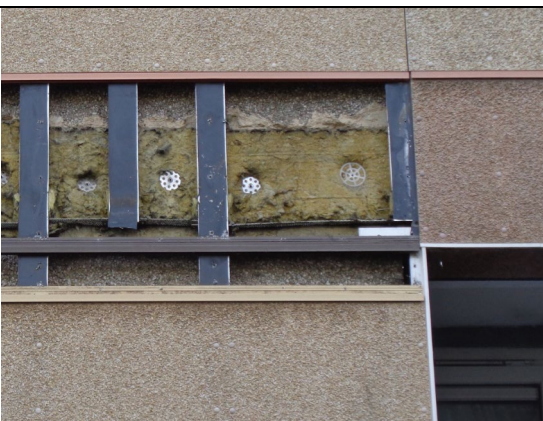
Figure 77: Close up view of compartment floor detail, which shows mineral wool insulation installed at compartment floor location, but this does not fully fill the void behind the Steni GRP rainscreen cladding panel (Taken from Queens Court 2021).

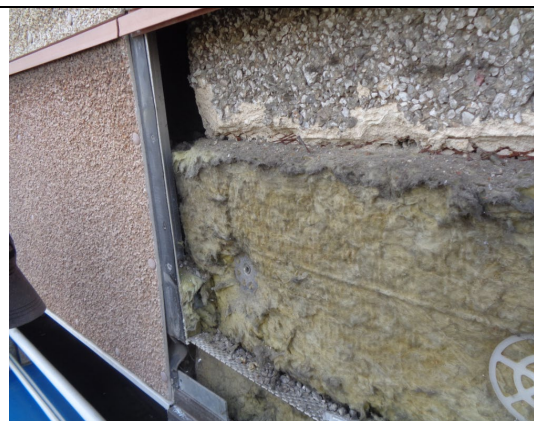
Figure 78: Alternative view of compartment floor detail, which shows mineral wool insulation installed at compartment floor location, but this does not fully fill the void behind the Steni GRP rainscreen cladding panel and the concrete floor slab (Taken from Queens Court 2021).

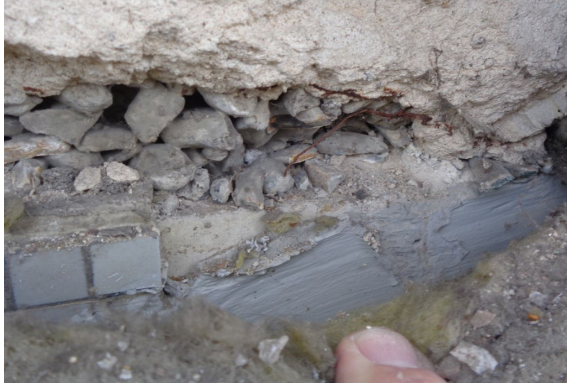
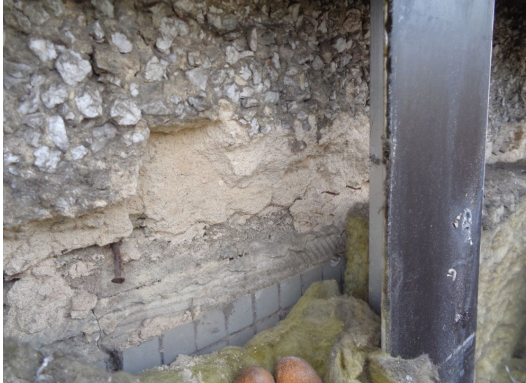
| <p><i>Figure 79: Close up view to show pebble dash render, Wimpey no fine concrete, concrete floor slab and mineral wool insulation installed at compartment floor location (Taken from Queens Court 2021).</i></p> | <p><i>Figure 80: Alternative view to show pebble dash render, Wimpey no fine concrete, concrete floor slab and mineral wool insulation installed at compartment floor location (Taken from Queens Court 2021).</i></p> |

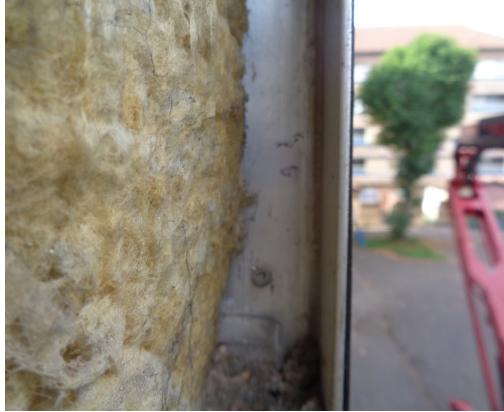
| <p><i>Figure 81: Close up view at compartment floor location to show that the mineral wool insulation does not fully fill the void and therefore does not form a suitable cavity barrier at compartment floor location (Taken from Queens Court 2021)</i></p> | <p><i>Figure 82: General view to show clear cavity between pebble dash render and the Steni GRP rainscreen cladding panel (Taken from Queens Court 2021).</i></p> |

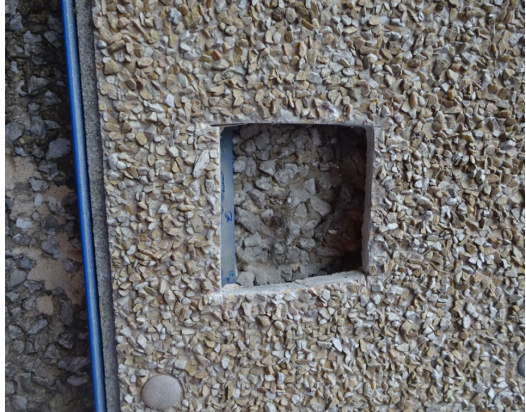
| <p><i>Figure 83: General view of sample locations to open access balcony wall reveals at first floor level.</i></p> | <p><i>Figure 84: Close up view of Steni GRP rainscreen cladding panel installed over pebble dash render finish with 10mm void.</i></p> |

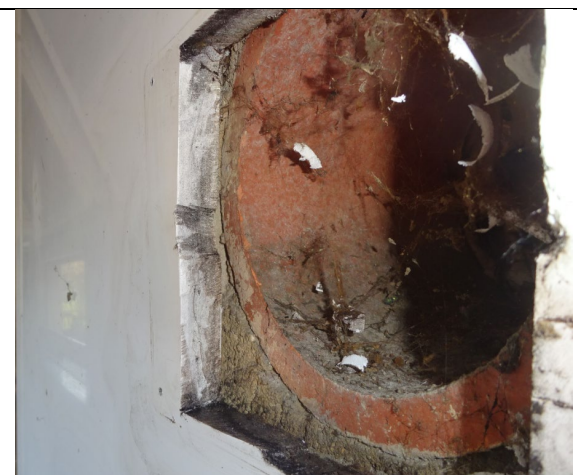
Figure 90: Close up view of the sample location.

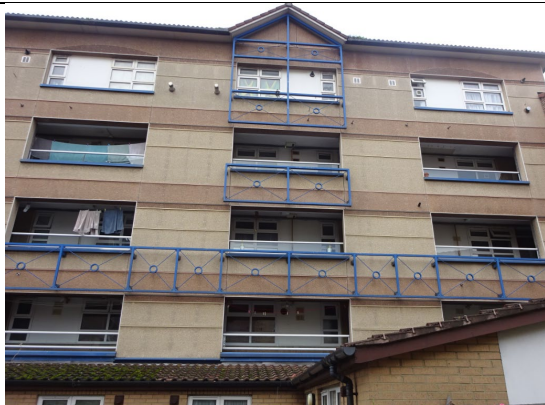
*Figure 93: General view to show solid uPVC panels installed at fourth floor level along the east elevation.*

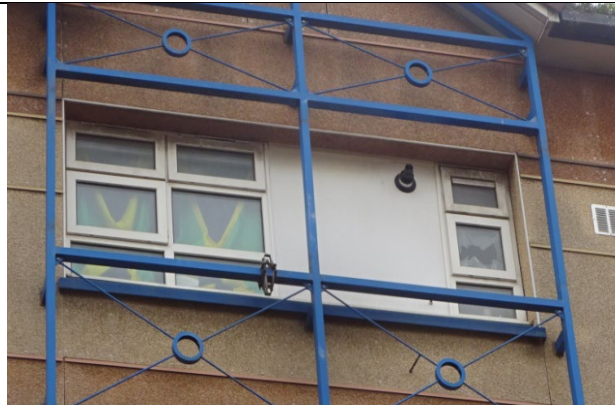
*Figure 94: Close up view of the solid uPVC panels installed at fourth floor level along the east elevation.*

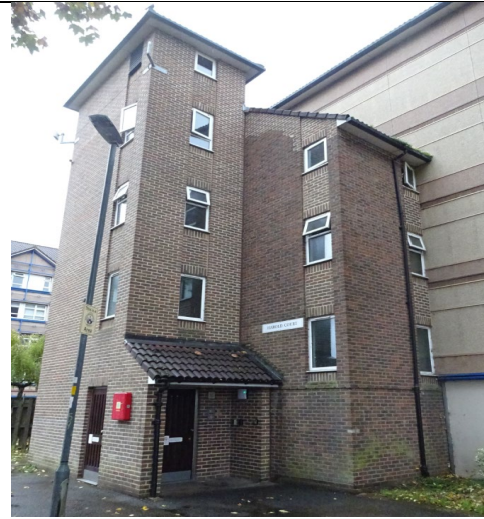
*Figure 96: Alternative view of the traditional masonry cavity wall construction to the escape staircase located on the north elevation.*

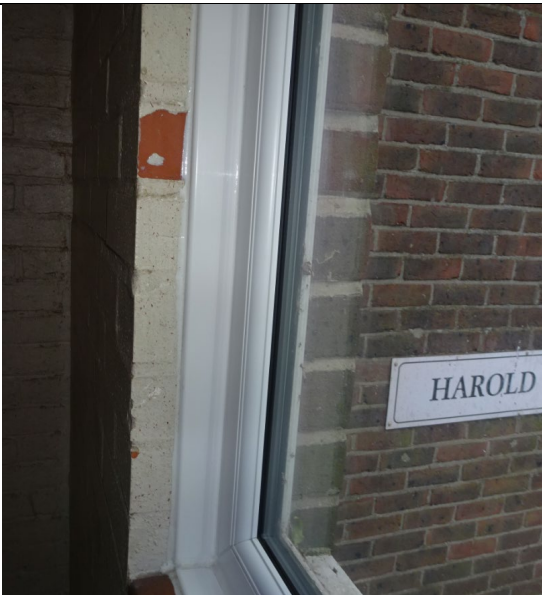
*Figure 97: General view of the wall construction to show brick inner leaf and brick outer leaf.*

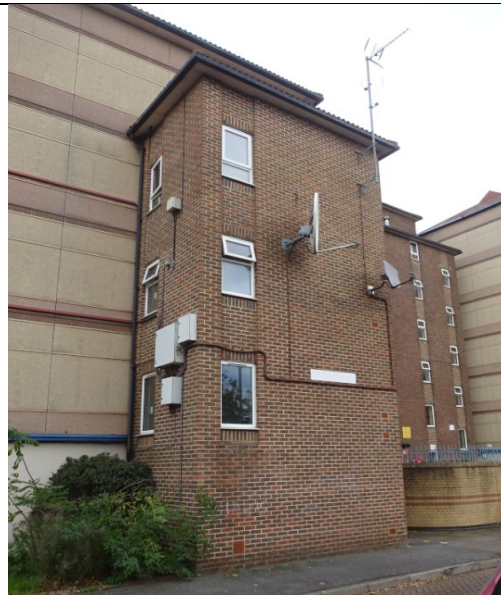
*Figure 98: General view of the traditional masonry cavity wall construction to the escape staircase located on the south elevation.*

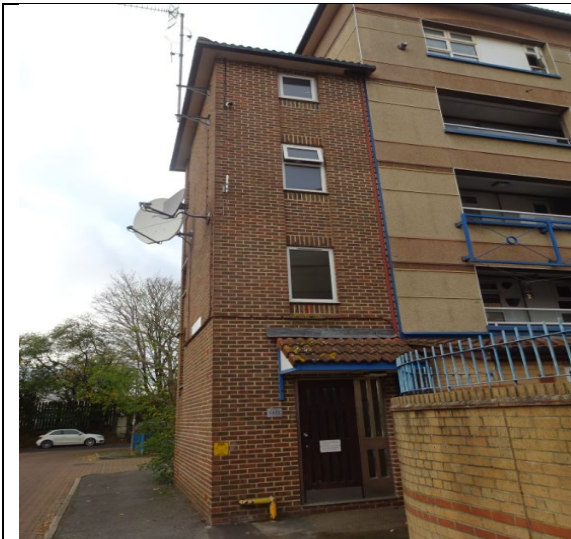
Figure 99: Alternative view of the traditional masonry cavity wall construction to the escape staircase located on the south elevation.

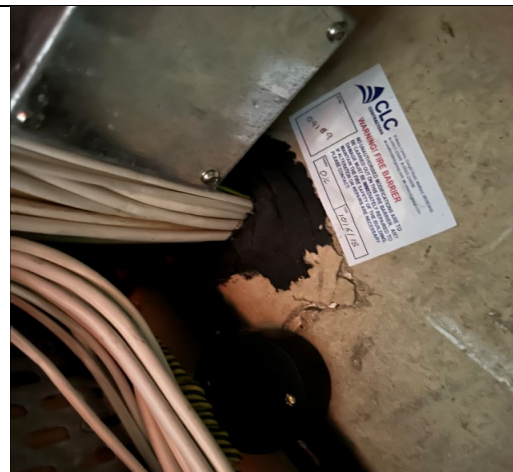
Figure 102: General view to show fire stopping works including ID labels completed to riser cupboards located in escape staircases.

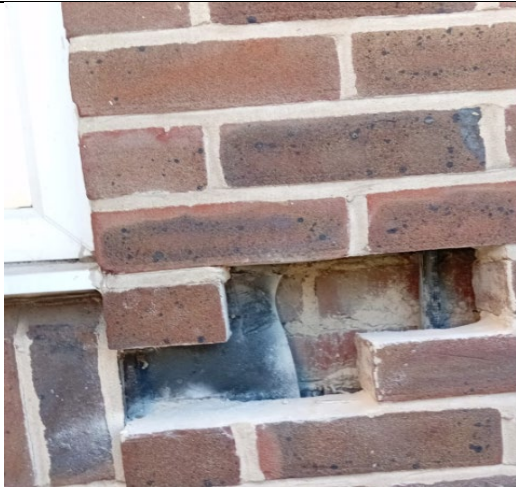
Figure 103: General view of sample location to window cill located on south elevation.

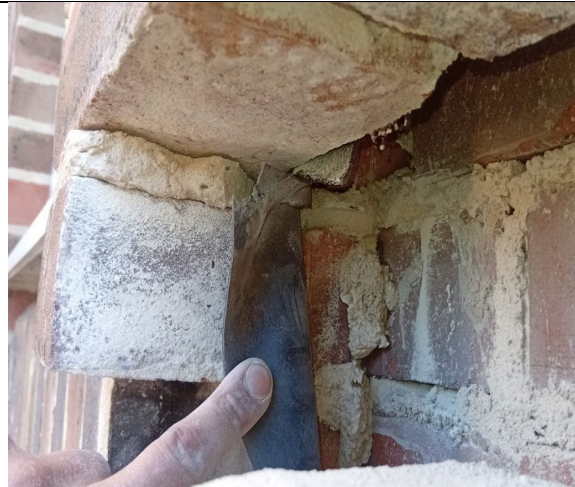
The intrusive survey identified that a clear cavity exists between the two leaves of masonry construction. The cavity is continuous vertically and horizontal with no cavity barriers observed during the inspection. However, the window openings are closed with the brickwork returning to close the cavity.

Figure 104: General view to show window cill cavity detail with masonry brickwork closing the cavity.

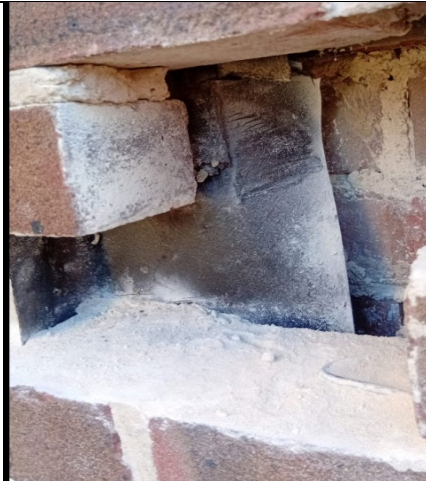
Figure 105: Alternative view of window cill detail.

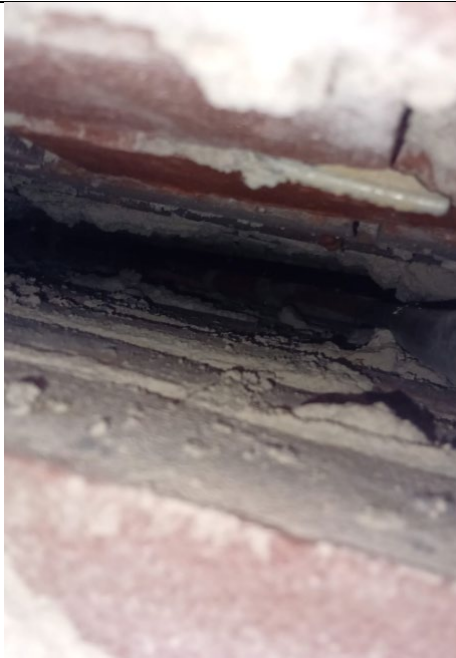
Figure 109: General view to show clear cavity to masonry wall.

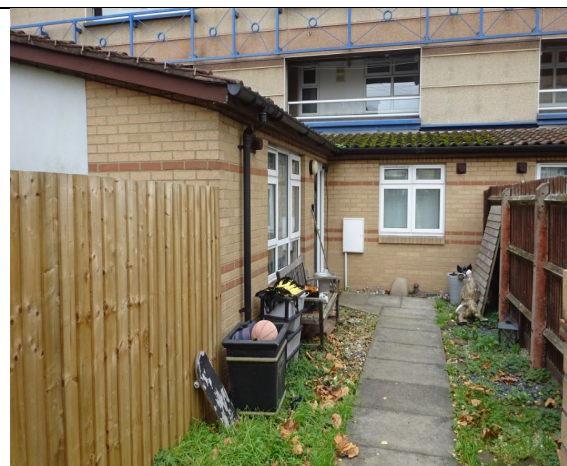
Figure 112: Alternative view of the traditional masonry cavity wall construction to the ground floor flats along the east elevation.

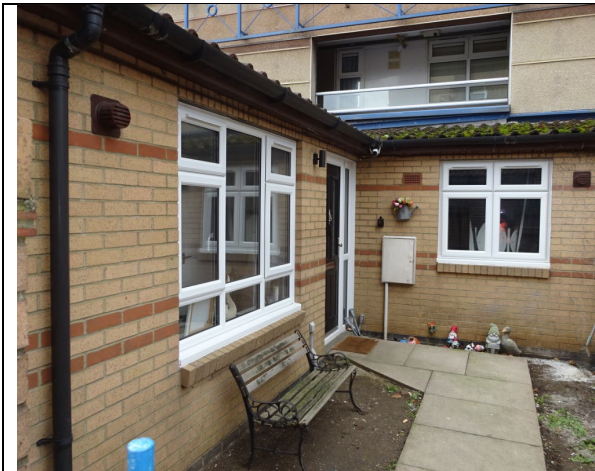
*Figure 113: Alternative view of the traditional masonry cavity wall construction to the ground floor flats along the east elevation.*

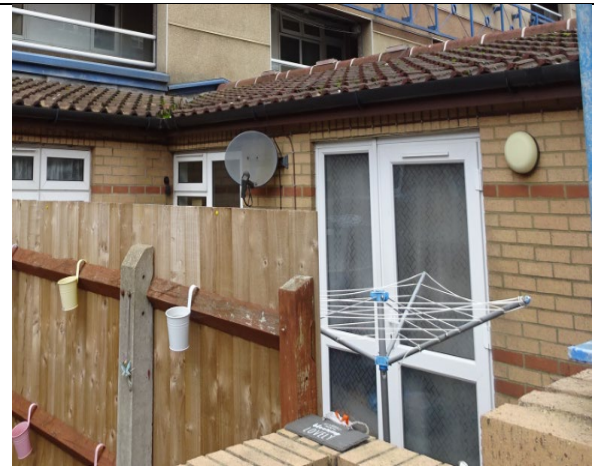
*Figure 114: Alternative view of the traditional masonry cavity wall construction to the ground floor flats along the east elevation.*

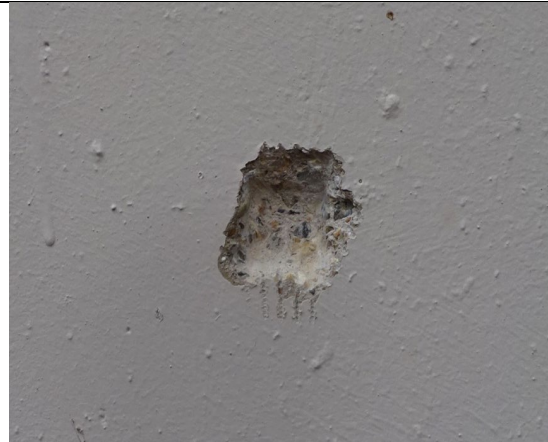
Figure 116: Close up view of the sample location to confirm solid concrete shear wall.

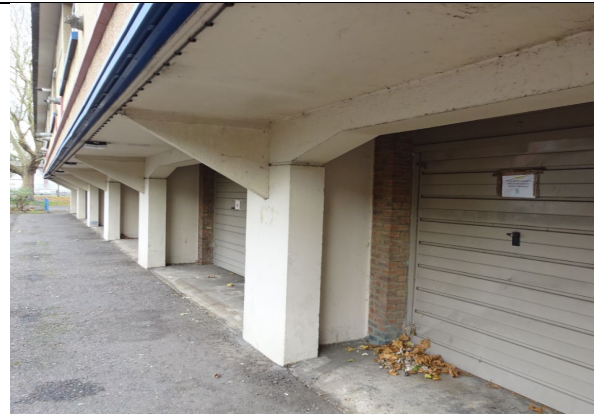
Figure 117: General view of the reinforced concrete frame and concrete floor to the west elevation. NB. that the garages are recessed back from the main elevation.

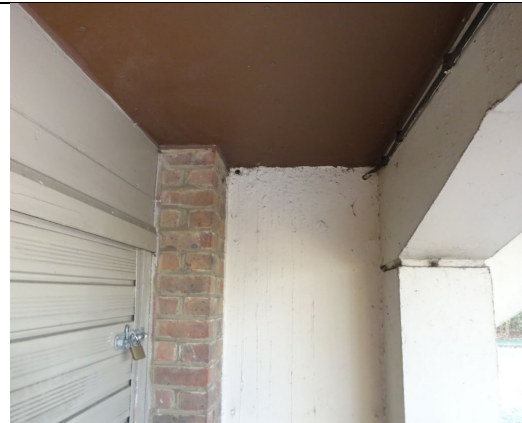
Figure 118: Close up view to show reinforced concrete wall and frame to the west elevation.

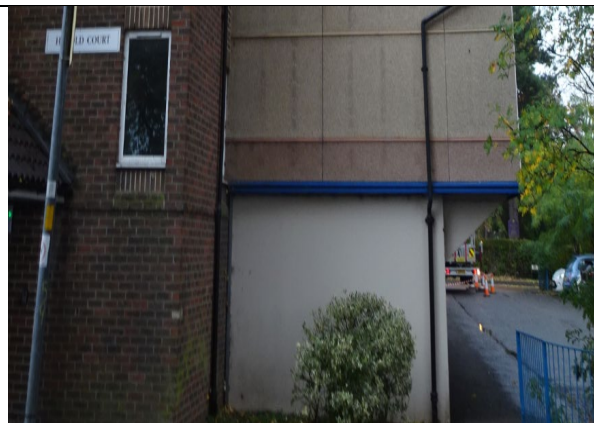
Figure 119: General view of the reinforced concrete wall to the north elevation at ground floor level.

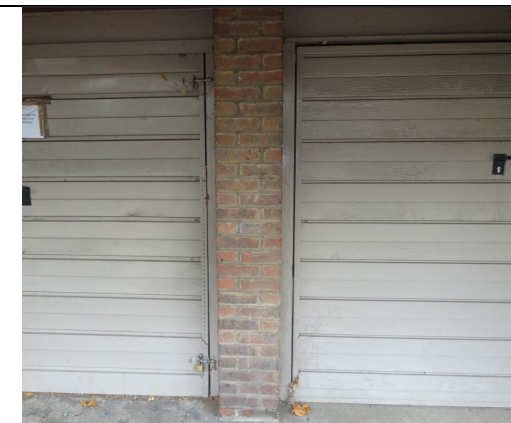
Figure 120: General view to show solid masonry wall located between garages.

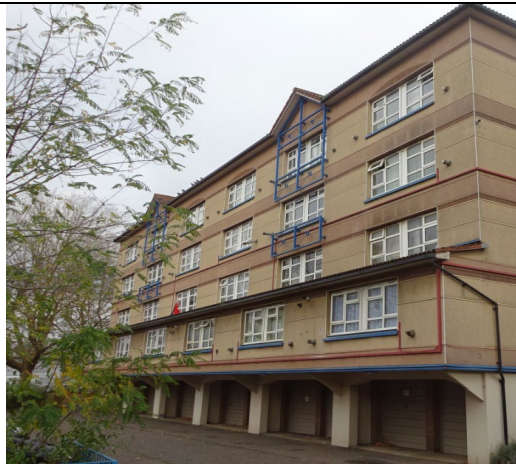
Therefore, the risk rating for the decorative steel attachments is **Low**.

*Figure 121: General view of the decorative architectural steel attachments installed to the west elevation.*

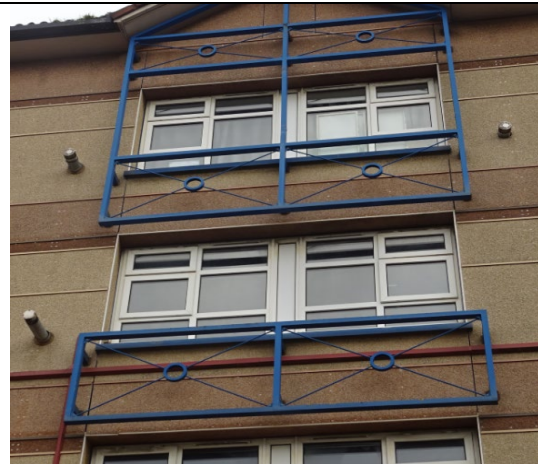
*Figure 122: Alternative view of the architectural decorative steel attachments installed to the west elevation.*

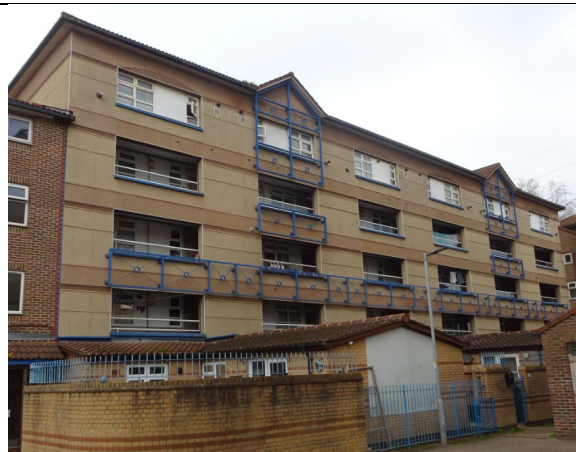
*Figure 123: General view of the decorative architectural steel attachments installed to the east elevation.*

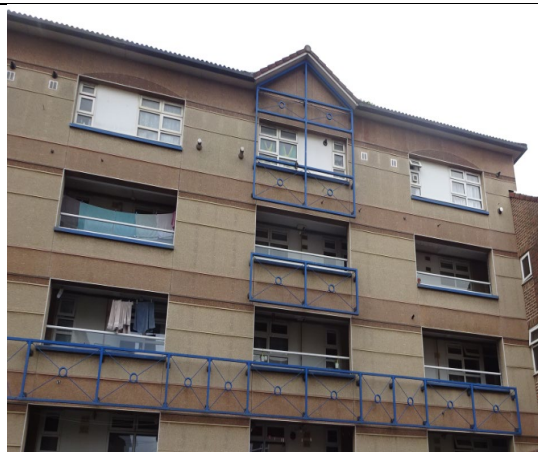
*Figure 124: Alternative view of the decorative architectural steel attachments installed to the east elevation.*

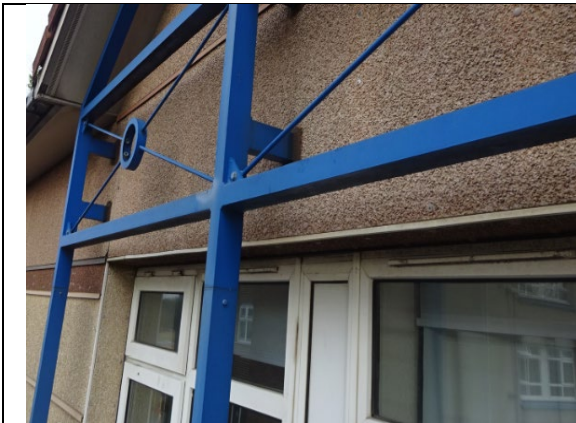
*Figure 125: Close up view of the decorative architectural steel attachments installed (Taken from Alexandra Court).*

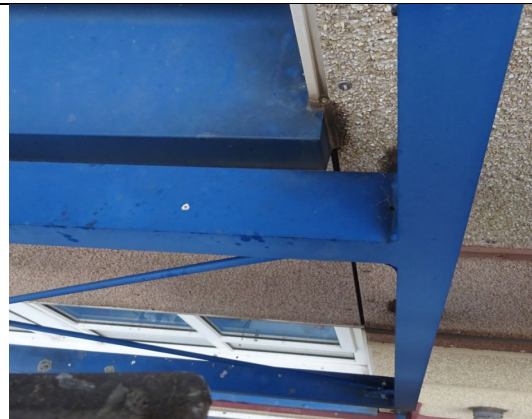
*Figure 126: Close up view of the decorative architectural steel attachments installed (Taken from Alexandra Court).*
